# School Assessment Report

Type: High Schools  
School: Austin High School  
Date: Jul 16, 2012

### School Name: Austin High School

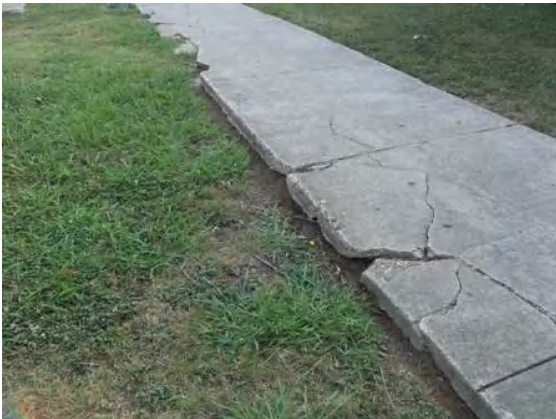
**System:** G2020 - Pedestrian Paving - sidewalks, etc.

**Analysis:** The system age is either beyond expected life or does not meet its intended performance under the Guidelines. The system may be in service and functioning but it is recommended to be replaced due to probable increased condition budget needs, the potential failure of its components, or in order to meet the performance Guidelines for this system. The system was installed in 1970. It has a 30-year service life which expired in 2000.

**Notes:** Pedestrian Paving - sidewalks beyond useful life.  
Replace

**Recommendation:** The system should be replaced.

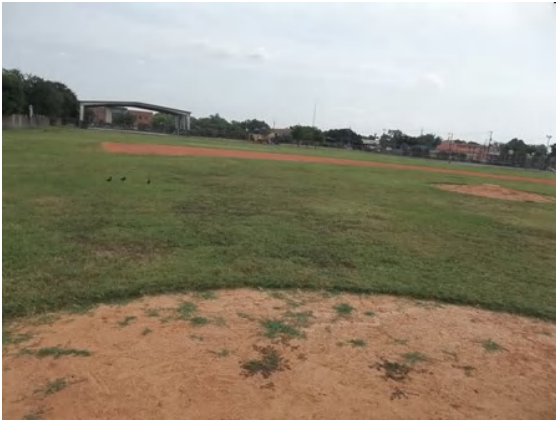
**System:** G2040 - Baseball Field

**Analysis:** The system age is either beyond expected life or does not meet its intended performance under the Guidelines. The system may be in service and functioning but it is recommended to be replaced due to probable increased condition budget needs, the potential failure of its components, or in order to meet the performance Guidelines for this system. The system was installed in 1970. It has a 30-year service life which expired in 2000.

**Notes:** baseball field beyond useful life. repair/reseed

**Recommendation:** The system should be replaced.

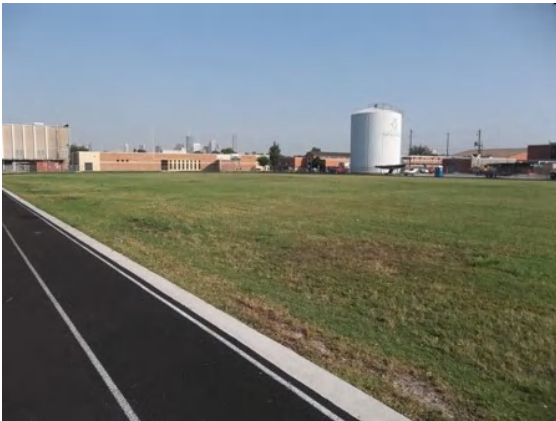
**System:** G2040 - Football Field Natural Turf

**Analysis:** The system age is either beyond expected life or does not meet its intended performance under the Guidelines. The system may be in service and functioning but it is recommended to be replaced due to probable increased condition budget needs, the potential failure of its components, or in order to meet the performance Guidelines for this system. The system was installed in 1980. It has a 10-year service life which expired in 1990.

**Notes:** Football Field Natural Turf System beyond useful life. Replace

**Recommendation:** The system should be replaced.

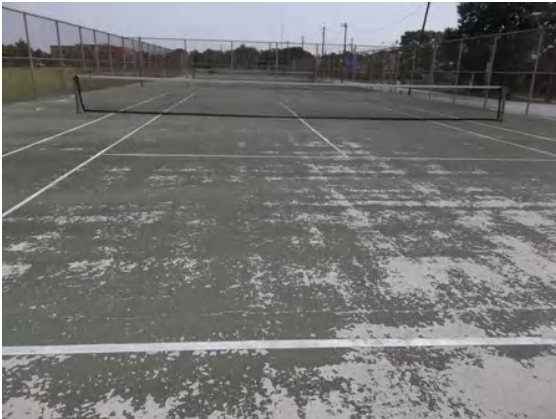
System: G2040 - Tennis Court (s)

Analysis: The system age is either beyond expected life or does not meet its intended performance under the Guidelines. The system may be in service and functioning but it is recommended to be replaced due to probable increased condition budget needs, the potential failure of its components, or in order to meet the performance Guidelines for this system. The system was installed in 2000. It has a 10-year service life which expired in 2010.

Recommendation: The system should be replaced.

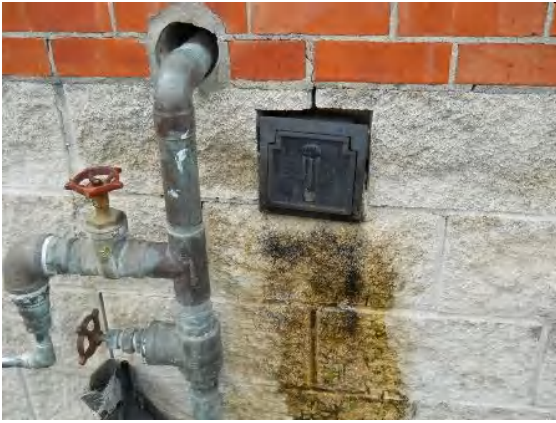
**System:** G3010 - Water Supply

**Analysis:** The system age is either beyond expected life or does not meet its intended performance under the Guidelines. The system may be in service and functioning but it is recommended to be replaced due to probable increased condition budget needs, the potential failure of its components, or in order to meet the performance Guidelines for this system. The system was installed in 1937. It has a 50-year service life which expired in 1987.

**Notes:** Water Supply System beyond useful life. Replace

**Recommendation:** The system should be replaced.

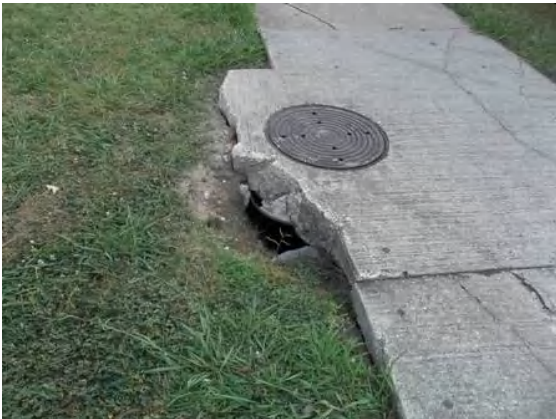
**System:** G3020 - Sanitary Sewer

**Analysis:** The system age is either beyond expected life or does not meet its intended performance under the Guidelines. The system may be in service and functioning but it is recommended to be replaced due to probable increased condition budget needs, the potential failure of its components, or in order to meet the performance Guidelines for this system. The system was installed in 1937. It has a 50-year service life which expired in 1987.

**Notes:** Sanitary Sewer System beyond useful life. Replace

**Recommendation:** The system should be replaced.

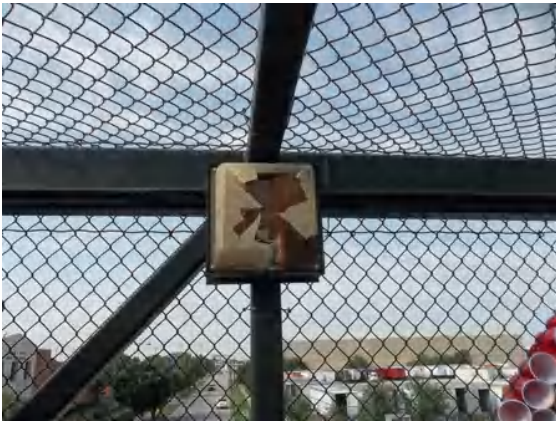
System: G4020 - Site Lighting

Analysis: The system age is either beyond expected life or does not meet its intended performance under the Guidelines. The system may be in service and functioning but it is recommended to be replaced due to probable increased condition budget needs, the potential failure of its components, or in order to meet the performance Guidelines for this system. The system was installed in 1980. It has a 30-year service life which expired in 2010.

Location: Site  
Distress: Beyond Expected Life  
Category: Deferred Maintenance  
Priority: 3 - Short Term Conditions (2-3 Years)  
Notes: Site Lighting System beyond useful life. Replace  
Correction: Renew System  
Qty: 1-Ea.  
Condition Budget: \$897,672

Recommendation: The system should be replaced.

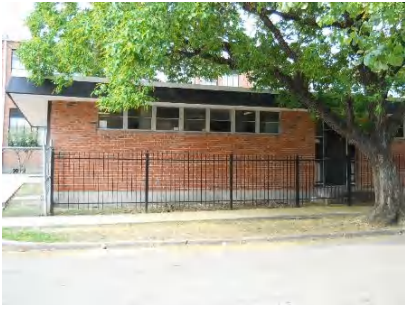
Location: Clinic  
Distress: Beyond Expected Life  
Category: Deferred Maintenance  
Priority: 3 - Short Term Conditions (2-3 Years)  
Notes: Exterior Windows System beyond useful life.  
Replace  
Correction: Renew System  
Qty: 1-Ea.  
Condition Budget: \$23,761

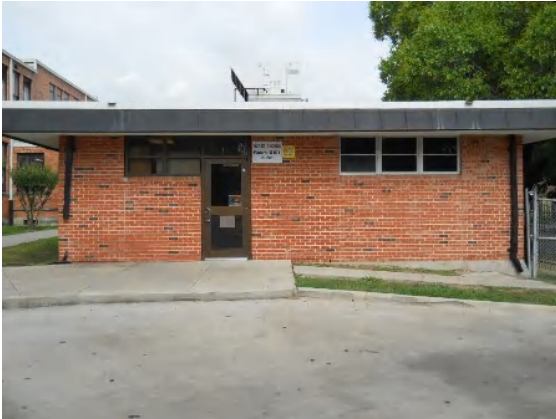
**System:** B2030 - Exterior Doors

Analysis: The system age is either beyond expected life or does not meet its intended performance under the Guidelines. The system may be in service and functioning but it is recommended to be replaced due to probable increased condition budget needs, the potential failure of its components, or in order to meet the performance Guidelines for this system. The system was installed in 1966. It has a 30-year service life which expired in 1996.

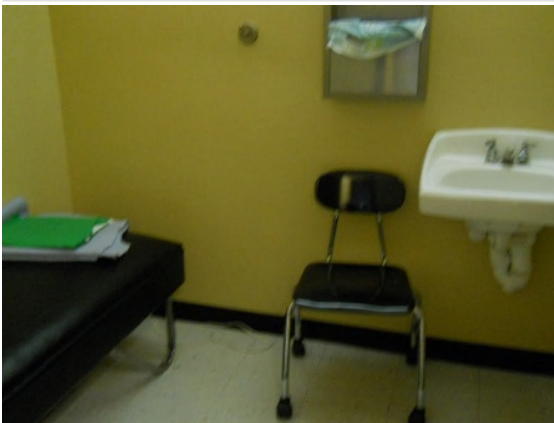
System: D2030 - Sanitary Waste

Analysis: The system age is either beyond expected life or does not meet its intended performance under the Guidelines. The system may be in service and functioning but it is recommended to be replaced due to probable increased condition budget needs, the potential failure of its components, or in order to meet the performance Guidelines for this system. The system was installed in 1966. It has a 30-year service life which expired in 1996.

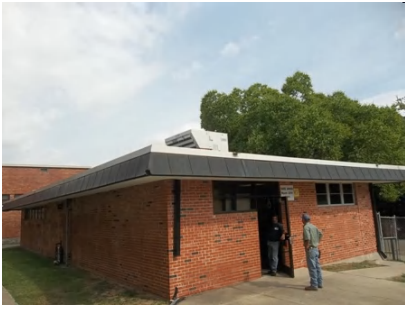
Location: Clinic  
Distress: Beyond Expected Life  
Category: Deferred Maintenance  
Priority: 3 - Short Term Conditions (2-3 Years)  
Notes: Rain Water Drainage System beyond useful life.  
Replace  
Correction: Renew System  
Qty: 1-Ea.  
Condition Budget: \$1,013

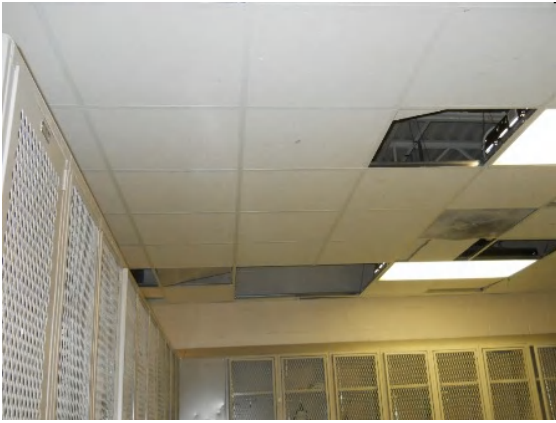
System: C3030 - Ceiling Finishes

Analysis: The system is in use and functioning with an estimated remaining service life as indicated in the report section "Condition/Replacement Budget Detail". The system was installed in 2004. It has a 20-year service life. However, in the assessment, it was found to be currently deficient.

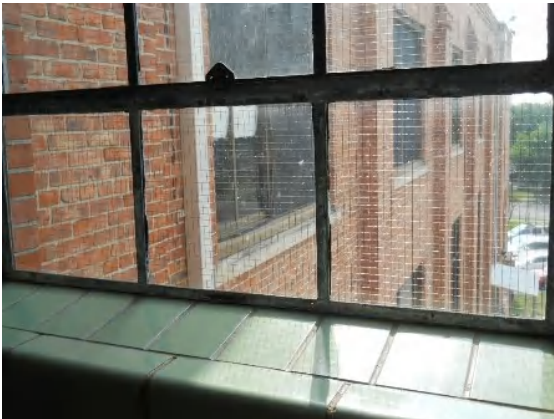
System: B2020 - Exterior Windows

Analysis: The system age is either beyond expected life or does not meet its intended performance under the Guidelines. The system may be in service and functioning but it is recommended to be replaced due to probable increased condition budget needs, the potential failure of its components, or in order to meet the performance Guidelines for this system. The system was installed in 1936. It has a 30-year service life which expired in 1966.

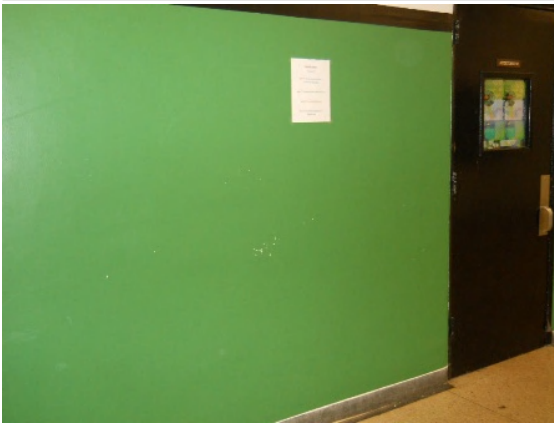
System: C3010 - Wall Finishes

Analysis: The system age is either beyond expected life or does not meet its intended performance under the Guidelines. The system may be in service and functioning but it is recommended to be replaced due to probable increased condition budget needs, the potential failure of its components, or in order to meet the performance Guidelines for this system. The system was installed in 1936. It has a 10-year service life which expired in 1946.

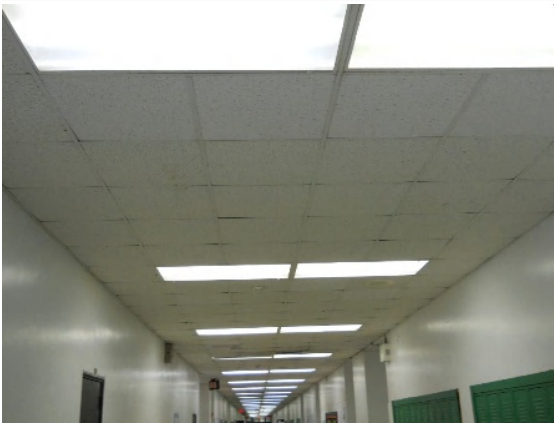
System: C3030 - Ceiling Finishes

Analysis: The system age is either beyond expected life or does not meet its intended performance under the Guidelines. The system may be in service and functioning but it is recommended to be replaced due to probable increased condition budget needs, the potential failure of its components, or in order to meet the performance Guidelines for this system. The system was installed in 1936. It has a 20-year service life which expired in 1956.

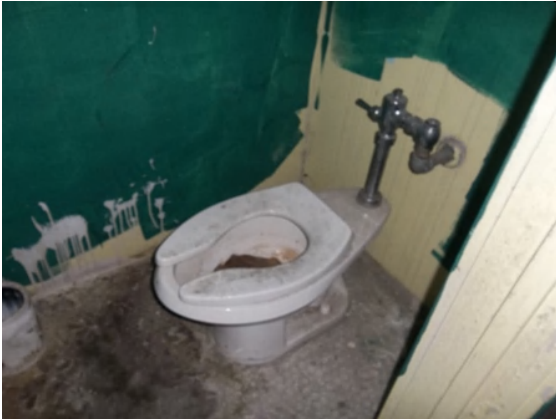
System: D2010 - Plumbing Fixtures

Analysis: The system age is either beyond expected life or does not meet its intended performance under the Guidelines. The system may be in service and functioning but it is recommended to be replaced due to probable increased condition budget needs, the potential failure of its components, or in order to meet the performance Guidelines for this system. The system was installed in 1980. It has a 30-year service life which expired in 2010.

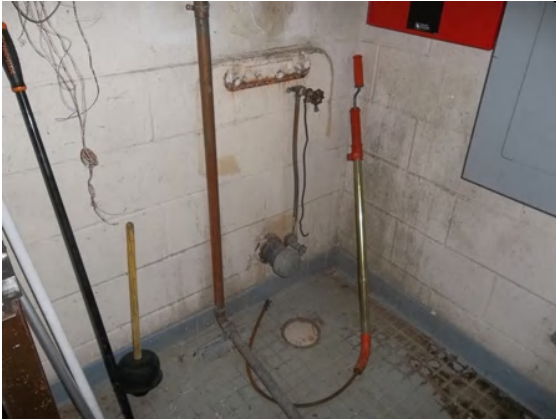
System: D2030 - Sanitary Waste

Analysis: The system age is either beyond expected life or does not meet its intended performance under the Guidelines. The system may be in service and functioning but it is recommended to be replaced due to probable increased condition budget needs, the potential failure of its components, or in order to meet the performance Guidelines for this system. The system was installed in 1980. It has a 30-year service life which expired in 2010.

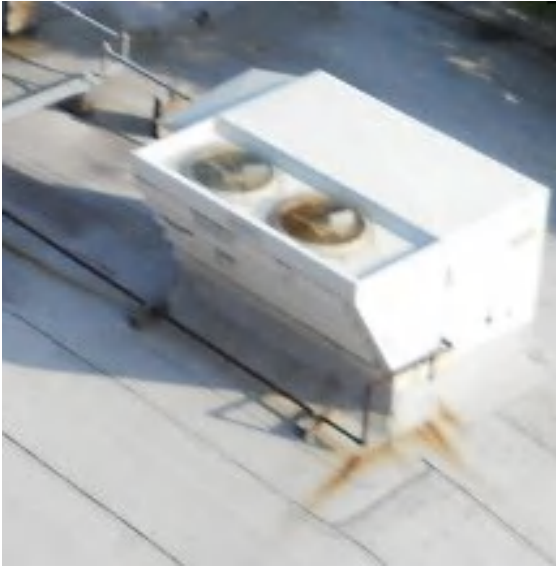
System: D3050 - Terminal & Package Units

Location: ROTC  
Distress: Beyond Expected Life  
Category: Deferred Maintenance  
Priority: 3 - Short Term Conditions (2-3 Years)  
Notes: Controls & Instrumentation beyond useful life.  
Replace  
Correction: Renew System  
Qty: 1-Ea.  
Condition Budget: \$22,816

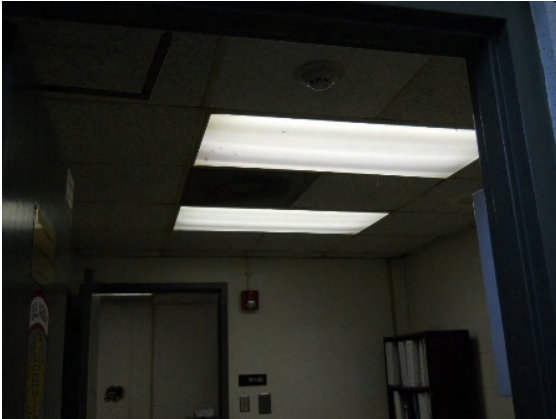
**System:** D3070 - Systems Testing & Balance

Location: ROTC  
Distress: Beyond Expected Life  
Category: Deferred Maintenance  
Priority: 3 - Short Term Conditions (2-3 Years)  
Notes: Electrical Service/Distribution System beyond useful life. Replace  
Correction: Renew System  
Qty: 1-Ea.  
Condition Budget: \$34,653

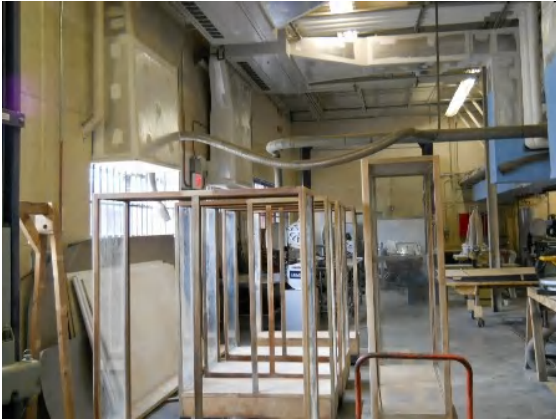
#### System: D3040 - Distribution Systems

Location: Vocational Shop 01  
Distress: Beyond Expected Life  
Category: Deferred Maintenance  
Priority: 3 - Short Term Conditions (2-3 Years)  
Notes: Controls & Instrumentation beyond useful life.  
Replace  
Correction: Renew System  
Qty: 1-Ea.  
Condition Budget: \$24,506

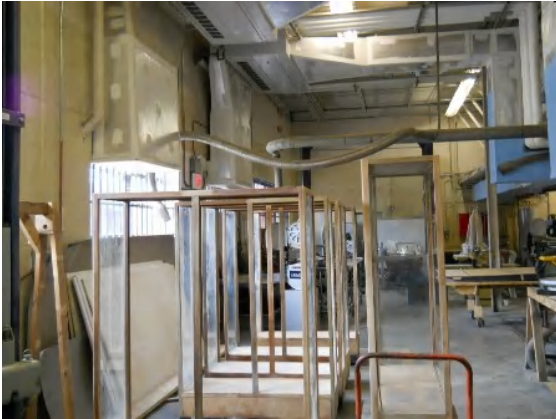
**System:** D3070 - Systems Testing & Balance

Location: Vocational Shop 01  
Distress: Beyond Expected Life  
Category: Deferred Maintenance  
Priority: 3 - Short Term Conditions (2-3 Years)  
Notes: Electrical Service/Distribution System beyond useful life. Replace  
Correction: Renew System  
Qty: 1-Ea.  
Condition Budget: \$37,092
