# School Assessment Report

Type: High Schools  
School: Booker T Washington High School  
Date: Jul 16, 2012

### School Name: Booker T Washington High School

Booker T. Washington High School campus is located at 119 East 39th Street, Houston TX, and consists of 4 main school buildings. The original campus was constructed in 1958 and additions to the main school building were constructed in 1962, 1988 and 2002. Ancillary buildings on campus include a classroom addition, Laboratory Building, Mechanical Building, T-Buildings and temporary storage sheds. In addition to the buildings, the campus contains covered walkways, baseball field, football field, track, and basketball hard-court. This report contains condition and adequacy data collected during the 2012 Facility Condition Assessment (FCA). The detailed condition and deficiency statements are contained in this report for each building and other facilities on the campus.

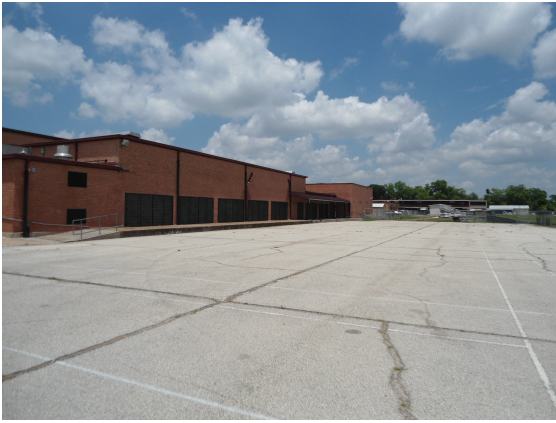
Notes: The basketball court / hard court play area is used for several activities, tennis is one of them and poles to support the net need to be installed and the court stripped for tennis. The basketball hoops are missing nets and the surface needs to be stripped at each hoop for basketball. The entire asphalt surfaces is cracked in several locations and needs to be resurfaced.

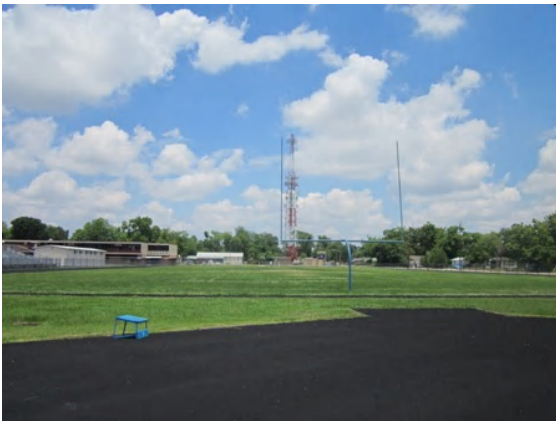
System: G2040 - Football Field Natural Turf

Analysis: The system age is either beyond expected life or does not meet its intended performance under the Guidelines. The system may be in service and functioning but it is recommended to be replaced due to probable increased condition budget needs, the potential failure of its components, or in order to meet the performance Guidelines for this system. The system was installed in 1988. It has a 10-year service life which expired in 1998.

Notes: The football field is inadequate. Re-sod, grade and level the playing field.

Recommendation: The system should be replaced.

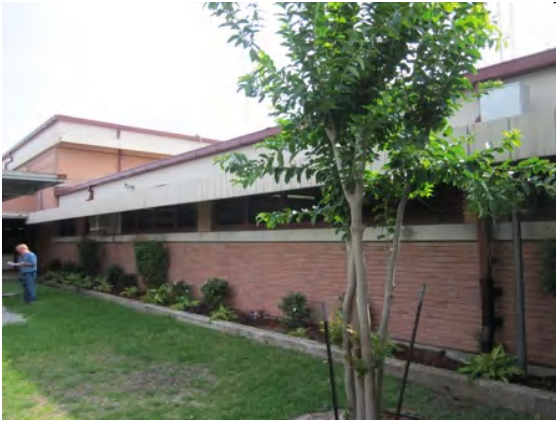
System: G2050 - Landscaping

Analysis: The system age is either beyond expected life or does not meet its intended performance under the Guidelines. The system may be in service and functioning but it is recommended to be replaced due to probable increased condition budget needs, the potential failure of its components, or in order to meet the performance Guidelines for this system. The system was installed in 1988. It has a 10-year service life which expired in 1998.

Notes: Landscaping is inadequate. Replace and enhance the landscaping.

Recommendation: The system should be replaced.

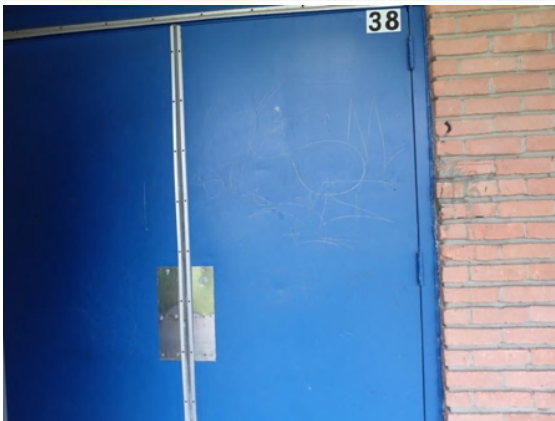
System: B2030 - Exterior Doors

Analysis: The system age is either beyond expected life or does not meet its intended performance under the Guidelines. The system may be in service and functioning but it is recommended to be replaced due to probable increased condition budget needs, the potential failure of its components, or in order to meet the performance Guidelines for this system. The system was installed in 1958. It has a 30-year service life which expired in 1988.

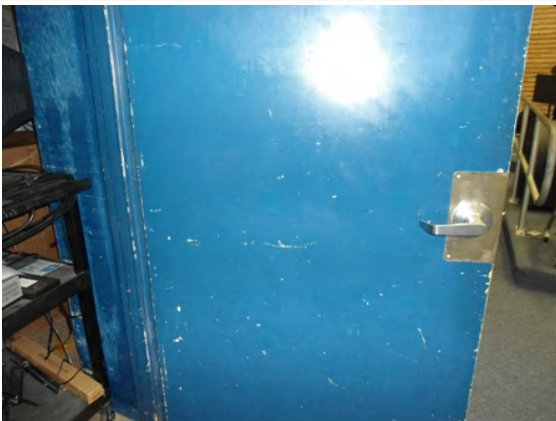
System: C1020 - Interior Doors

Analysis: The system age is either beyond expected life or does not meet its intended performance under the Guidelines. The system may be in service and functioning but it is recommended to be replaced due to probable increased condition budget needs, the potential failure of its components, or in order to meet the performance Guidelines for this system. The system was installed in 1958. It has a 40-year service life which expired in 1998.

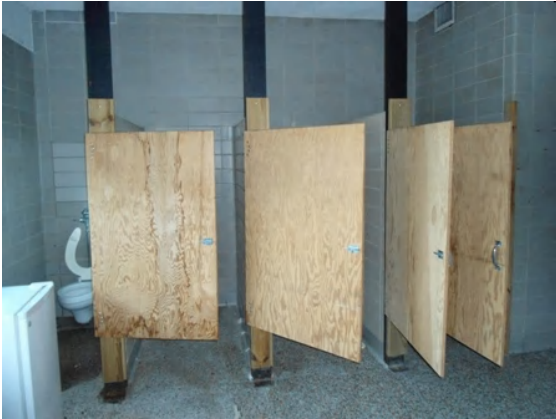
System: C1030 - Fittings

Analysis: The system age is either beyond expected life or does not meet its intended performance under the Guidelines. The system may be in service and functioning but it is recommended to be replaced due to probable increased condition budget needs, the potential failure of its components, or in order to meet the performance Guidelines for this system. The system was installed in 1988. It has a 20-year service life which expired in 2008.

Recommendation: The system should be replaced.

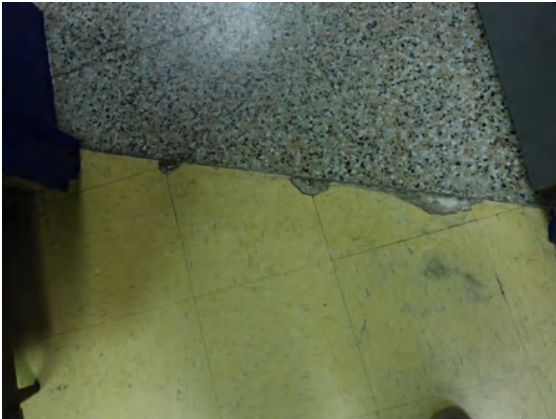
System: C3020410 - VCT

Analysis: The system age is either beyond expected life or does not meet its intended performance under the Guidelines. The system may be in service and functioning but it is recommended to be replaced due to probable increased condition budget needs, the potential failure of its components, or in order to meet the performance Guidelines for this system. The system was installed in 1988. It has a 12-year service life which expired in 2000.

Recommendation: The system should be replaced.

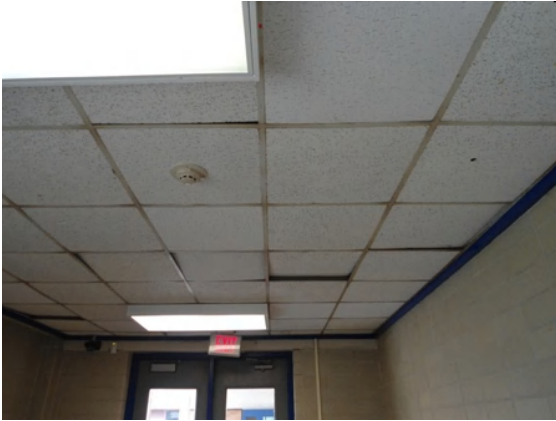
System: C3030 - Ceiling Finishes

Analysis: The system age is either beyond expected life or does not meet its intended performance under the Guidelines. The system may be in service and functioning but it is recommended to be replaced due to probable increased condition budget needs, the potential failure of its components, or in order to meet the performance Guidelines for this system. The system was installed in 1988. It has a 20-year service life which expired in 2008.

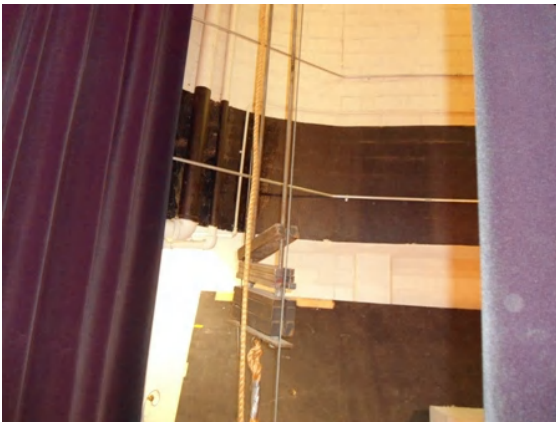
System: E1020 - Institutional Equipment

Analysis: The system age is either beyond expected life or does not meet its intended performance under the Guidelines. The system may be in service and functioning but it is recommended to be replaced due to probable increased condition budget needs, the potential failure of its components, or in order to meet the performance Guidelines for this system. The system was installed in 1989. It has a 20-year service life which expired in 2009.

Recommendation: The system should be replaced.

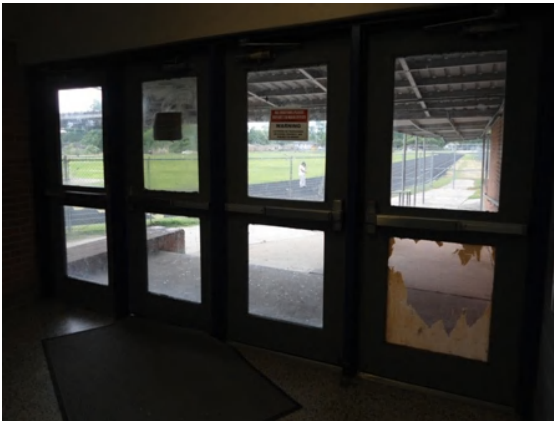
System: B2030 - Exterior Doors

Analysis: The system age is either beyond expected life or does not meet its intended performance under the Guidelines. The system may be in service and functioning but it is recommended to be replaced due to probable increased condition budget needs, the potential failure of its components, or in order to meet the performance Guidelines for this system. The system was installed in 1958. It has a 30-year service life which expired in 1988.

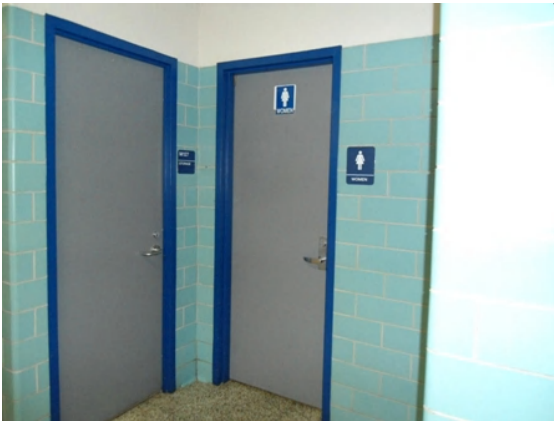
System: C1020 - Interior Doors

Analysis: The system age is either beyond expected life or does not meet its intended performance under the Guidelines. The system may be in service and functioning but it is recommended to be replaced due to probable increased condition budget needs, the potential failure of its components, or in order to meet the performance Guidelines for this system. The system was installed in 1958. It has a 40-year service life which expired in 1998.

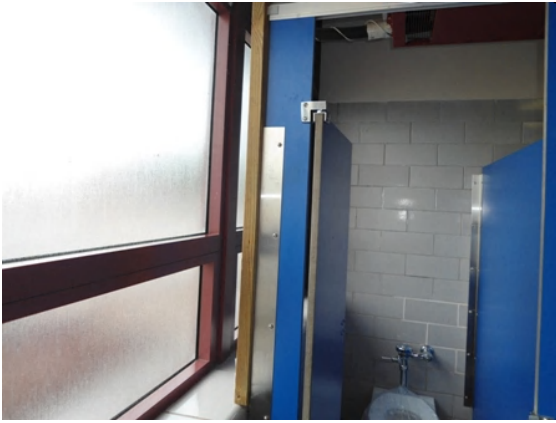
System: C1030 - Fittings

Analysis: The system age is either beyond expected life or does not meet its intended performance under the Guidelines. The system may be in service and functioning but it is recommended to be replaced due to probable increased condition budget needs, the potential failure of its components, or in order to meet the performance Guidelines for this system. The system was installed in 1989. It has a 20-year service life which expired in 2009.

Recommendation: The system should be replaced.

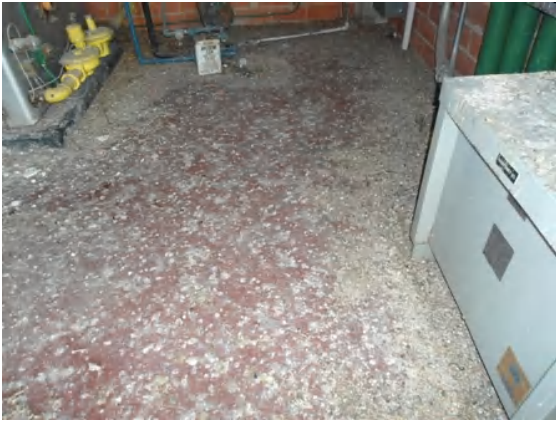
System: C3020410 - Sealed Concrete

Analysis: The system age is either beyond expected life or does not meet its intended performance under the Guidelines. The system may be in service and functioning but it is recommended to be replaced due to probable increased condition budget needs, the potential failure of its components, or in order to meet the performance Guidelines for this system. The system was installed in 1958. It has a 0-year service life which expired in 1958.

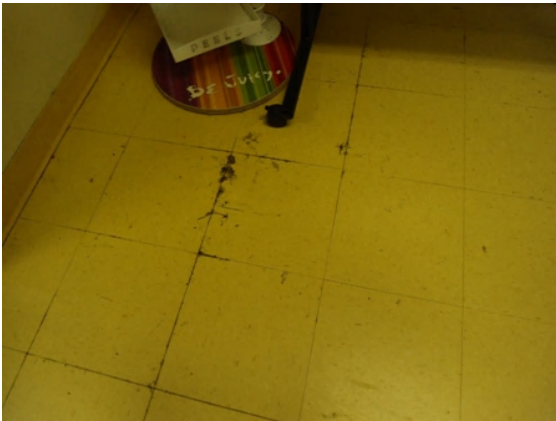
System: C3020410 - VCT

Analysis: The system age is either beyond expected life or does not meet its intended performance under the Guidelines. The system may be in service and functioning but it is recommended to be replaced due to probable increased condition budget needs, the potential failure of its components, or in order to meet the performance Guidelines for this system. The system was installed in 1958. It has a 0-year service life which expired in 1958.

Recommendation: The system should be replaced.

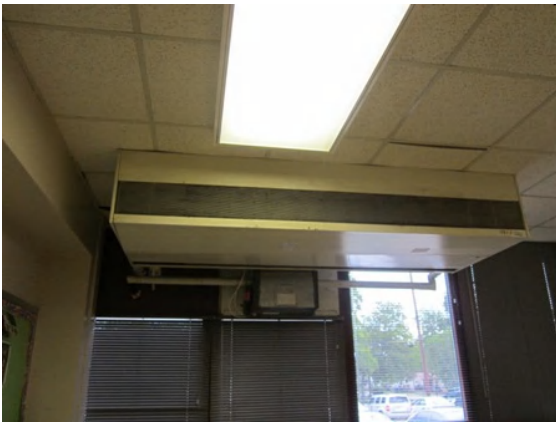
System: D3050 - Terminal & Package Units

Analysis: The system age is either beyond expected life or does not meet its intended performance under the Guidelines. The system may be in service and functioning but it is recommended to be replaced due to probable increased condition budget needs, the potential failure of its components, or in order to meet the performance Guidelines for this system. The system was installed in 1989. It has a 15-year service life which expired in 2004.

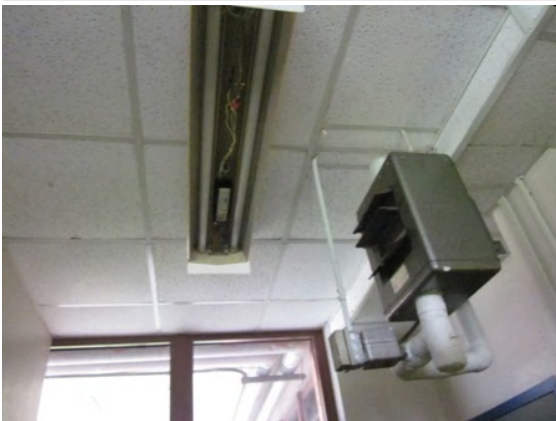
System: D3060 - Controls & Instrumentation

Analysis: The system age is either beyond expected life or does not meet its intended performance under the Guidelines. The system may be in service and functioning but it is recommended to be replaced due to probable increased condition budget needs, the potential failure of its components, or in order to meet the performance Guidelines for this system. The system was installed in 1989. It has a 15-year service life which expired in 2004.

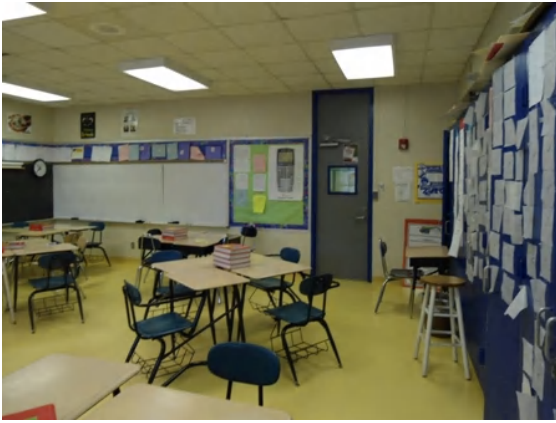
System: E1020 - Institutional Equipment

Analysis: The system age is either beyond expected life or does not meet its intended performance under the Guidelines. The system may be in service and functioning but it is recommended to be replaced due to probable increased condition budget needs, the potential failure of its components, or in order to meet the performance Guidelines for this system. The system was installed in 1958. It has a 20-year service life which expired in 1978.

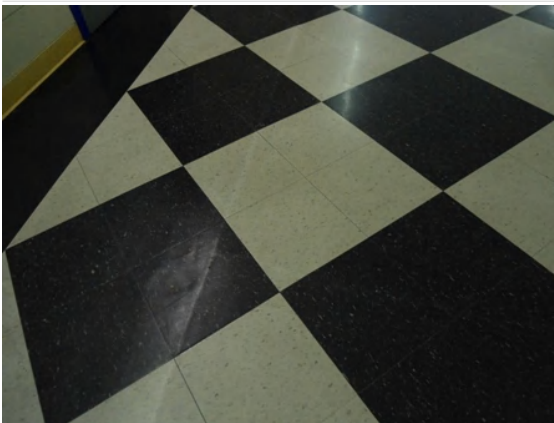
System: C3020410 - VCT

Analysis: The system age is either beyond expected life or does not meet its intended performance under the Guidelines. The system may be in service and functioning but it is recommended to be replaced due to probable increased condition budget needs, the potential failure of its components, or in order to meet the performance Guidelines for this system. The system was installed in 1988. It has a 12-year service life which expired in 2000.

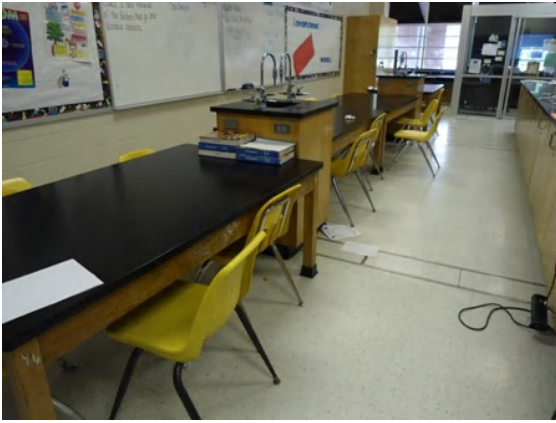
**System:** E1020 - Institutional Equipment

**Analysis:** The system age is either beyond expected life or does not meet its intended performance under the Guidelines. The system may be in service and functioning but it is recommended to be replaced due to probable increased condition budget needs, the potential failure of its components, or in order to meet the performance Guidelines for this system. The system was installed in 1988. It has a 20-year service life which expired in 2008.

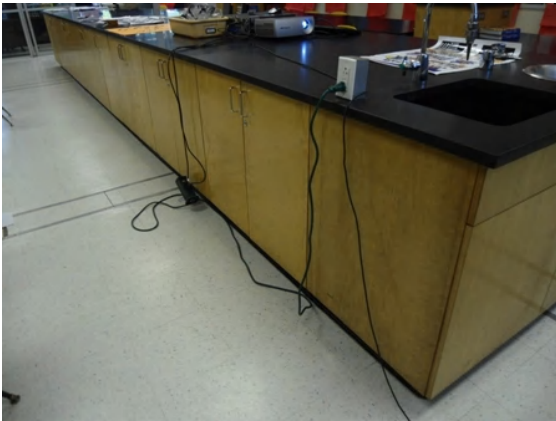
**System:** E2010 - Fixed Furnishings

**Analysis:** The system age is either beyond expected life or does not meet its intended performance under the Guidelines. The system may be in service and functioning but it is recommended to be replaced due to probable increased condition budget needs, the potential failure of its components, or in order to meet the performance Guidelines for this system. The system was installed in 1988. It has a 20-year service life which expired in 2008.

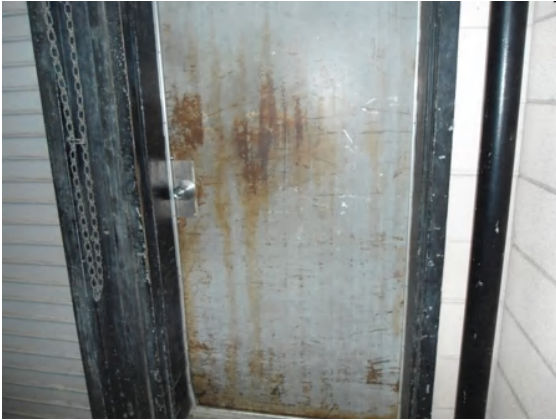
System: B2030 - Exterior Doors

Analysis: The system age is either beyond expected life or does not meet its intended performance under the Guidelines. The system may be in service and functioning but it is recommended to be replaced due to probable increased condition budget needs, the potential failure of its components, or in order to meet the performance Guidelines for this system. The system was installed in 1988. It has a 30-year service life. However, in the assessment, it was found to be currently deficient.

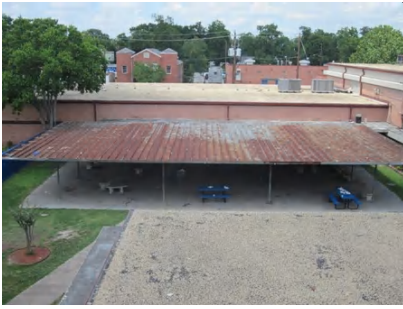
Location: Covered Patio Cafateria  
 Distress: Beyond Expected Life  
 Category: Deferred Maintenance  
 Priority: 3 - Short Term Conditions (2-3 Years)  
 Notes: Preformed metal framed roofing is beyond expected life. Replace preformed metal roofing.  
 Correction: Renew System  
 Qty: 1-Ea.  
 Condition Budget: \$83,592
