# School Assessment Report

Type: High Schools  
School: Lamar High School  
Date: Jul 16, 2012

### School Name: Lamar High School

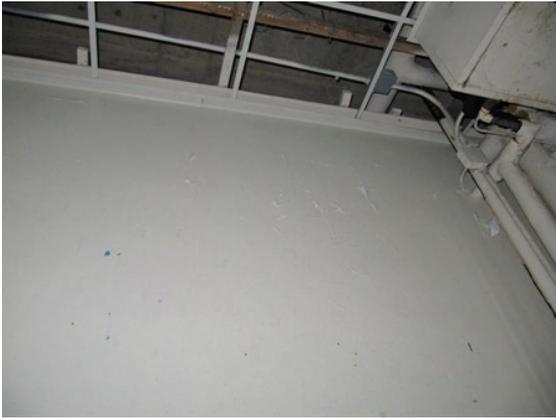
**System:** C3010 - Wall Finishes

**Analysis:** The system age is either beyond expected life or does not meet its intended performance under the Guidelines. The system may be in service and functioning but it is recommended to be replaced due to probable increased condition budget needs, the potential failure of its components, or in order to meet the performance Guidelines for this system. The system was installed in 2003. It has a 10-year service life. However, in the assessment, it was found to be currently deficient.

**Recommendation:** The system should be replaced.

**Priority:** 3 - Short Term Conditions (2-3 Years)

**Condition Budget:** \$962,085

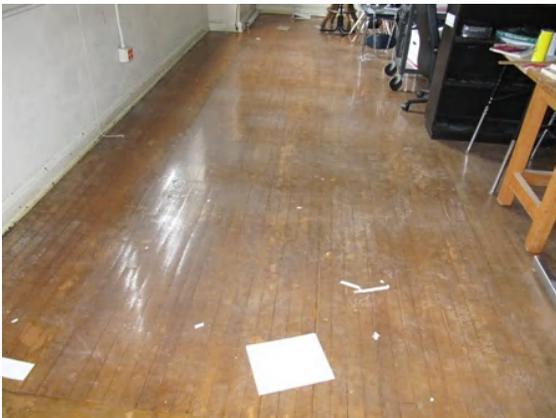
**System:** C3020 - Floor Finishes

**Analysis:** The system is in use and functioning with an estimated remaining service life as indicated in the report section "Condition/Replacement Budget Detail". The system was installed in 2003. It has a 20-year service life. However, in the assessment, it was found to be currently deficient.

**Distress:** Needs Replacement

**Notes:** Wood flooring in classrooms is in need of replacement / repair / refinish as necessary

**Recommendation:** The system should be replaced.

**Correction:** Replace Hardwood Flooring

**Condition Budget:** \$170,969

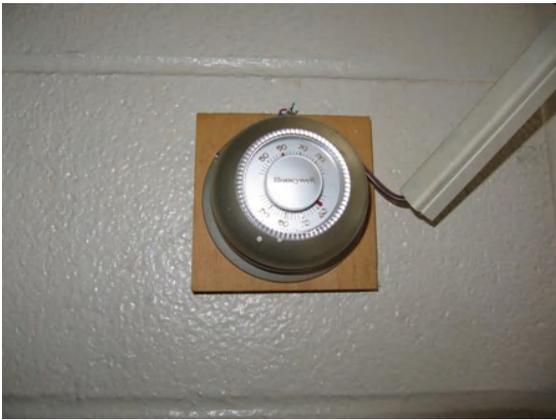
System: D3060 - Controls & Instrumentation

Analysis: The system age is either beyond expected life or does not meet its intended performance under the Guidelines. The system may be in service and functioning but it is recommended to be replaced due to probable increased condition budget needs, the potential failure of its components, or in order to meet the performance Guidelines for this system. The system was installed in 1987. It has a 15-year service life which expired in 2002.

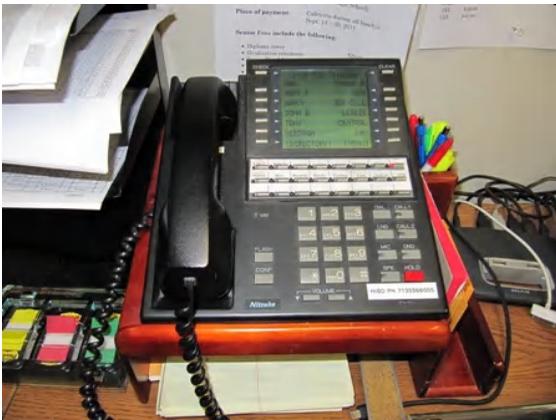
System: D5030310 - Telephone Systems

Analysis: The system age is either beyond expected life or does not meet its intended performance under the Guidelines. The system may be in service and functioning but it is recommended to be replaced due to probable increased condition budget needs, the potential failure of its components, or in order to meet the performance Guidelines for this system. The system was installed in 1992. It has a 15-year service life which expired in 2007.

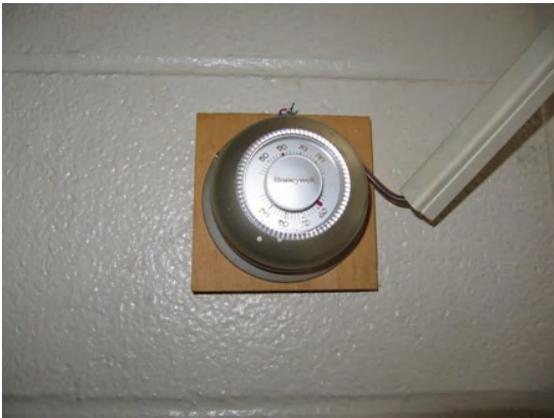
System: D3060 - Controls & Instrumentation

Analysis: The system age is either beyond expected life or does not meet its intended performance under the Guidelines. The system may be in service and functioning but it is recommended to be replaced due to probable increased condition budget needs, the potential failure of its components, or in order to meet the performance Guidelines for this system. The system was installed in 1987. It has a 15-year service life which expired in 2002.

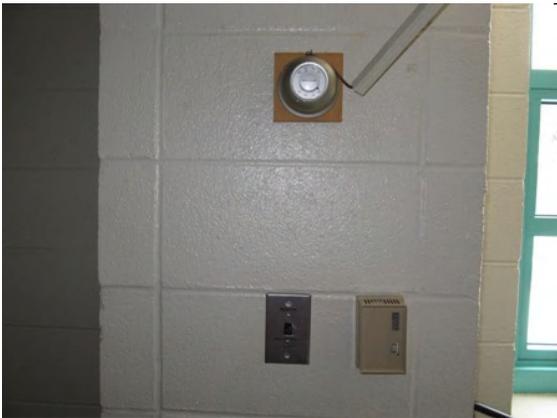
**System:** D3060 - Controls & Instrumentation

**Analysis:** The system age is either beyond expected life or does not meet its intended performance under the Guidelines. The system may be in service and functioning but it is recommended to be replaced due to probable increased condition budget needs, the potential failure of its components, or in order to meet the performance Guidelines for this system. The system was installed in 1987. It has a 15-year service life which expired in 2002.
