# School Assessment Report

Type: High Schools  
School: Lee High School  
Date: Jul 16, 2012

### School Name: Lee High School

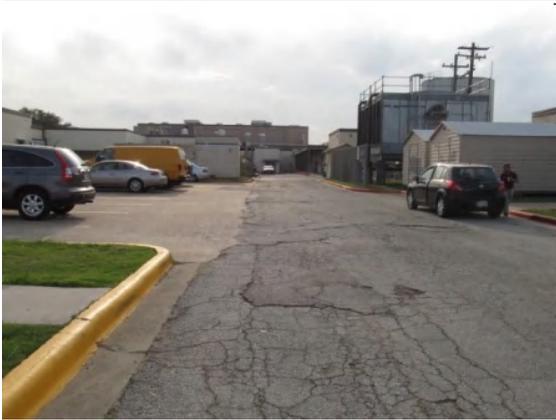
**System:** G2010 - Roadways

**Analysis:** The system age is either beyond expected life or does not meet its intended performance under the Guidelines. The system may be in service and functioning but it is recommended to be replaced due to probable increased condition budget needs, the potential failure of its components, or in order to meet the performance Guidelines for this system. The system was installed in 1962. It has a 25-year service life which expired in 1987.

**Notes:** The roadway for used for deliveries is showing major signs of distress. The asphalt is no longer level and holes have developed throughout. Some of the asphalt is loose and poses as a possible slip hazard. Demo old pavement, replace with concrete, approx 40' x 300'

**Recommendation:** The system should be replaced.

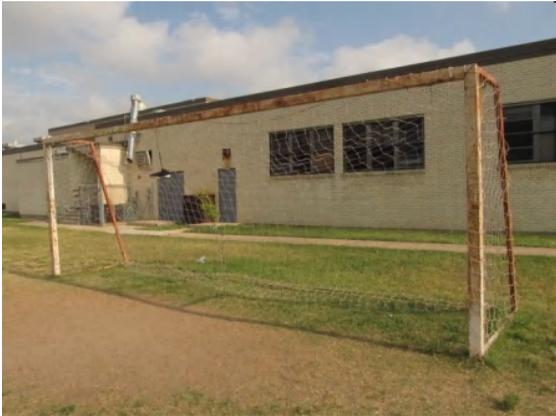
System: G2040 - Soccer / Practice Field

Analysis: The system age is either beyond expected life or does not meet its intended performance under the Guidelines. The system may be in service and functioning but it is recommended to be replaced due to probable increased condition budget needs, the potential failure of its components, or in order to meet the performance Guidelines for this system. The system was installed in 1962. It has a 10-year service life which expired in 1972.

Notes: The soccer field has patches of dead grass, bare spots and the equipment is rusting severely.

Recommendation: The system should be replaced.

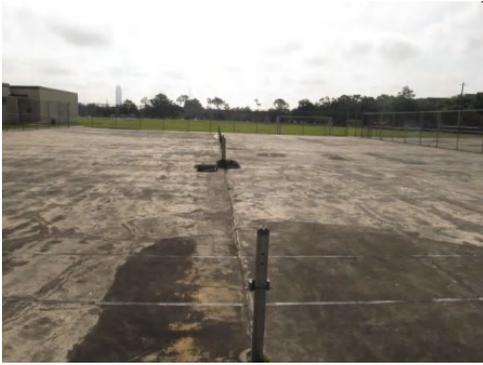
Location: Site  
Distress: Beyond Expected Life  
Category: Deferred Maintenance  
Priority: 3 - Short Term Conditions (2-3 Years)

Notes: The tennis courts on site are no longer adequate. The courts are showing age and wear, the fencing is rusting and the tennis nets are either missing or damaged.

Correction: Renew System  
Qty: 1-Ea.  
Condition Budget: \$531,765

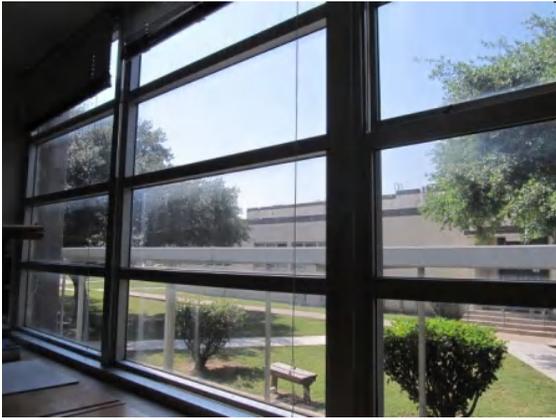
**System:** B2020 - Exterior Windows

**Analysis:** The system age is either beyond expected life or does not meet its intended performance under the Guidelines. The system may be in service and functioning but it is recommended to be replaced due to probable increased condition budget needs, the potential failure of its components, or in order to meet the performance Guidelines for this system. The system was installed in 1997. It has a 30-year service life. However, in the assessment, it was found to be currently deficient.

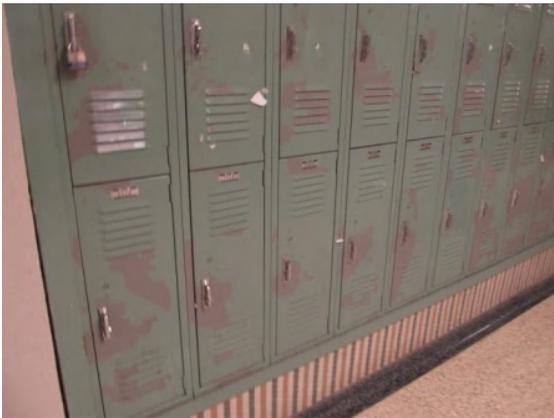
System: C1030 - Fittings

Analysis: The system age is either beyond expected life or does not meet its intended performance under the Guidelines. The system may be in service and functioning but it is recommended to be replaced due to probable increased condition budget needs, the potential failure of its components, or in order to meet the performance Guidelines for this system. The system was installed in 1962. It has a 20-year service life which expired in 1982.

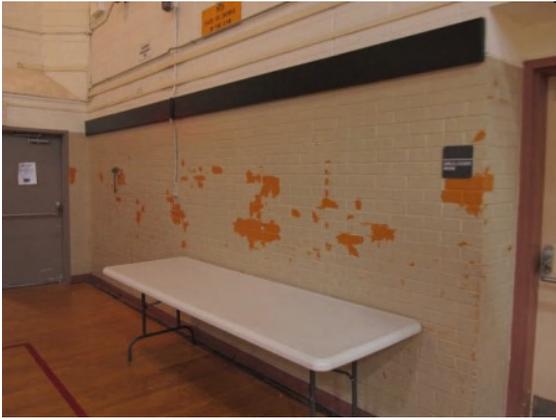
**System:** C3010 - Wall Finishes

**Analysis:** The system age is either beyond expected life or does not meet its intended performance under the Guidelines. The system may be in service and functioning but it is recommended to be replaced due to probable increased condition budget needs, the potential failure of its components, or in order to meet the performance Guidelines for this system. The system was installed in 1962. It has a 10-year service life which expired in 1972.

**Recommendation:** The system should be replaced.

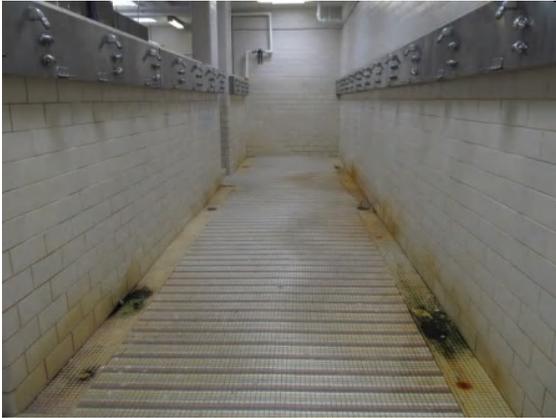
System: C3020410 - Ceramic Tile

Analysis: The system age is either beyond expected life or does not meet its intended performance under the Guidelines. The system may be in service and functioning but it is recommended to be replaced due to probable increased condition budget needs, the potential failure of its components, or in order to meet the performance Guidelines for this system. The system was installed in 1962. It has a 50-year service life. However, in the assessment, it was found to be currently deficient.

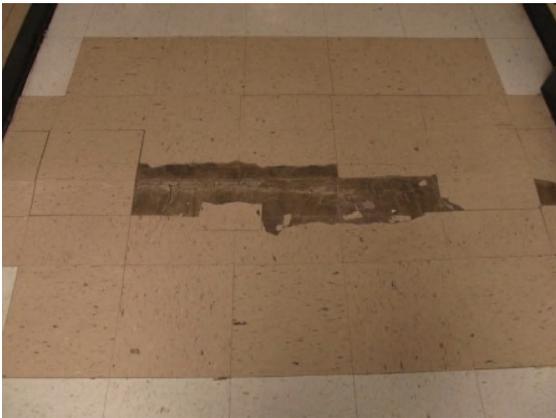
System: C3020410 - VCT

Analysis: The system age is either beyond expected life or does not meet its intended performance under the Guidelines. The system may be in service and functioning but it is recommended to be replaced due to probable increased condition budget needs, the potential failure of its components, or in order to meet the performance Guidelines for this system. The system was installed in 1997. It has a 12-year service life which expired in 2009.

Recommendation: The system should be replaced.

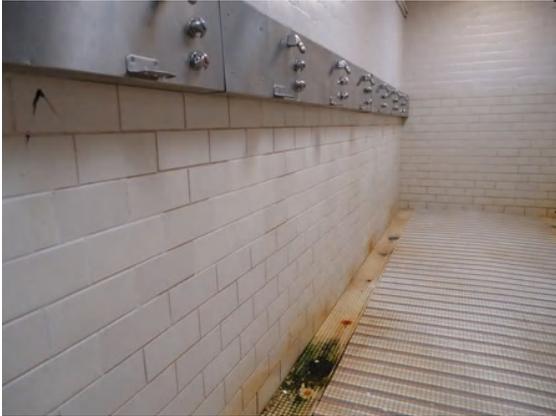
System: D2010 - Plumbing Fixtures

Analysis: The system age is either beyond expected life or does not meet its intended performance under the Guidelines. The system may be in service and functioning but it is recommended to be replaced due to probable increased condition budget needs, the potential failure of its components, or in order to meet the performance Guidelines for this system. The system was installed in 1982. It has a 30-year service life. However, in the assessment, it was found to be currently deficient.

Recommendation: The system should be replaced.

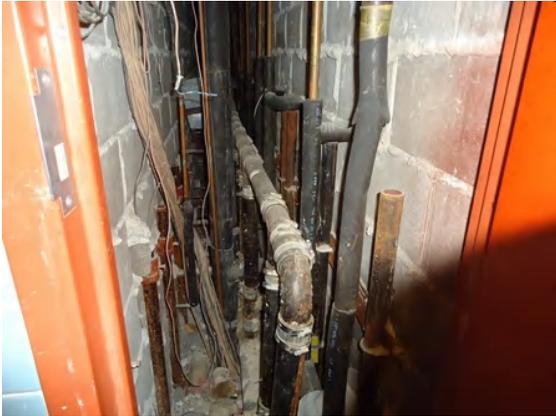
**System:** D2030 - Sanitary Waste

**Analysis:** The system age is either beyond expected life or does not meet its intended performance under the Guidelines. The system may be in service and functioning but it is recommended to be replaced due to probable increased condition budget needs, the potential failure of its components, or in order to meet the performance Guidelines for this system. The system was installed in 1962. It has a 30-year service life which expired in 1992.

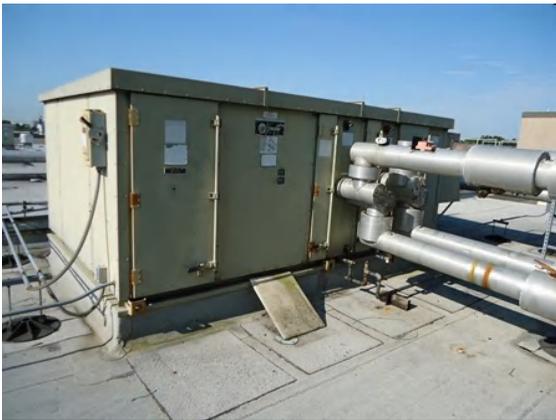
System: D3050 - Terminal & Package Units

Analysis: The system is in use and functioning with an estimated remaining service life as indicated in the report section "Condition/Replacement Budget Detail". The system was installed in 2005. It has a 15-year service life. However, in the assessment, it was found to be currently deficient.

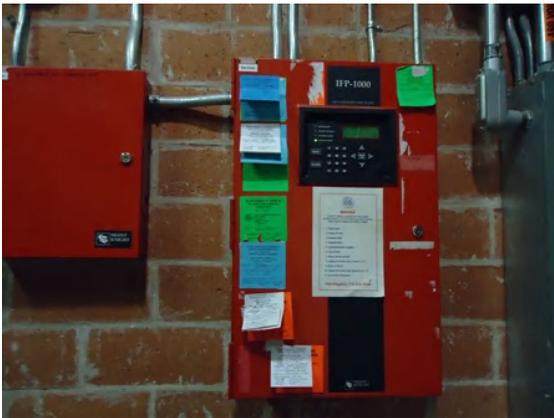
System: D5030910 - Fire Alarm System

Analysis: The system age is either beyond expected life or does not meet its intended performance under the Guidelines. The system may be in service and functioning but it is recommended to be replaced due to probable increased condition budget needs, the potential failure of its components, or in order to meet the performance Guidelines for this system. The system was installed in 2000. It has a 10-year service life which expired in 2010.

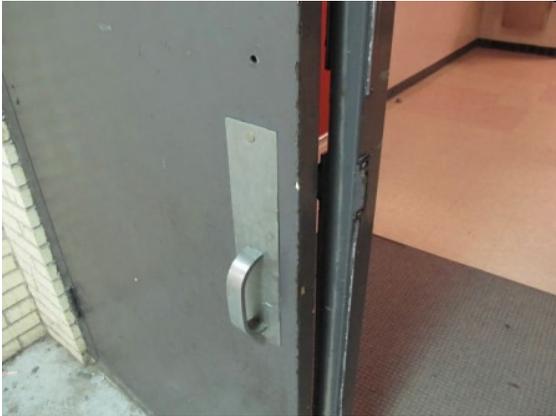
System: B2030 - Exterior Doors

Analysis: The system age is either beyond expected life or does not meet its intended performance under the Guidelines. The system may be in service and functioning but it is recommended to be replaced due to probable increased condition budget needs, the potential failure of its components, or in order to meet the performance Guidelines for this system. The system was installed in 1992. It has a 30-year service life. However, in the assessment, it was found to be currently deficient.

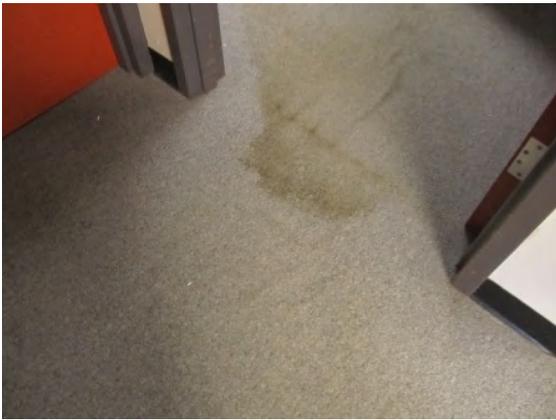
**System:** C3020410 - Carpet

**Analysis:** The system age is either beyond expected life or does not meet its intended performance under the Guidelines. The system may be in service and functioning but it is recommended to be replaced due to probable increased condition budget needs, the potential failure of its components, or in order to meet the performance Guidelines for this system. The system was installed in 1998. It has a 12-year service life which expired in 2010.

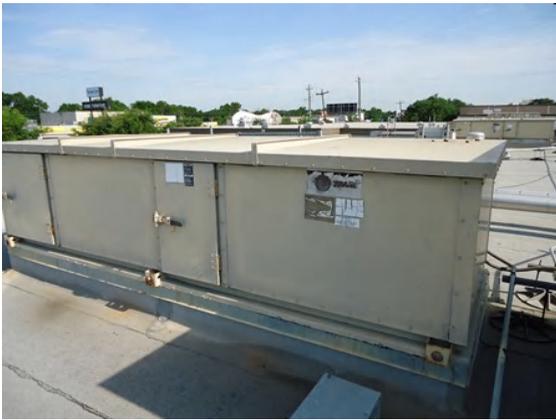
System: D3050 - Terminal & Package Units

Analysis: The system age is either beyond expected life or does not meet its intended performance under the Guidelines. The system may be in service and functioning but it is recommended to be replaced due to probable increased condition budget needs, the potential failure of its components, or in order to meet the performance Guidelines for this system. The system was installed in 1996. It has a 15-year service life which expired in 2011.

Recommendation: The system should be replaced.

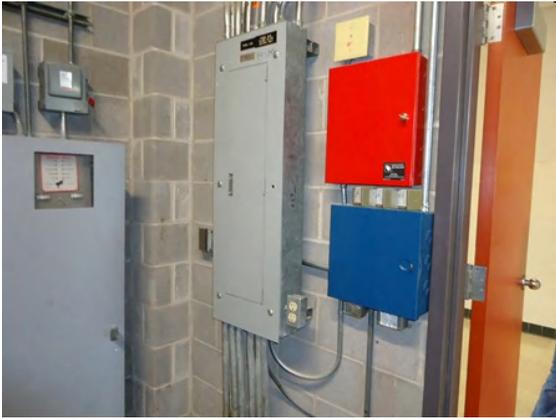
System: D5030910 - Fire Alarm System

Analysis: The system age is either beyond expected life or does not meet its intended performance under the Guidelines. The system may be in service and functioning but it is recommended to be replaced due to probable increased condition budget needs, the potential failure of its components, or in order to meet the performance Guidelines for this system. The system was installed in 2000. It has a 10-year service life which expired in 2010.

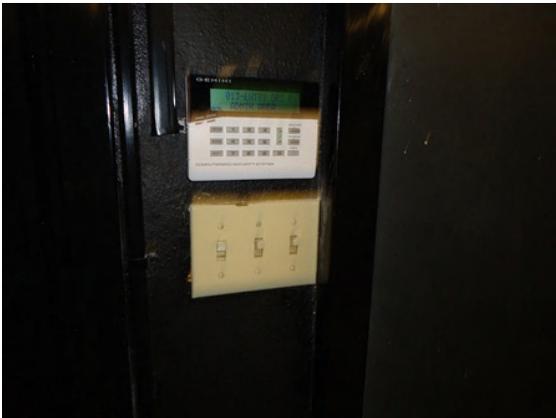
System: D5030910 - Security System, Camers, Access Control

Analysis: The system age is either beyond expected life or does not meet its intended performance under the Guidelines. The system may be in service and functioning but it is recommended to be replaced due to probable increased condition budget needs, the potential failure of its components, or in order to meet the performance Guidelines for this system. The system was installed in 1984. It has a 15-year service life which expired in 1999.

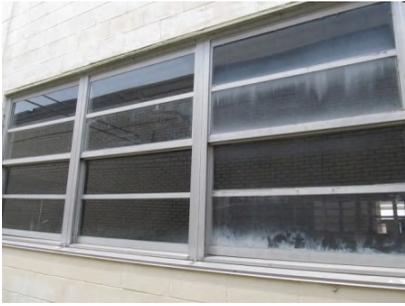
Location: Main - Stor Bldg 03  
Distress: Beyond Expected Life  
Category: Deferred Maintenance  
Priority: 3 - Short Term Conditions (2-3 Years)  
Notes: The exterior windows are single pane and no longer energy efficient.

Correction: Renew System  
Qty: 1-Ea.  
Condition Budget: \$49,879

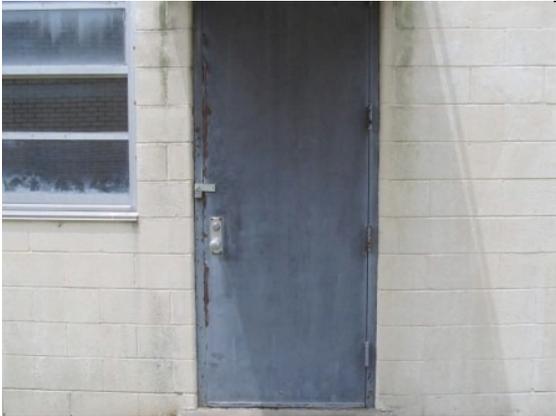
**System:** B2030 - Exterior Doors

Analysis: The system age is either beyond expected life or does not meet its intended performance under the Guidelines. The system may be in service and functioning but it is recommended to be replaced due to probable increased condition budget needs, the potential failure of its components, or in order to meet the performance Guidelines for this system. The system was installed in 1992. It has a 30-year service life. However, in the assessment, it was found to be currently deficient.

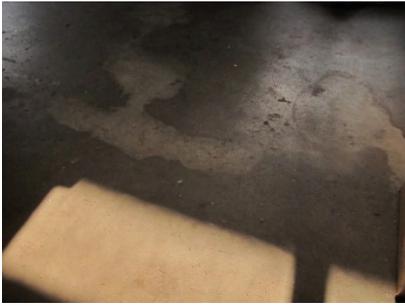
Location: Main - Stor Bldg 03  
Distress: Beyond Expected Life  
Category: Deferred Maintenance  
Priority: 3 - Short Term Conditions (2-3 Years)  
Notes: The sealed concrete flooring is wearing down in areas throughout the facility.  
Correction: Renew System  
Qty: 1-Ea.  
Condition Budget: \$5,129

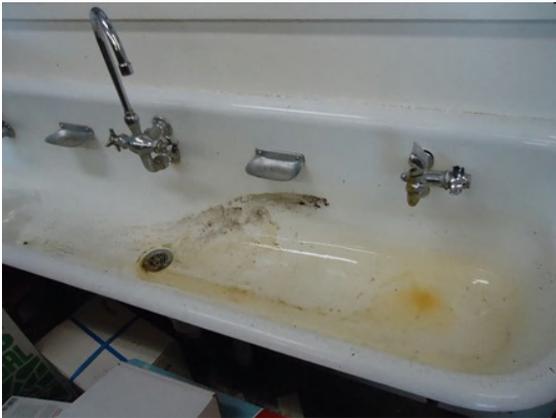
System: D2010 - Plumbing Fixtures

Analysis: The system age is either beyond expected life or does not meet its intended performance under the Guidelines. The system may be in service and functioning but it is recommended to be replaced due to probable increased condition budget needs, the potential failure of its components, or in order to meet the performance Guidelines for this system. The system was installed in 1982. It has a 30-year service life. However, in the assessment, it was found to be currently deficient.

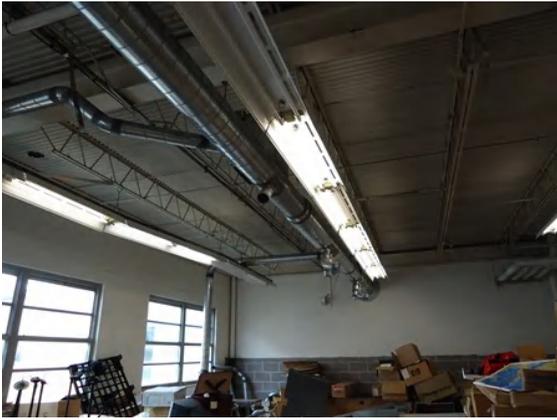
**System:** D5020 - Lighting and Branch Wiring

**Analysis:** The system age is either beyond expected life or does not meet its intended performance under the Guidelines. The system may be in service and functioning but it is recommended to be replaced due to probable increased condition budget needs, the potential failure of its components, or in order to meet the performance Guidelines for this system. The system was installed in 1962. It has a 30-year service life which expired in 1992.
