School Assessment Report

Type: High Schools
School: Madison High School
Date: Jul 16, 2012

School Name: Madison High School

Madison High School campus is located at 13719 Whiteheather, Houston TX, and consists of 5 main school building(s). The original campus was constructed in 1966 and an addition to the main school building was constructed in 1988 to house mechanical equipment. Ancillary buildings on campus include, Gym Building E, Library Building D, Classroom Buildings B and C, Storage Building F, Greenhouse, T-Buildings and miscellaneous metal sheds. In addition to the buildings, the campus contains covered walkways, baseball field, football practice field and track. This report contains condition and adequacy data collected during the 2012 Facility Condition Assessment (FCA). The detailed condition and deficiency statements are contained in this report for each building and other facilities on the campus.

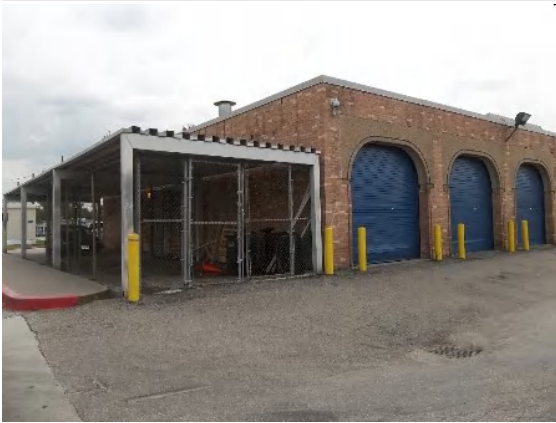
System: G2010 - Roadways

Analysis: The system age is either beyond expected life or does not meet its intended performance under the Guidelines. The system may be in service and functioning but it is recommended to be replaced due to probable increased condition budget needs, the potential failure of its components, or in order to meet the performance Guidelines for this system. The system was installed in 1988. It has a 25-year service life. However, in the assessment, it was found to be currently deficient.

Notes: Areas of pavement on the site are in good condition, but the majority of the pavement is in poor condition and should be replaced.

Recommendation: The system should be replaced.

Condition Budget: \$498,560

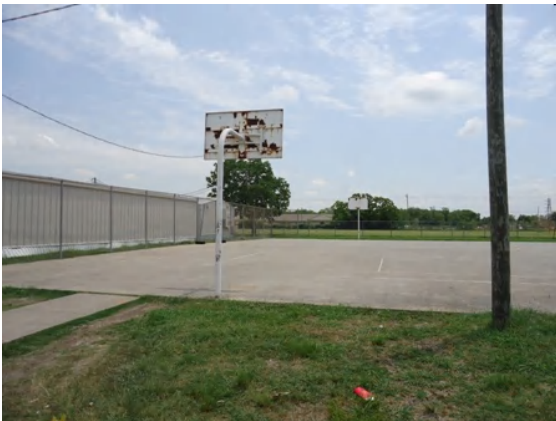
System: G2040 - Basketball / hard court play area

Analysis: The system age is either beyond expected life or does not meet its intended performance under the Guidelines. The system may be in service and functioning but it is recommended to be replaced due to probable increased condition budget needs, the potential failure of its components, or in order to meet the performance Guidelines for this system. The system was installed in 1992. It has a 10-year service life which expired in 2002.

Location: Site
Distress: Beyond Expected Life
Category: Deferred Maintenance
Priority: 3 - Short Term Conditions (2-3 Years)
Notes: This basketball court can be adapted into a tennis court. The play surface is damaged and the basketball goals are rusted.
Correction: Renew System
Qty: 1-Ea.
Condition Budget: \$194,659

Recommendation: The system should be replaced.

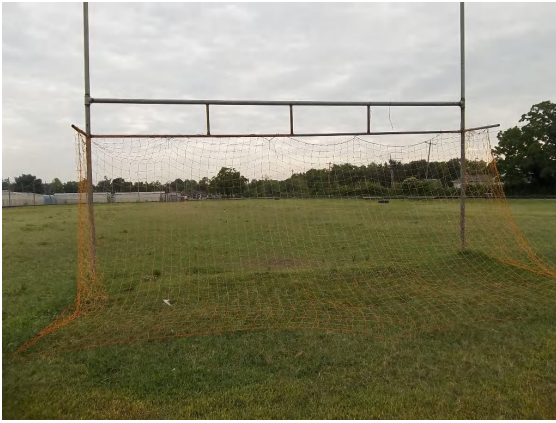
System: G2040 - Football Field Natural Turf

Analysis: The system age is either beyond expected life or does not meet its intended performance under the Guidelines. The system may be in service and functioning but it is recommended to be replaced due to probable increased condition budget needs, the potential failure of its components, or in order to meet the performance Guidelines for this system. The system was installed in 1992. It has a 10-year service life which expired in 2002.

Notes: The football field is unkept and has equipment in poor condition.

Recommendation: The system should be replaced.

Condition Budget: \$156,890

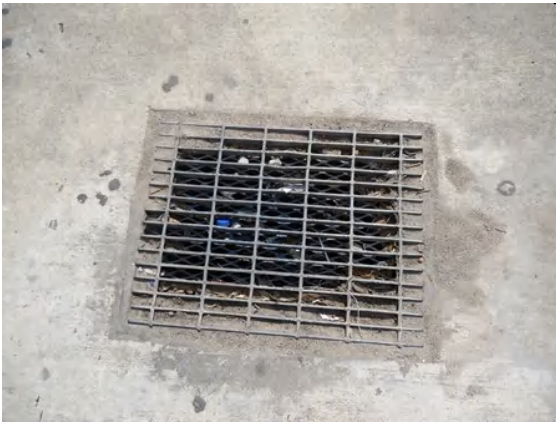
System: G3030 - Storm Sewer

Analysis: The system age is either beyond expected life or does not meet its intended performance under the Guidelines. The system may be in service and functioning but it is recommended to be replaced due to probable increased condition budget needs, the potential failure of its components, or in order to meet the performance Guidelines for this system. The system was installed in 1966. It has a 50-year service life. However, in the assessment, it was found to be currently deficient.

Notes: Storm Sewer System is clogged in diferent areas and is beyond its expected life. Replace Storm Sewer System.

Recommendation: The system should be replaced.

Condition Budget: \$271,506

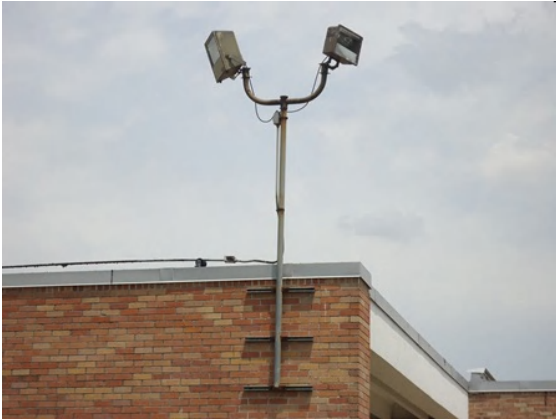
System: G4020 - Site Lighting

Analysis: The system age is either beyond expected life or does not meet its intended performance under the Guidelines. The system may be in service and functioning but it is recommended to be replaced due to probable increased condition budget needs, the potential failure of its components, or in order to meet the performance Guidelines for this system. The system was installed in 1966. It has a 30-year service life which expired in 1996.

Location: Site
Distress: Beyond Expected Life
Category: Deferred Maintenance
Priority: 3 - Short Term Conditions (2-3 Years)
Notes: Site Lighting is beyond its expected life and it's recommended to be replaced.

Recommendation: The system should be replaced.

Correction: Renew System
Qty: 1-Ea.
Condition Budget: \$659,517

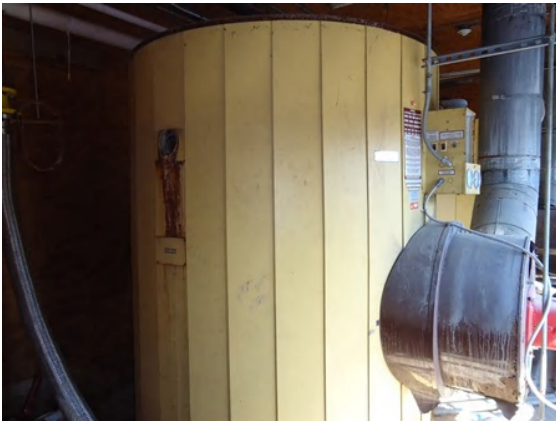
System: D2020 - Domestic Water Distribution

Analysis: The system age is either beyond expected life or does not meet its intended performance under the Guidelines. The system may be in service and functioning but it is recommended to be replaced due to probable increased condition budget needs, the potential failure of its components, or in order to meet the performance Guidelines for this system. The system was installed in 1992. It has a 30-year service life. However, in the assessment, it was found to be currently deficient.

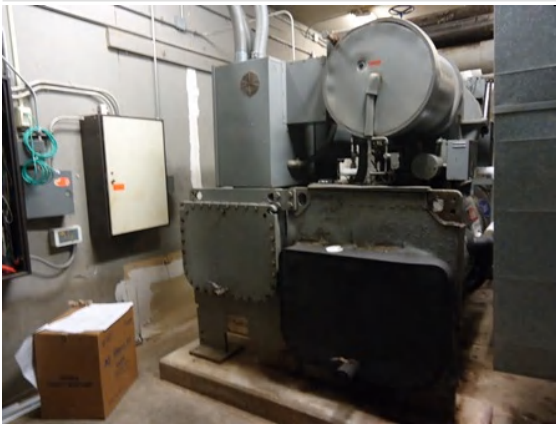
System: D3020 - Heat Generating Systems

Analysis: The system age is either beyond expected life or does not meet its intended performance under the Guidelines. The system may be in service and functioning but it is recommended to be replaced due to probable increased condition budget needs, the potential failure of its components, or in order to meet the performance Guidelines for this system. The system was installed in 1988. It has a 30-year service life. However, in the assessment, it was found to be currently deficient.

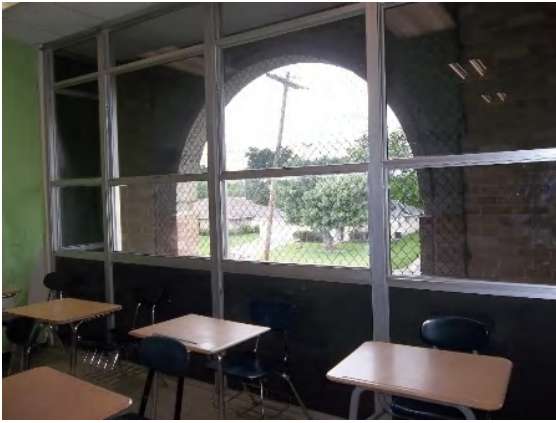
System: B2020 - Exterior Windows

Analysis: The system age is either beyond expected life or does not meet its intended performance under the Guidelines. The system may be in service and functioning but it is recommended to be replaced due to probable increased condition budget needs, the potential failure of its components, or in order to meet the performance Guidelines for this system. The system was installed in 1970. It has a 30-year service life which expired in 2000.

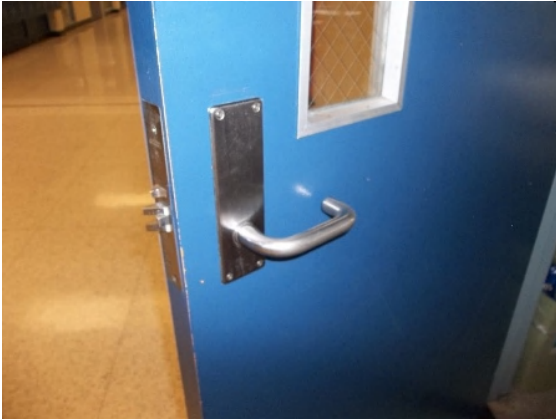
System: C1020 - Interior Doors

Analysis: The system age is either beyond expected life or does not meet its intended performance under the Guidelines. The system may be in service and functioning but it is recommended to be replaced due to probable increased condition budget needs, the potential failure of its components, or in order to meet the performance Guidelines for this system. The system was installed in 1970. It has a 40-year service life which expired in 2010.

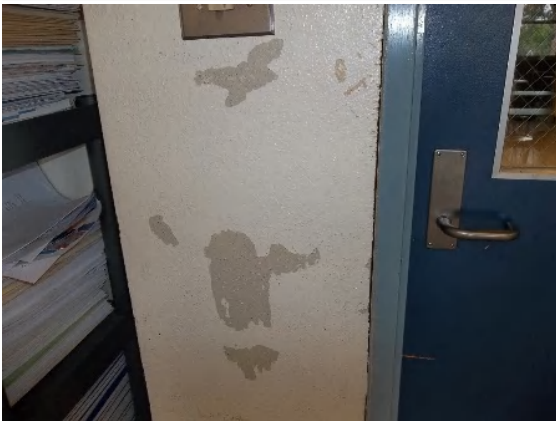
System: C3010 - Wall Finishes

Analysis: The system age is either beyond expected life or does not meet its intended performance under the Guidelines. The system may be in service and functioning but it is recommended to be replaced due to probable increased condition budget needs, the potential failure of its components, or in order to meet the performance Guidelines for this system. The system was installed in 1970. It has a 10-year service life which expired in 1980.

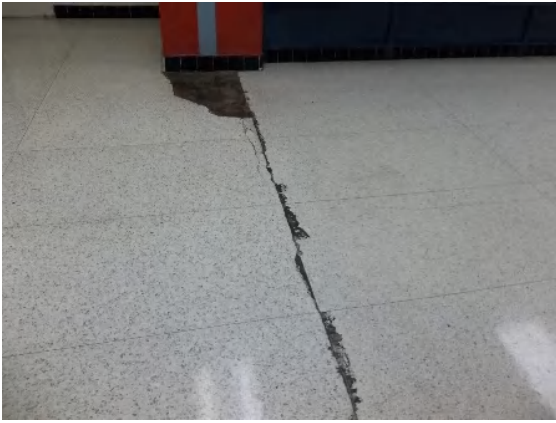
System: C3020210 - Terrazzo

Analysis: The system is in use and functioning with an estimated remaining service life as indicated in the report section "Condition/Replacement Budget Detail". The system was installed in 1970. It has a 50-year service life. However, in the assessment, it was found to be currently deficient.

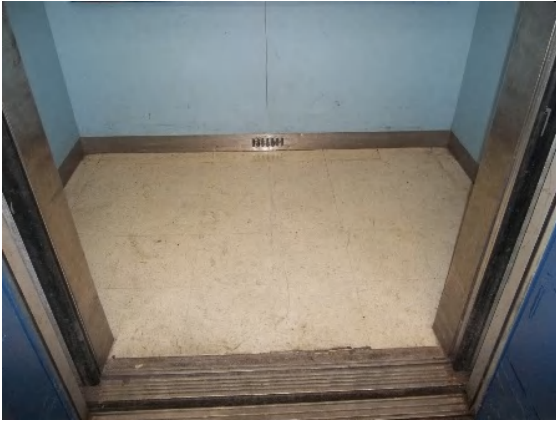
System: D1010 - Elevators and Lifts

Analysis: The system age is either beyond expected life or does not meet its intended performance under the Guidelines. The system may be in service and functioning but it is recommended to be replaced due to probable increased condition budget needs, the potential failure of its components, or in order to meet the performance Guidelines for this system. The system was installed in 1970. It has a 35-year service life which expired in 2005.

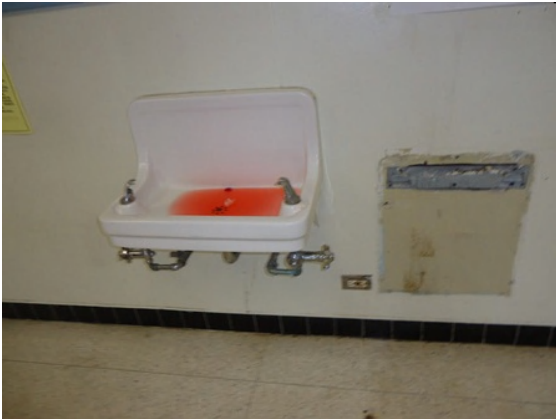
System: D2020 - Domestic Water Distribution

Analysis: The system age is either beyond expected life or does not meet its intended performance under the Guidelines. The system may be in service and functioning but it is recommended to be replaced due to probable increased condition budget needs, the potential failure of its components, or in order to meet the performance Guidelines for this system. The system was installed in 1970. It has a 30-year service life which expired in 2000.

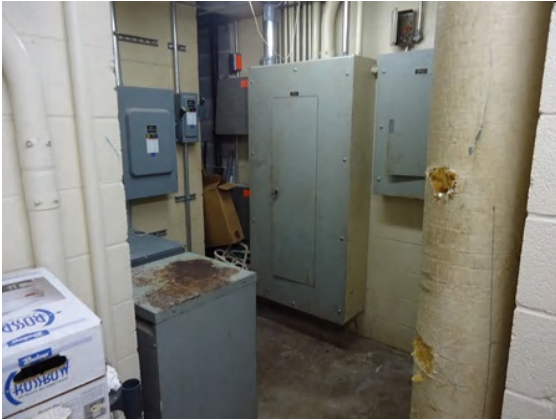
System: D5010 - Electrical Service/Distribution

Analysis: The system age is either beyond expected life or does not meet its intended performance under the Guidelines. The system may be in service and functioning but it is recommended to be replaced due to probable increased condition budget needs, the potential failure of its components, or in order to meet the performance Guidelines for this system. The system was installed in 1970. It has a 30-year service life which expired in 2000.

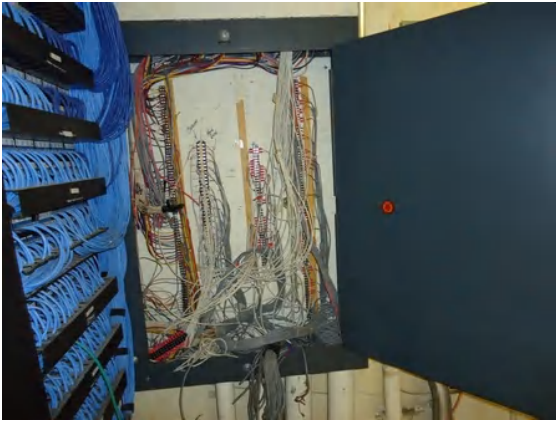
System: D5030310 - Telephone Systems

Analysis: The system age is either beyond expected life or does not meet its intended performance under the Guidelines. The system may be in service and functioning but it is recommended to be replaced due to probable increased condition budget needs, the potential failure of its components, or in order to meet the performance Guidelines for this system. The system was installed in 1970. It has a 15-year service life which expired in 1985.

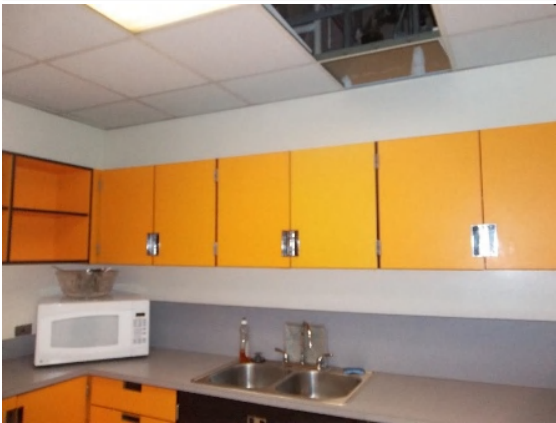
System: E2010 - Fixed Furnishings

Analysis: The system age is either beyond expected life or does not meet its intended performance under the Guidelines. The system may be in service and functioning but it is recommended to be replaced due to probable increased condition budget needs, the potential failure of its components, or in order to meet the performance Guidelines for this system. The system was installed in 1992. It has a 20-year service life. However, in the assessment, it was found to be currently deficient.

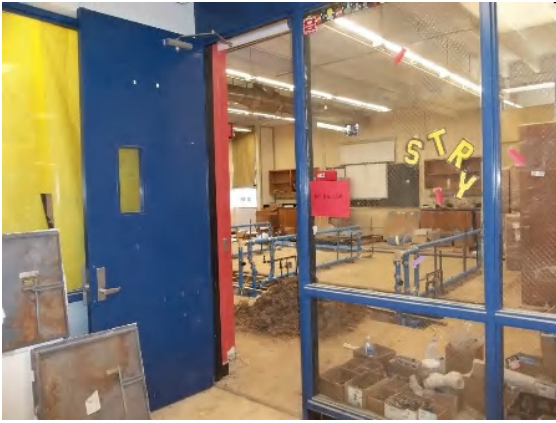
System: C1020 - Interior Doors

Analysis: The system age is either beyond expected life or does not meet its intended performance under the Guidelines. The system may be in service and functioning but it is recommended to be replaced due to probable increased condition budget needs, the potential failure of its components, or in order to meet the performance Guidelines for this system. The system was installed in 1966. It has a 40-year service life which expired in 2006.

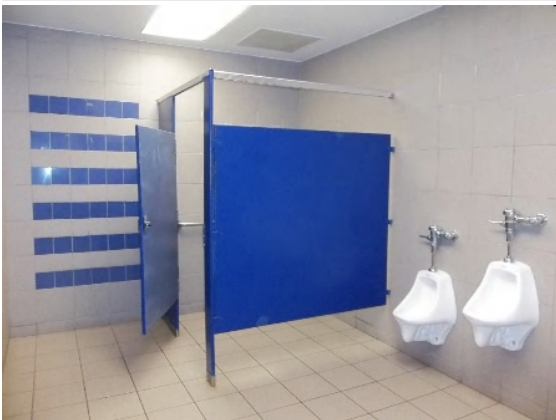
System: C1030 - Fittings

Analysis: The system age is either beyond expected life or does not meet its intended performance under the Guidelines. The system may be in service and functioning but it is recommended to be replaced due to probable increased condition budget needs, the potential failure of its components, or in order to meet the performance Guidelines for this system. The system was installed in 2000. It has a 20-year service life. However, in the assessment, it was found to be currently deficient.

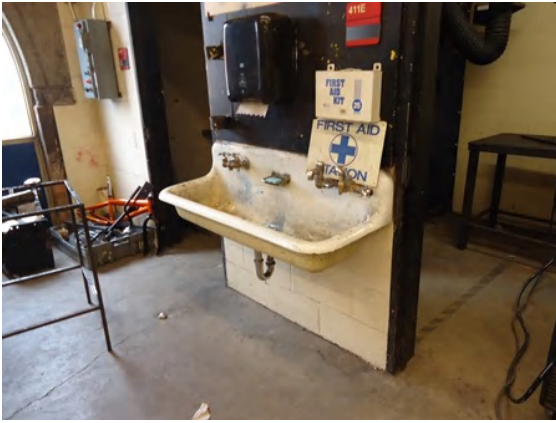
System: D2010 - Plumbing Fixtures

Analysis: The system age is either beyond expected life or does not meet its intended performance under the Guidelines. The system may be in service and functioning but it is recommended to be replaced due to probable increased condition budget needs, the potential failure of its components, or in order to meet the performance Guidelines for this system. The system was installed in 1966. It has a 30-year service life which expired in 1996.

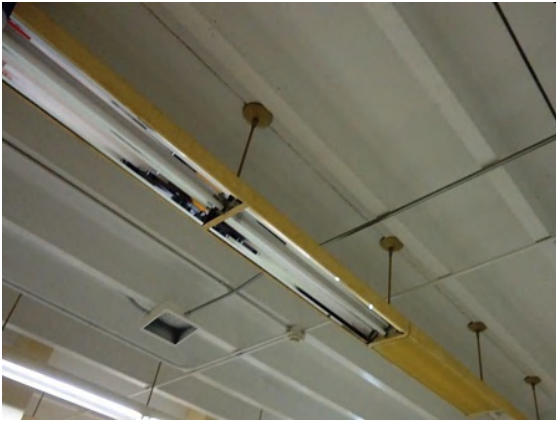
System: D5020 - Lighting and Branch Wiring

Analysis: The system age is either beyond expected life or does not meet its intended performance under the Guidelines. The system may be in service and functioning but it is recommended to be replaced due to probable increased condition budget needs, the potential failure of its components, or in order to meet the performance Guidelines for this system. The system was installed in 1966. It has a 30-year service life which expired in 1996.
