School Assessment Report

Type: High Schools
School: Milby High School
Date: Jul 16, 2012

School Name: Milby High School

Milby High School campus is located at 1601 Broadway Street, Houston TX, and consists of 8 main school buildings. The original campus was constructed in 1926 and additions to the main school building was/were constructed in 1934, 1940, 1959, 1960, and 1978. Ancillary buildings on campus include classroom buildings, gym, T-Buildings, storage building. In addition to the buildings, the campus contains covered walkways, baseball field, football field with bleachers, and track. This report contains condition and adequacy data collected during the 2012 Facility Condition Assessment (FCA). The detailed condition and deficiency statements are contained in this report for each building and other facilities on the campus.

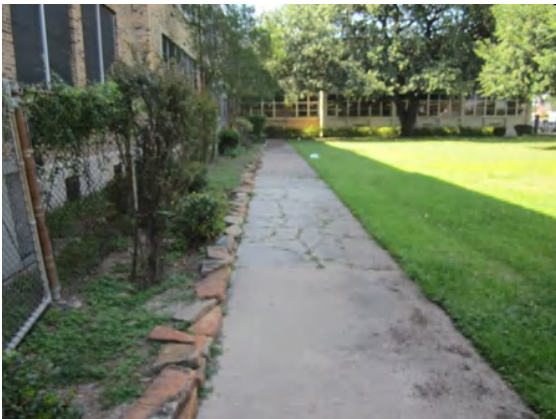
System: G2020 - Pedestrian Paving - sidewalks, etc

Analysis: The system age is either beyond expected life or does not meet its intended performance under the Guidelines. The system may be in service and functioning but it is recommended to be replaced due to probable increased condition budget needs, the potential failure of its components, or in order to meet the performance Guidelines for this system. The system was installed in 1978. It has a 30-year service life which expired in 2008.

Notes: The pedestrian pavement is damaged. Replace all damaged pedestrian pavement.

Recommendation: The system should be replaced.

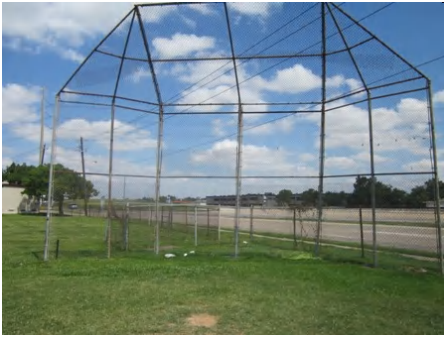
Notes: The baseball field is inadequate. Replace the backstop, equipment, re-sod, level and grade the playing field.

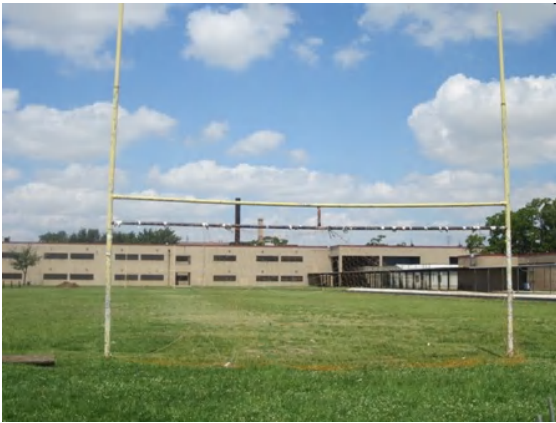
System: G2040 - Football Field Natural Turf

Analysis: The system age is either beyond expected life or does not meet its intended performance under the Guidelines. The system may be in service and functioning but it is recommended to be replaced due to probable increased condition budget needs, the potential failure of its components, or in order to meet the performance Guidelines for this system. The system was installed in 2001. It has a 10-year service life which expired in 2011.

Notes: Football field is inadequate. Replace the equipment, re-sod after leveling and grading the field.

Recommendation: The system should be replaced.

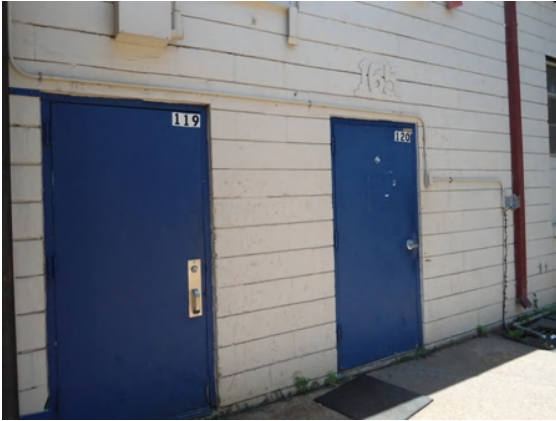
System: B2030 - Exterior Doors

Analysis: The system age is either beyond expected life or does not meet its intended performance under the Guidelines. The system may be in service and functioning but it is recommended to be replaced due to probable increased condition budget needs, the potential failure of its components, or in order to meet the performance Guidelines for this system. The system was installed in 1978. It has a 30-year service life which expired in 2008.

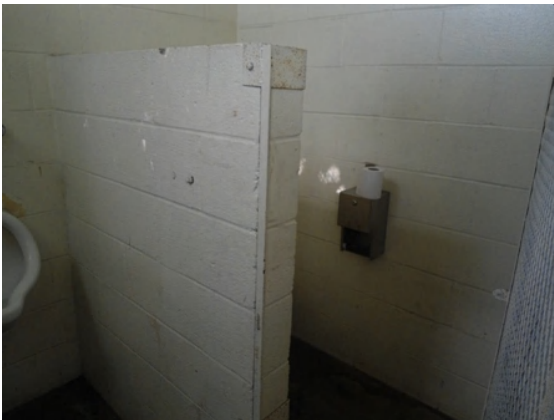
System: C1030 - Fittings

Analysis: The system age is either beyond expected life or does not meet its intended performance under the Guidelines. The system may be in service and functioning but it is recommended to be replaced due to probable increased condition budget needs, the potential failure of its components, or in order to meet the performance Guidelines for this system. The system was installed in 1978. It has a 20-year service life which expired in 1998.

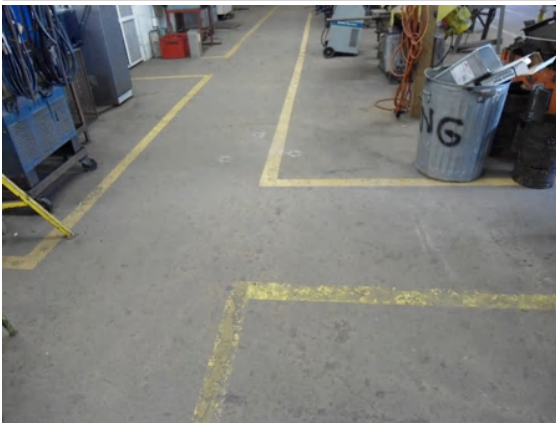
System: C3020410 - Sealed Concrete

Analysis: The system age is either beyond expected life or does not meet its intended performance under the Guidelines. The system may be in service and functioning but it is recommended to be replaced due to probable increased condition budget needs, the potential failure of its components, or in order to meet the performance Guidelines for this system. The system was installed in 1984. It has a 20-year service life which expired in 2004.

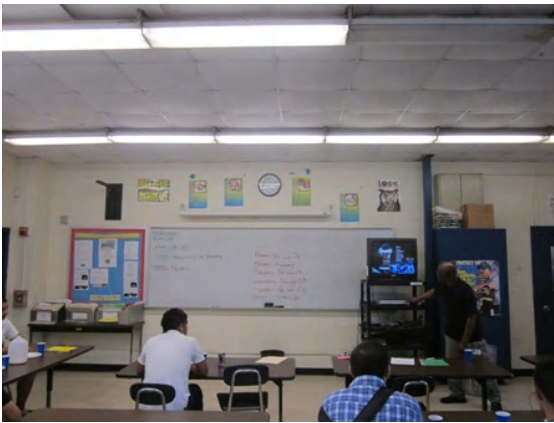
System: E1020 - Institutional Equipment

Analysis: The system age is either beyond expected life or does not meet its intended performance under the Guidelines. The system may be in service and functioning but it is recommended to be replaced due to probable increased condition budget needs, the potential failure of its components, or in order to meet the performance Guidelines for this system. The system was installed in 1984. It has a 20-year service life which expired in 2004.

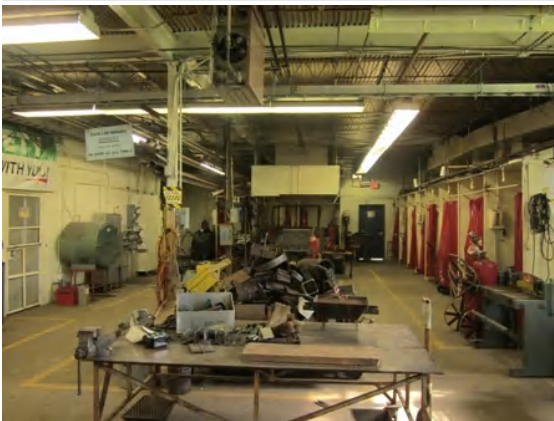
System: E2010 - Fixed Furnishings

Analysis: The system age is either beyond expected life or does not meet its intended performance under the Guidelines. The system may be in service and functioning but it is recommended to be replaced due to probable increased condition budget needs, the potential failure of its components, or in order to meet the performance Guidelines for this system. The system was installed in 1984. It has a 20-year service life which expired in 2004.

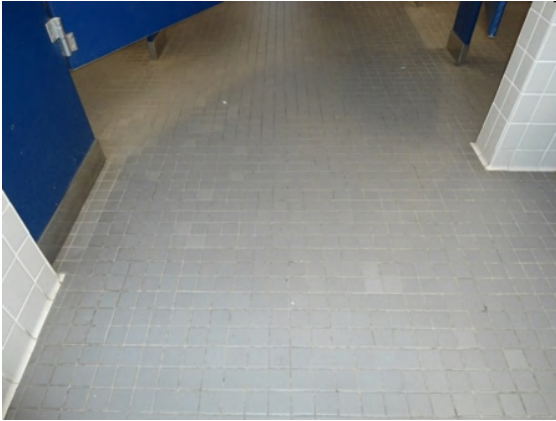
System: C3020 - Floor Finishes

Analysis: The system age is either beyond expected life or does not meet its intended performance under the Guidelines. The system may be in service and functioning but it is recommended to be replaced due to probable increased condition budget needs, the potential failure of its components, or in order to meet the performance Guidelines for this system. The system was installed in 1984. It has a 20-year service life which expired in 2004.

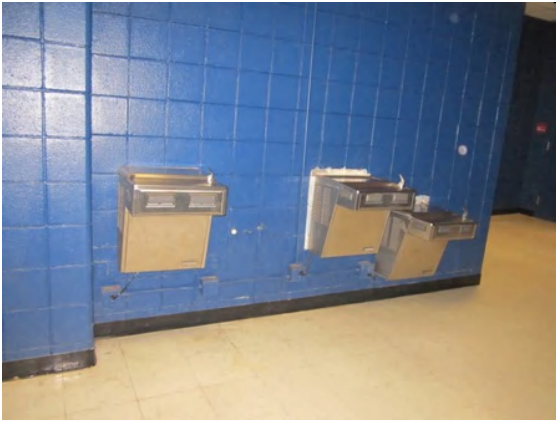
System: C3020410 - Vinyl Tile

Analysis: The system age is either beyond expected life or does not meet its intended performance under the Guidelines. The system may be in service and functioning but it is recommended to be replaced due to probable increased condition budget needs, the potential failure of its components, or in order to meet the performance Guidelines for this system. The system was installed in 1984. It has a 15-year service life which expired in 1999.

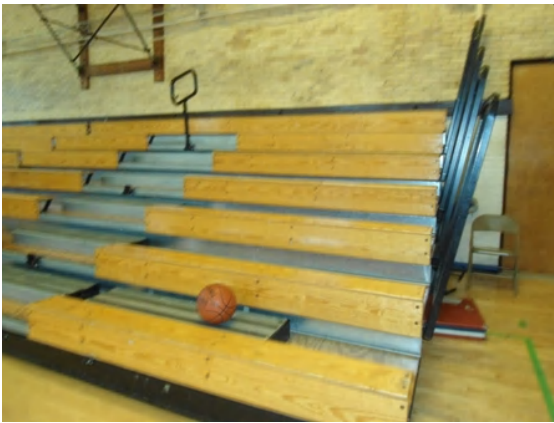
System: E2010 - Fixed Furnishings

Analysis: The system age is either beyond expected life or does not meet its intended performance under the Guidelines. The system may be in service and functioning but it is recommended to be replaced due to probable increased condition budget needs, the potential failure of its components, or in order to meet the performance Guidelines for this system. The system was installed in 1984. It has a 20-year service life which expired in 2004.

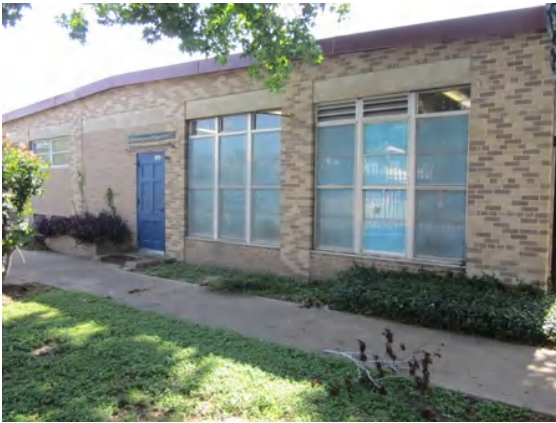
System: B2030 - Exterior Doors

Analysis: The system age is either beyond expected life or does not meet its intended performance under the Guidelines. The system may be in service and functioning but it is recommended to be replaced due to probable increased condition budget needs, the potential failure of its components, or in order to meet the performance Guidelines for this system. The system was installed in 1978. It has a 30-year service life which expired in 2008.

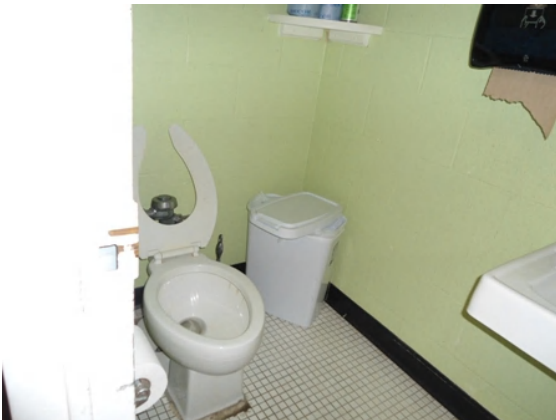
System: C1030 - Fittings

Analysis: The system age is either beyond expected life or does not meet its intended performance under the Guidelines. The system may be in service and functioning but it is recommended to be replaced due to probable increased condition budget needs, the potential failure of its components, or in order to meet the performance Guidelines for this system. The system was installed in 1978. It has a 20-year service life which expired in 1998.

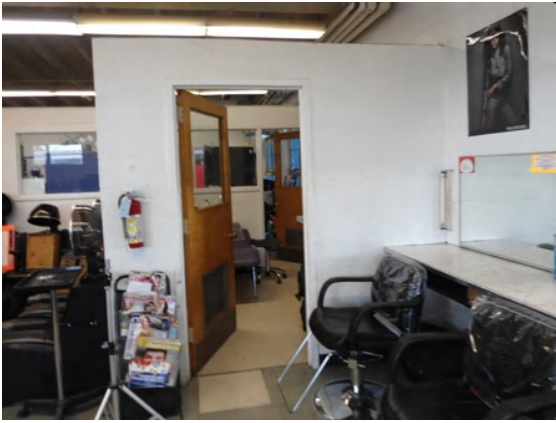
System: C3010 - Wall Finishes

Analysis: The system age is either beyond expected life or does not meet its intended performance under the Guidelines. The system may be in service and functioning but it is recommended to be replaced due to probable increased condition budget needs, the potential failure of its components, or in order to meet the performance Guidelines for this system. The system was installed in 1995. It has a 10-year service life which expired in 2005.

Recommendation: The system should be replaced.

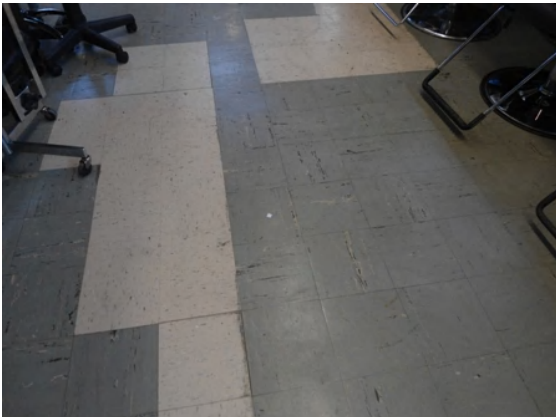
System: C3020410 - VCT

Analysis: The system age is either beyond expected life or does not meet its intended performance under the Guidelines. The system may be in service and functioning but it is recommended to be replaced due to probable increased condition budget needs, the potential failure of its components, or in order to meet the performance Guidelines for this system. The system was installed in 1978. It has a 15-year service life which expired in 1993.

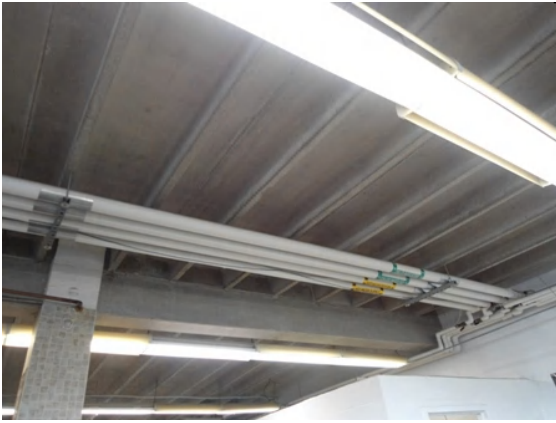
System: C3030 - Ceiling Finishes

Analysis: The system age is either beyond expected life or does not meet its intended performance under the Guidelines. The system may be in service and functioning but it is recommended to be replaced due to probable increased condition budget needs, the potential failure of its components, or in order to meet the performance Guidelines for this system. The system was installed in 1978. It has a 20-year service life which expired in 1998.

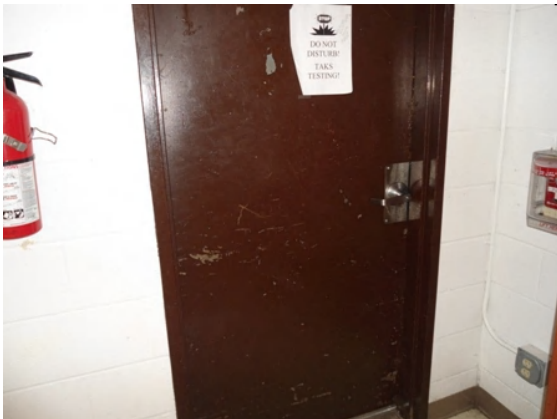
System: B2030 - Exterior Doors

Analysis: The system age is either beyond expected life or does not meet its intended performance under the Guidelines. The system may be in service and functioning but it is recommended to be replaced due to probable increased condition budget needs, the potential failure of its components, or in order to meet the performance Guidelines for this system. The system was installed in 1978. It has a 30-year service life which expired in 2008.

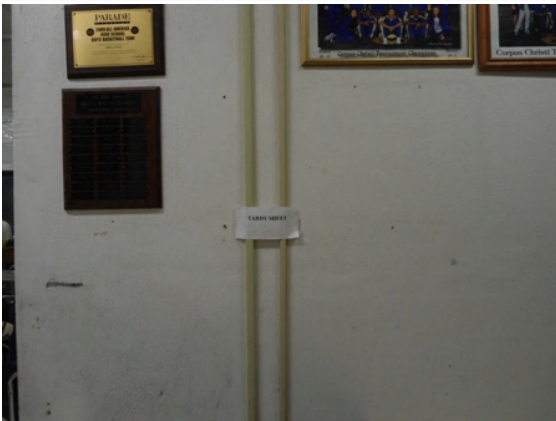
System: C3010 - Wall Finishes

Analysis: The system age is either beyond expected life or does not meet its intended performance under the Guidelines. The system may be in service and functioning but it is recommended to be replaced due to probable increased condition budget needs, the potential failure of its components, or in order to meet the performance Guidelines for this system. The system was installed in 2002. It has a 10-year service life. However, in the assessment, it was found to be currently deficient.

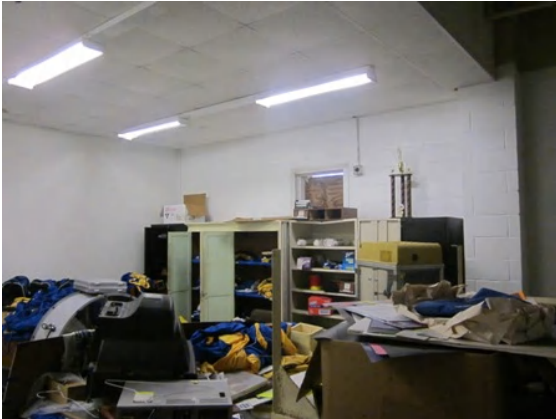
System: E1090 - Other Equipment

Analysis: The system age is either beyond expected life or does not meet its intended performance under the Guidelines. The system may be in service and functioning but it is recommended to be replaced due to probable increased condition budget needs, the potential failure of its components, or in order to meet the performance Guidelines for this system. The system was installed in 1984. It has a 20-year service life which expired in 2004.

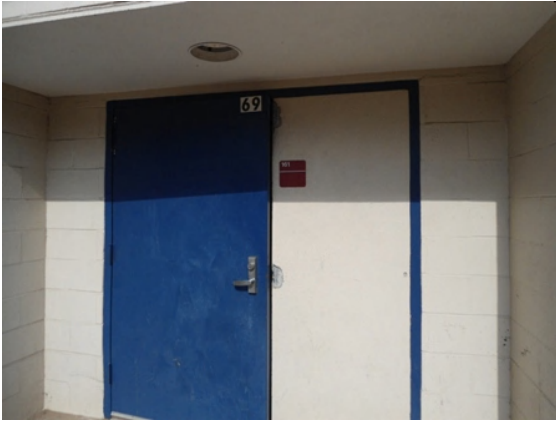
System: B2030 - Exterior Doors

Analysis: The system age is either beyond expected life or does not meet its intended performance under the Guidelines. The system may be in service and functioning but it is recommended to be replaced due to probable increased condition budget needs, the potential failure of its components, or in order to meet the performance Guidelines for this system. The system was installed in 1978. It has a 30-year service life which expired in 2008.
