School Assessment Report

School: Sam Houston High School

Date: Jul 16, 2012

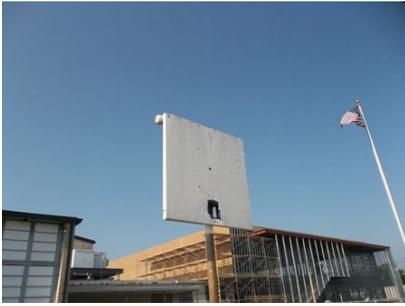
Analysis: The system age is either beyond expected life or does not meet its intended performance under the Guidelines. The system may be in service and functioning but it is recommended to be replaced due to probable increased condition budget needs, the potential failure of its components, or in order to meet the performance Guidelines for this system. The system was installed in 1954. It has a 10-year service life which expired in 1964.

Location: Site
Distress: Beyond Expected Life
Category: Deferred Maintenance
Priority: 3 - Short Term Conditions (2-3 Years)
Notes: Basketball / hard court, play area beyond useful life. replace
Correction: Renew System
Qty: 1-Ea.
Condition Budget: \$189,395

Recommendation: The system should be replaced.

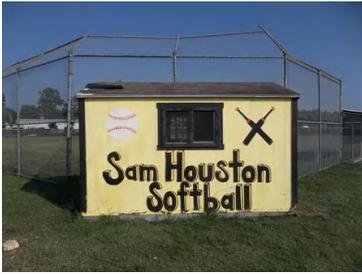
Analysis: The system age is either beyond expected life or does not meet its intended performance under the Guidelines. The system may be in service and functioning but it is recommended to be replaced due to probable increased condition budget needs, the potential failure of its components, or in order to meet the performance Guidelines for this system. The system was installed in 2000. It has a 10-year service life which expired in 2010.

Location: Site
Distress: Beyond Expected Life
Category: Deferred Maintenance
Priority: 3 - Short Term Conditions (2-3 Years)
Notes: Softball Field System beyond useful life. Replace
Correction: Renew System
Qty: 1-Ea.
Condition Budget: \$39,457

Recommendation: The system should be replaced.

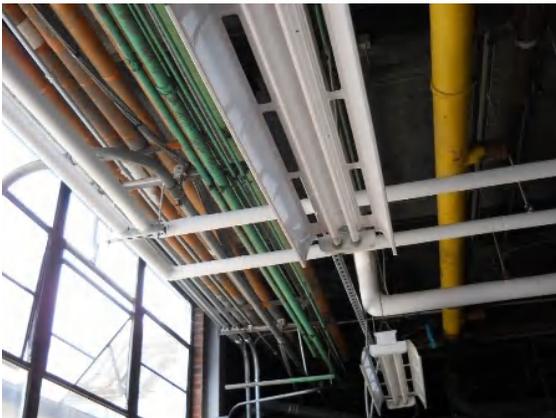
System: G3010 - Water Supply

Analysis: The system age is either beyond expected life or does not meet its intended performance under the Guidelines. The system may be in service and functioning but it is recommended to be replaced due to probable increased condition budget needs, the potential failure of its components, or in order to meet the performance Guidelines for this system. The system was installed in 1954. It has a 50-year service life which expired in 2004.

Location: Site
Distress: Beyond Expected Life
Category: Deferred Maintenance
Priority: 3 - Short Term Conditions (2-3 Years)
Notes: water supply System beyond useful life. Replace
Correction: Renew System
Qty: 1-Ea.
Condition Budget: \$186,436

Recommendation: The system should be replaced.

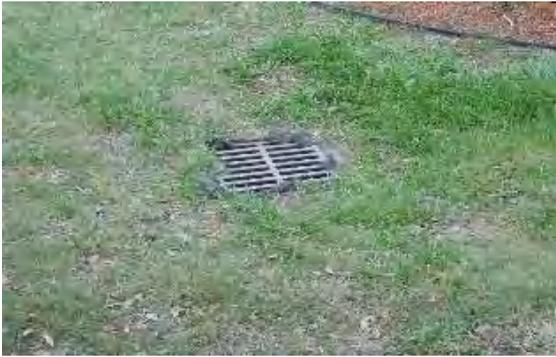
System: G3020 - Sanitary Sewer

Analysis: The system age is either beyond expected life or does not meet its intended performance under the Guidelines. The system may be in service and functioning but it is recommended to be replaced due to probable increased condition budget needs, the potential failure of its components, or in order to meet the performance Guidelines for this system. The system was installed in 1954. It has a 50-year service life which expired in 2004.

Notes: Sanitary Sewer System beyond useful life. Replace

Recommendation: The system should be replaced.

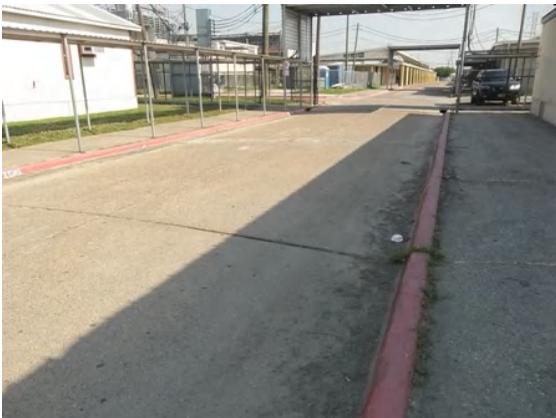
System: G3030 - Storm Sewer

Analysis: The system age is either beyond expected life or does not meet its intended performance under the Guidelines. The system may be in service and functioning but it is recommended to be replaced due to probable increased condition budget needs, the potential failure of its components, or in order to meet the performance Guidelines for this system. The system was installed in 1954. It has a 50-year service life which expired in 2004.

Notes: Storm Sewer System beyond useful life. Replace

Recommendation: The system should be replaced.

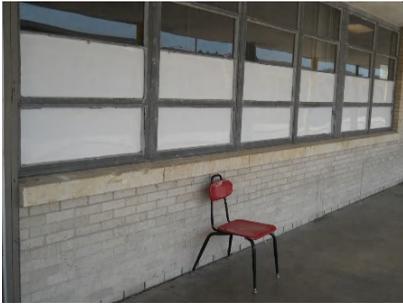
Location: Building 2 - B
Distress: Beyond Expected Life
Category: Deferred Maintenance
Priority: 3 - Short Term Conditions (2-3 Years)
Notes: Exterior Windows System beyond useful life.
Replace
Correction: Renew System
Qty: 1-Ea.
Condition Budget: \$361,054

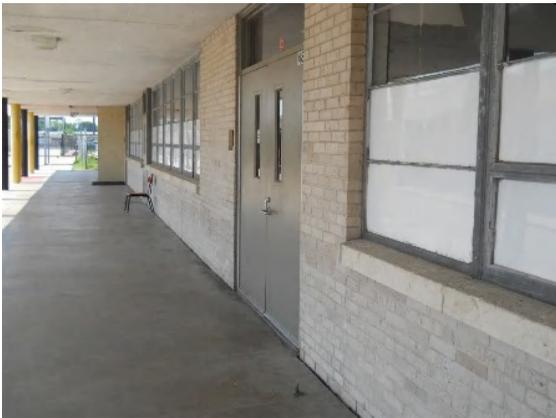
System: C1030 - Fittings

Analysis: The system age is either beyond expected life or does not meet its intended performance under the Guidelines. The system may be in service and functioning but it is recommended to be replaced due to probable increased condition budget needs, the potential failure of its components, or in order to meet the performance Guidelines for this system. The system was installed in 1992. It has a 15-year service life which expired in 2007.

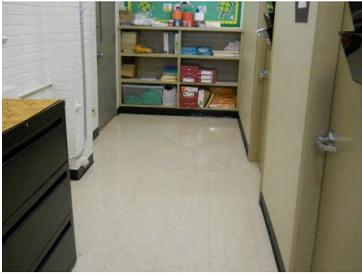
Location: Building 2 - B
Distress: Beyond Expected Life
Category: Deferred Maintenance
Priority: 3 - Short Term Conditions (2-3 Years)
Notes: VCT System beyond useful life. Replace
Correction: Renew System
Qty: 1-Ea.
Condition Budget: \$112,177

Recommendation: The system should be replaced.

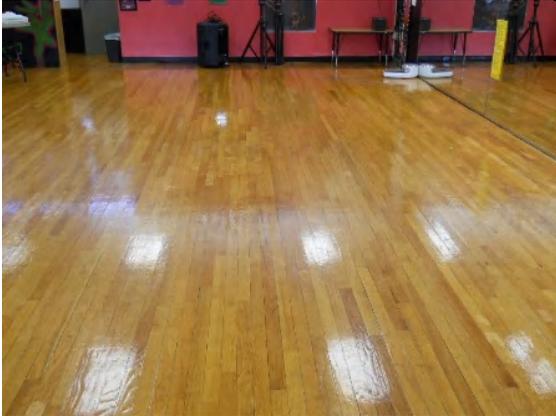
System: C3020410 - Wood

Analysis: The system age is either beyond expected life or does not meet its intended performance under the Guidelines. The system may be in service and functioning but it is recommended to be replaced due to probable increased condition budget needs, the potential failure of its components, or in order to meet the performance Guidelines for this system. The system was installed in 1954. It has a 30-year service life which expired in 1984.

Location: Building 2 - B
Distress: Beyond Expected Life
Category: Deferred Maintenance
Priority: 3 - Short Term Conditions (2-3 Years)
Notes: Wood System beyond useful life. Replace
Correction: Renew System
Qty: 1-Ea.
Condition Budget: \$43,124

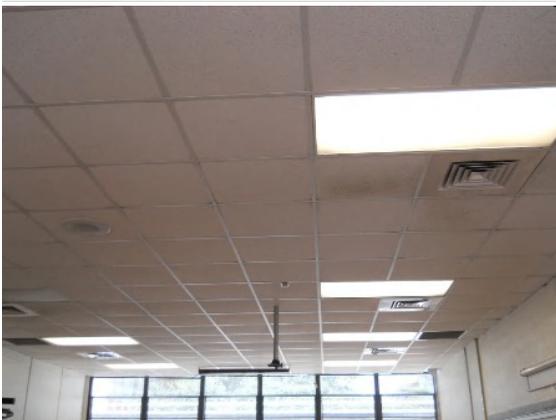
System: C3030 - Ceiling Finishes

Analysis: The system age is either beyond expected life or does not meet its intended performance under the Guidelines. The system may be in service and functioning but it is recommended to be replaced due to probable increased condition budget needs, the potential failure of its components, or in order to meet the performance Guidelines for this system. The system was installed in 1954. It has a 20-year service life which expired in 1974.

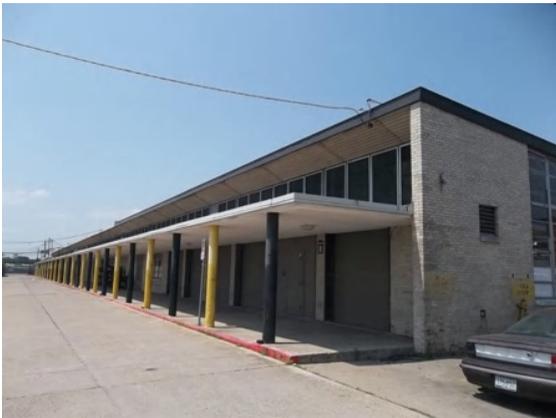
System: D2040 - Rain Water Drainage

Analysis: The system age is either beyond expected life or does not meet its intended performance under the Guidelines. The system may be in service and functioning but it is recommended to be replaced due to probable increased condition budget needs, the potential failure of its components, or in order to meet the performance Guidelines for this system. The system was installed in 1954. It has a 30-year service life which expired in 1984.

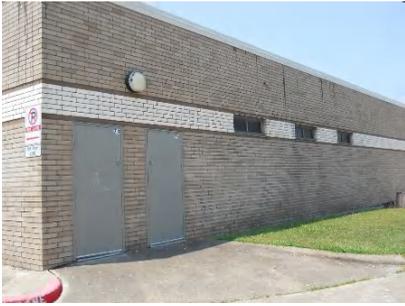
Location: Building 3 - C
Distress: Beyond Expected Life
Category: Deferred Maintenance
Priority: 3 - Short Term Conditions (2-3 Years)
Notes: Exterior Windows System beyond useful life.
Replace

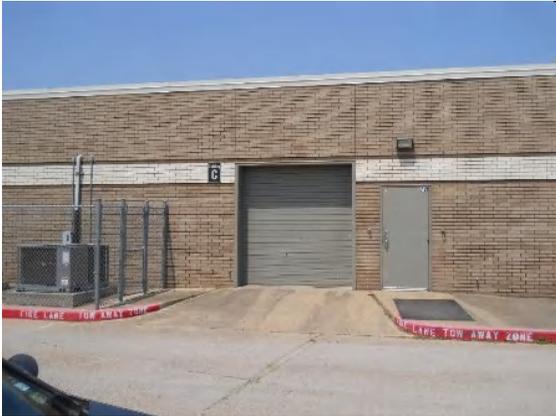
System: B2030 - Exterior Doors

Analysis: The system age is either beyond expected life or does not meet its intended performance under the Guidelines. The system may be in service and functioning but it is recommended to be replaced due to probable increased condition budget needs, the potential failure of its components, or in order to meet the performance Guidelines for this system. The system was installed in 1978. It has a 30-year service life which expired in 2008.

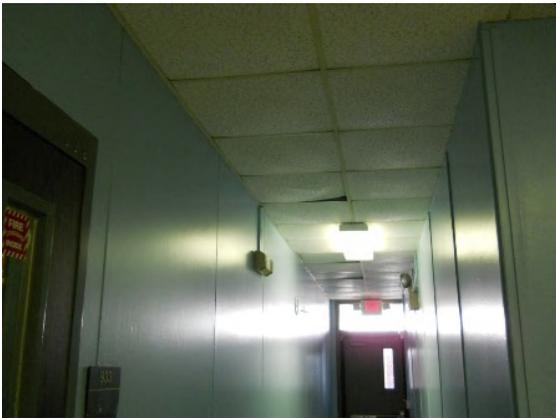
System: C1030 - Fittings

Analysis: The system age is either beyond expected life or does not meet its intended performance under the Guidelines. The system may be in service and functioning but it is recommended to be replaced due to probable increased condition budget needs, the potential failure of its components, or in order to meet the performance Guidelines for this system. The system was installed in 1978. It has a 20-year service life which expired in 1998.

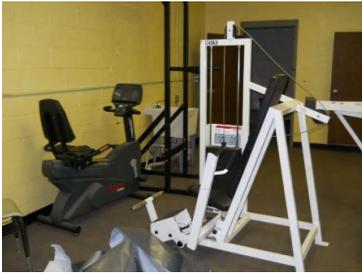
Location: Building 3 - C
Distress: Beyond Expected Life
Category: Deferred Maintenance
Priority: 3 - Short Term Conditions (2-3 Years)
Notes: Wall Finishes System beyond useful life. Replace
Correction: Renew System
Qty: 1-Ea.
Condition Budget: \$114,404

Recommendation: The system should be replaced.

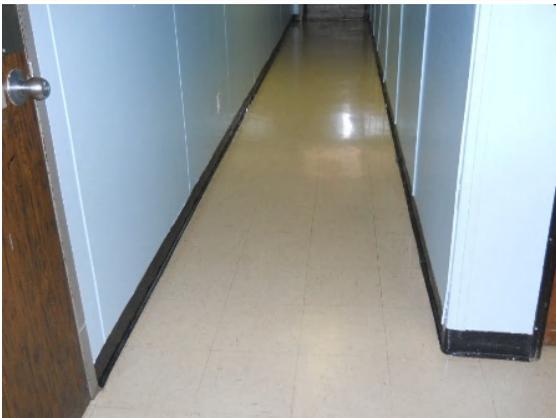
System: C3020410 - VCT

Analysis: The system age is either beyond expected life or does not meet its intended performance under the Guidelines. The system may be in service and functioning but it is recommended to be replaced due to probable increased condition budget needs, the potential failure of its components, or in order to meet the performance Guidelines for this system. The system was installed in 1985. It has a 12-year service life which expired in 1997.

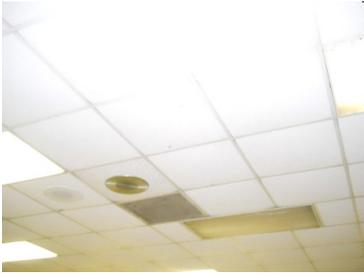
Location: Building 3 - C
Distress: Beyond Expected Life
Category: Deferred Maintenance
Priority: 3 - Short Term Conditions (2-3 Years)
Notes: Ceiling Finishes Beyond useful life. replace
Correction: Renew System
Qty: 1-Ea.
Condition Budget: \$203,326

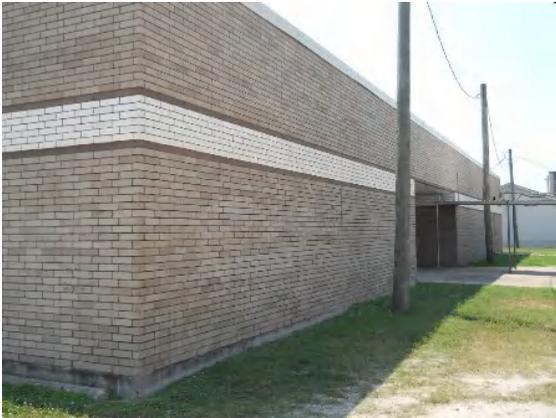
System: D2040 - Rain Water Drainage

Analysis: The system age is either beyond expected life or does not meet its intended performance under the Guidelines. The system may be in service and functioning but it is recommended to be replaced due to probable increased condition budget needs, the potential failure of its components, or in order to meet the performance Guidelines for this system. The system was installed in 1978. It has a 30-year service life which expired in 2008.

Location: Building 3 - C
Distress: Beyond Expected Life
Category: Deferred Maintenance
Priority: 3 - Short Term Conditions (2-3 Years)
Notes: Rain Water Drainage System beyond useful life. Replace
Correction: Renew System
Qty: 1-Ea.
Condition Budget: \$9,445

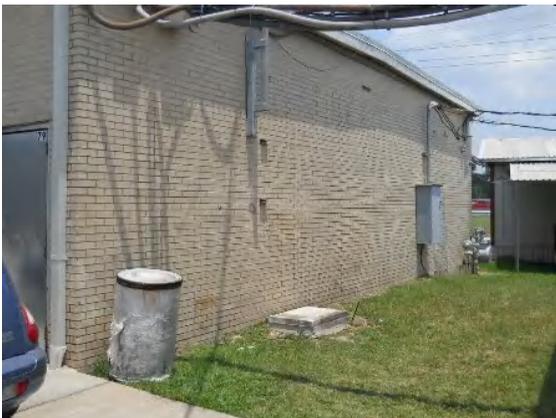
System: D2090 - Other Plumbing Systems-Nat Gas

Analysis: The system age is either beyond expected life or does not meet its intended performance under the Guidelines. The system may be in service and functioning but it is recommended to be replaced due to probable increased condition budget needs, the potential failure of its components, or in order to meet the performance Guidelines for this system. The system was installed in 1978. It has a 20-year service life which expired in 1998.

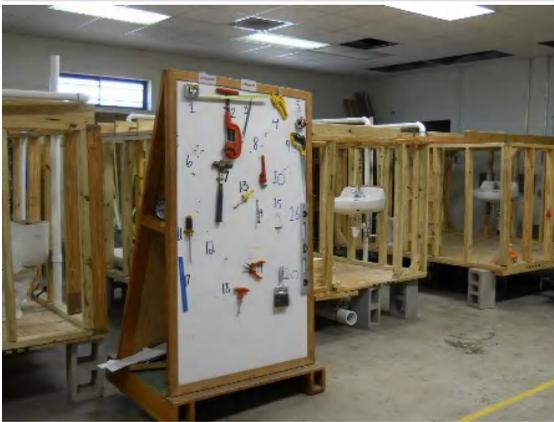
System: E2010 - Fixed Furnishings

Analysis: The system age is either beyond expected life or does not meet its intended performance under the Guidelines. The system may be in service and functioning but it is recommended to be replaced due to probable increased condition budget needs, the potential failure of its components, or in order to meet the performance Guidelines for this system. The system was installed in 1985. It has a 20-year service life which expired in 2005.

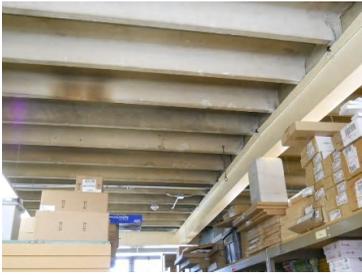
Location: Building 5 - E
Distress: Beyond Expected Life
Category: Deferred Maintenance
Priority: 3 - Short Term Conditions (2-3 Years)
Notes: Ceiling Finishes Beyond useful life. replace
Correction: Renew System
Qty: 1-Ea.
Condition Budget: \$141,699

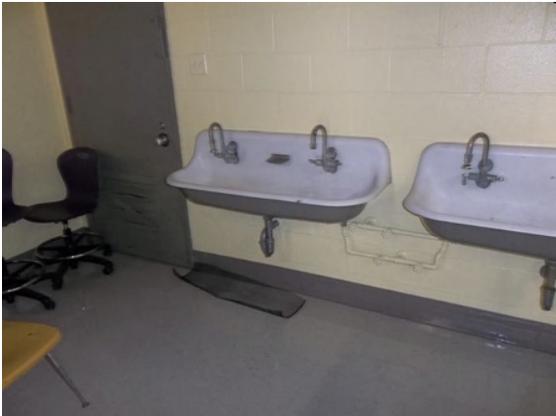
System: D2010 - Plumbing Fixtures

Location: Building 5 - E
Distress: Beyond Expected Life
Category: Deferred Maintenance
Priority: 3 - Short Term Conditions (2-3 Years)
Notes: Plumbing Fixtures System beyond useful life. Replace
Correction: Renew System
Qty: 1-Ea.
Condition Budget: \$113,385

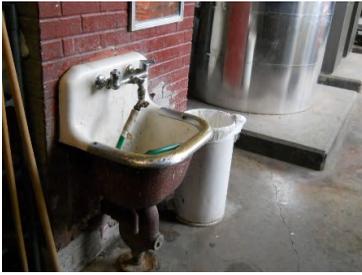
Location: Mechanical Building 6 - F
Distress: Beyond Expected Life
Category: Deferred Maintenance
Priority: 3 - Short Term Conditions (2-3 Years)
Notes: Fittings System beyond useful life. Replace
Correction: Renew System
Qty: 1-Ea.
Condition Budget: \$3,359
