School Assessment Report

School: Sharpstown International School, Charter High School

Date: Jul 16, 2012

School Name: Sharpstown International School, Charter High School

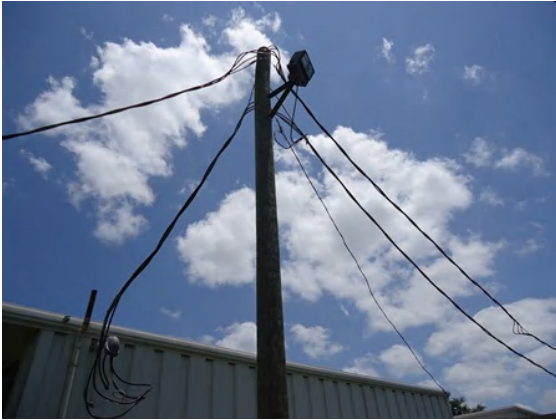
System: G4020 - Site Lighting

Analysis: The system age is either beyond expected life or does not meet its intended performance under the Guidelines. The system may be in service and functioning but it is recommended to be replaced due to probable increased condition budget needs, the potential failure of its components, or in order to meet the performance Guidelines for this system. The system was installed in 1967. It has a 30-year service life which expired in 1997.

Notes: Site Lighting System is inadequate and beyond its expected life and should be replaced.

Recommendation: The system should be replaced.

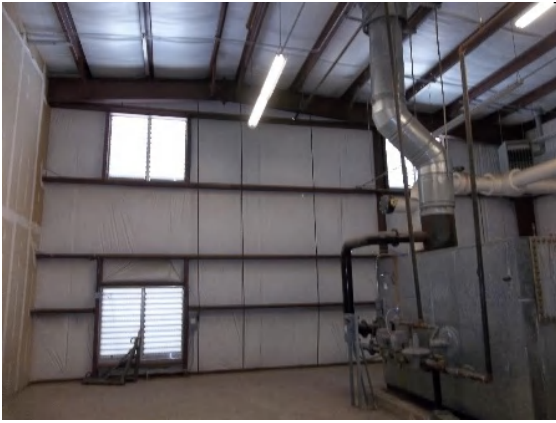
System: B2020 - Exterior Windows

Analysis: The system age is either beyond expected life or does not meet its intended performance under the Guidelines. The system may be in service and functioning but it is recommended to be replaced due to probable increased condition budget needs, the potential failure of its components, or in order to meet the performance Guidelines for this system. The system was installed in 1967. It has a 30-year service life which expired in 1997.

Notes: The building does not have windows. The louvers are damaged.

Recommendation: The system should be replaced.

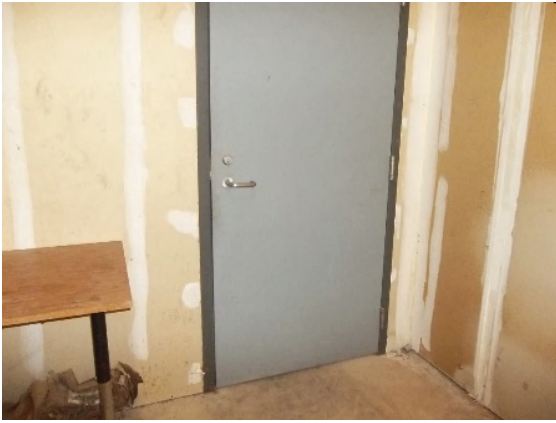
System: C3010 - Wall Finishes

Analysis: The system is missing.

Distress: Missing

Recommendation: The system should be installed.

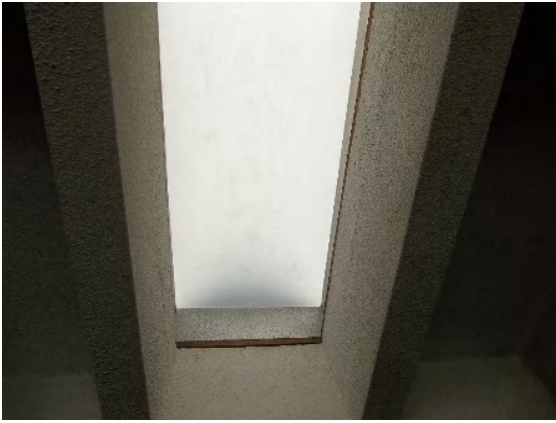
System: B3020 - Roof Openings

Analysis: The system age is either beyond expected life or does not meet its intended performance under the Guidelines. The system may be in service and functioning but it is recommended to be replaced due to probable increased condition budget needs, the potential failure of its components, or in order to meet the performance Guidelines for this system. The system was installed in 1967. It has a 30-year service life which expired in 1997.

Recommendation: The system should be replaced.

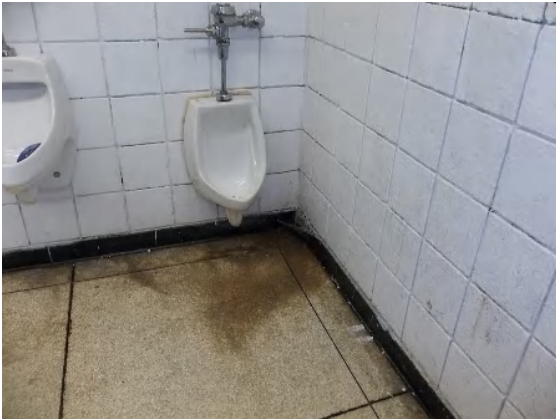
System: C3020210 - Terrazzo

Analysis: The system is in use and functioning with an estimated remaining service life as indicated in the report section "Condition/Replacement Budget Detail". The system was installed in 1961. It has a 50-year service life which expired in 2011. However, based on the 2009 assessment, the service life has been extended to 2017.

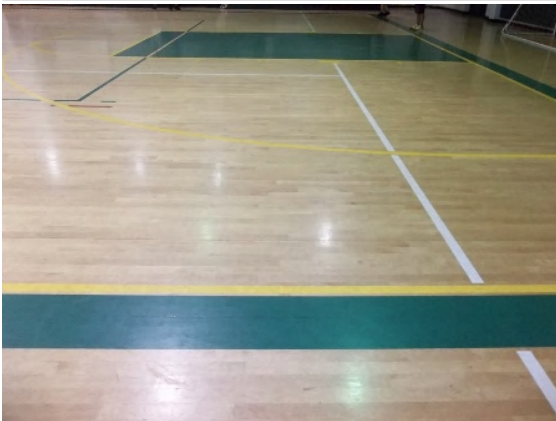
System: C3020410 - Wood

Analysis: The system is in use and functioning with an estimated remaining service life as indicated in the report section "Condition/Replacement Budget Detail". The system was installed in 1967. It has a 50-year service life. However, in the assessment, it was found to be currently deficient.

Recommendation: The system should be replaced.

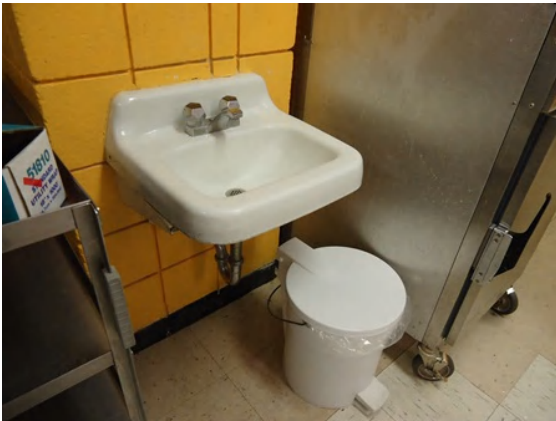
System: D2010 - Plumbing Fixtures

Analysis: The system age is either beyond expected life or does not meet its intended performance under the Guidelines. The system may be in service and functioning but it is recommended to be replaced due to probable increased condition budget needs, the potential failure of its components, or in order to meet the performance Guidelines for this system. The system was installed in 1997. It has a 30-year service life. However, in the assessment, it was found to be currently deficient.

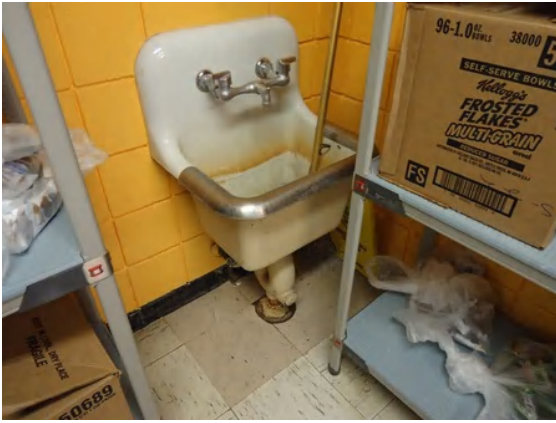
System: D2020 - Domestic Water Distribution

Analysis: The system age is either beyond expected life or does not meet its intended performance under the Guidelines. The system may be in service and functioning but it is recommended to be replaced due to probable increased condition budget needs, the potential failure of its components, or in order to meet the performance Guidelines for this system. The system was installed in 1967. It has a 30-year service life which expired in 1997.

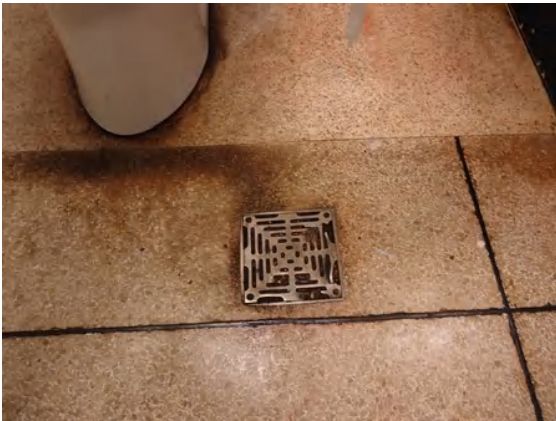
System: D2030 - Sanitary Waste

Analysis: The system age is either beyond expected life or does not meet its intended performance under the Guidelines. The system may be in service and functioning but it is recommended to be replaced due to probable increased condition budget needs, the potential failure of its components, or in order to meet the performance Guidelines for this system. The system was installed in 1967. It has a 30-year service life which expired in 1997.

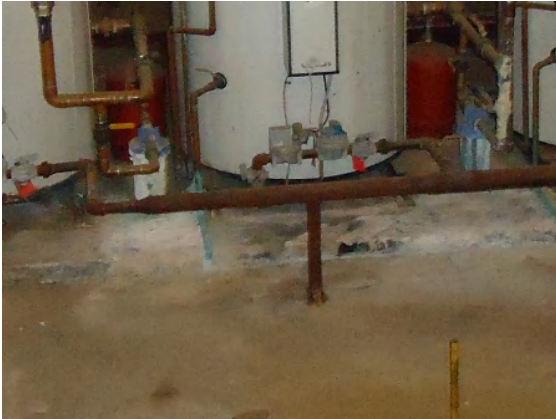
System: D2090 - Other Plumbing Systems-Nat Gas

Analysis: The system age is either beyond expected life or does not meet its intended performance under the Guidelines. The system may be in service and functioning but it is recommended to be replaced due to probable increased condition budget needs, the potential failure of its components, or in order to meet the performance Guidelines for this system. The system was installed in 1967. It has a 20-year service life which expired in 1987.

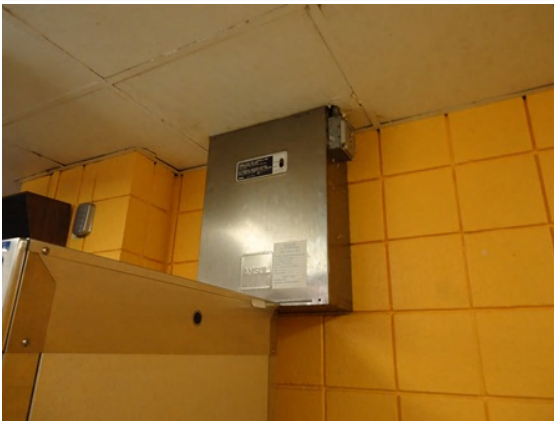
System: D4090 - Other Fire Protection Systems

Analysis: The system age is either beyond expected life or does not meet its intended performance under the Guidelines. The system may be in service and functioning but it is recommended to be replaced due to probable increased condition budget needs, the potential failure of its components, or in order to meet the performance Guidelines for this system. The system was installed in 1997. It has a 15-year service life. However, in the assessment, it was found to be currently deficient.

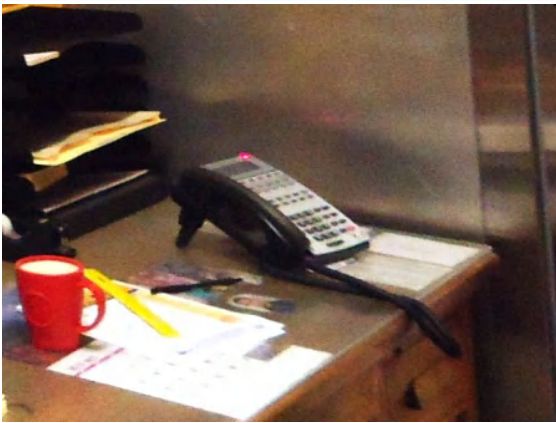
System: D5030310 - Telephone Systems

Analysis: The system age is either beyond expected life or does not meet its intended performance under the Guidelines. The system may be in service and functioning but it is recommended to be replaced due to probable increased condition budget needs, the potential failure of its components, or in order to meet the performance Guidelines for this system. The system was installed in 1990. It has a 15-year service life which expired in 2005.

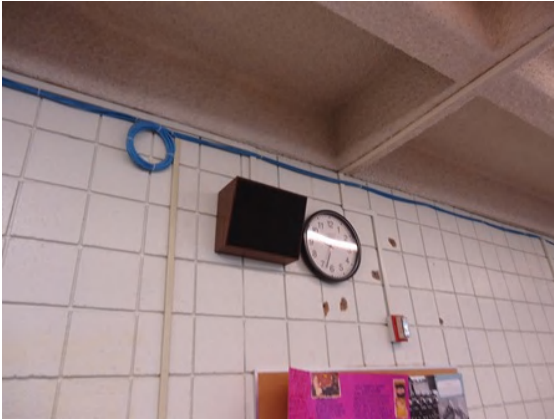
System: D5030920 - Public Address / Clock System

Analysis: The system age is either beyond expected life or does not meet its intended performance under the Guidelines. The system may be in service and functioning but it is recommended to be replaced due to probable increased condition budget needs, the potential failure of its components, or in order to meet the performance Guidelines for this system. The system was installed in 1967. It has a 15-year service life which expired in 1982.
