School Assessment Report

School: Mandarin Chinese Language Immersion Magnet
School at Gordon

Date: Jul 16, 2012

School Name: Mandarin Chinese Language Immersion Magnet School at Gordon

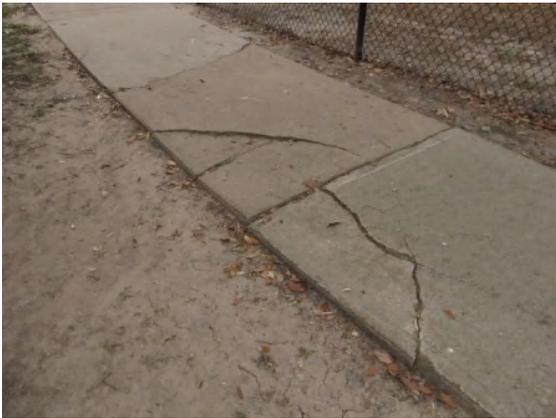
System: G2020 - Pedestrian Paving - sidewalks, etc.

Analysis: The system age is either beyond expected life or does not meet its intended performance under the Guidelines. The system may be in service and functioning but it is recommended to be replaced due to probable increased condition budget needs, the potential failure of its components, or in order to meet the performance Guidelines for this system. The system was installed in 1953. It has a 30-year service life which expired in 1983.

Notes: The sidewalks throughout the site are showing major age and wear. The sidewalks are cracking and split and uneven in some areas.

Recommendation: The system should be replaced.

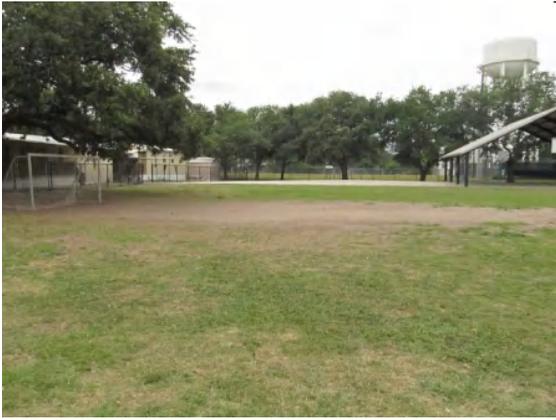
System: G2040 - Soccer / Practice Field

Analysis: The system age is either beyond expected life or does not meet its intended performance under the Guidelines. The system may be in service and functioning but it is recommended to be replaced due to probable increased condition budget needs, the potential failure of its components, or in order to meet the performance Guidelines for this system. The system was installed in 1953. It has a 10-year service life which expired in 1963.

Notes: The soccer field grounds are sparse and almost all dirt. The goals are fading and in some areas rusting.

Recommendation: The system should be replaced.

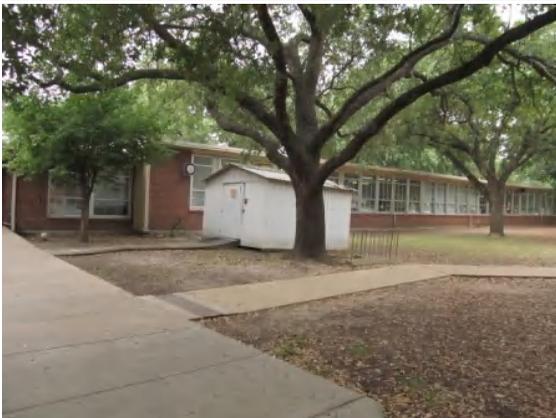
System: G2050 - Landscaping

Analysis: The system age is either beyond expected life or does not meet its intended performance under the Guidelines. The system may be in service and functioning but it is recommended to be replaced due to probable increased condition budget needs, the potential failure of its components, or in order to meet the performance Guidelines for this system. The system was installed in 1953. It has a 10-year service life which expired in 1963.

Notes: The landscaping is sparse throughout the entire site of the building. There are many areas of just dirt and the ground is cracking due to lack of irrigation.

Recommendation: The system should be replaced.

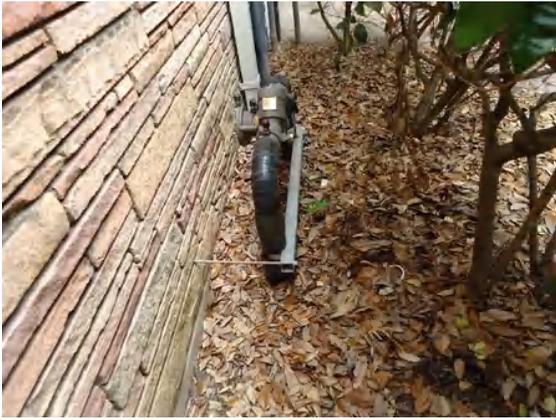
System: G3010 - Water Supply

Analysis: The system age is either beyond expected life or does not meet its intended performance under the Guidelines. The system may be in service and functioning but it is recommended to be replaced due to probable increased condition budget needs, the potential failure of its components, or in order to meet the performance Guidelines for this system. The system was installed in 1953. It has a 50-year service life which expired in 2003.

Recommendation: The system should be replaced.

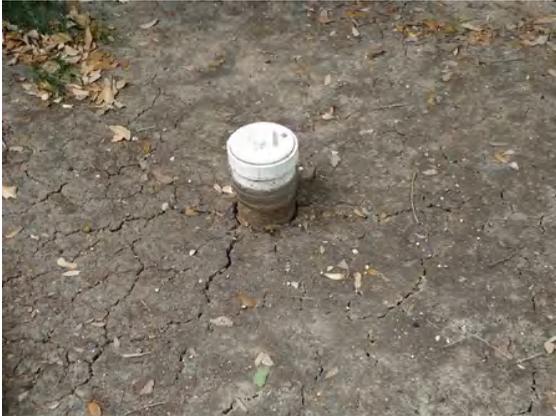
System: G3020 - Sanitary Sewer

Analysis: The system age is either beyond expected life or does not meet its intended performance under the Guidelines. The system may be in service and functioning but it is recommended to be replaced due to probable increased condition budget needs, the potential failure of its components, or in order to meet the performance Guidelines for this system. The system was installed in 1953. It has a 50-year service life which expired in 2003.

Notes: The original sanitary sewer laterals are aged, and should be replaced.

Recommendation: The system should be replaced.

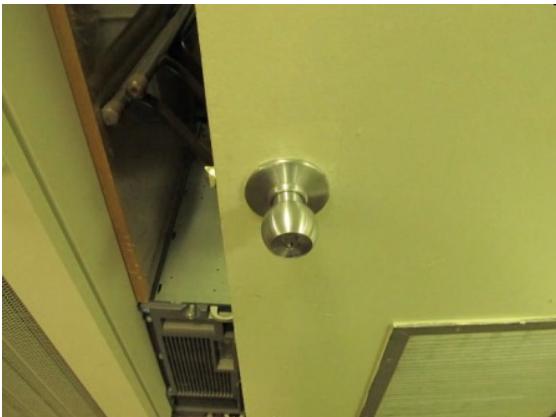
System: C1020 - Interior Doors

Analysis: The system age is either beyond expected life or does not meet its intended performance under the Guidelines. The system may be in service and functioning but it is recommended to be replaced due to probable increased condition budget needs, the potential failure of its components, or in order to meet the performance Guidelines for this system. The system was installed in 1953. It has a 40-year service life which expired in 1993.

Recommendation: The system should be replaced.

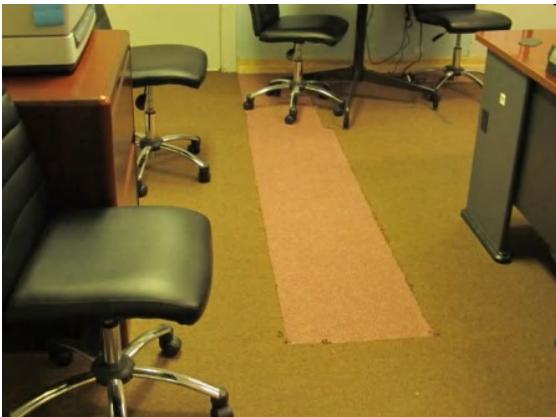
System: C3020410 - Carpet

Analysis: The system age is either beyond expected life or does not meet its intended performance under the Guidelines. The system may be in service and functioning but it is recommended to be replaced due to probable increased condition budget needs, the potential failure of its components, or in order to meet the performance Guidelines for this system. The system was installed in 2000. It has a 12-year service life. However, in the assessment, it was found to be currently deficient.

Notes: The carpet in the main building is showing major age and wear. Portions of the carpet have had to be replaced with mis matched carpet. There are also areas where the carpet is snagging.

Recommendation: The system should be replaced.

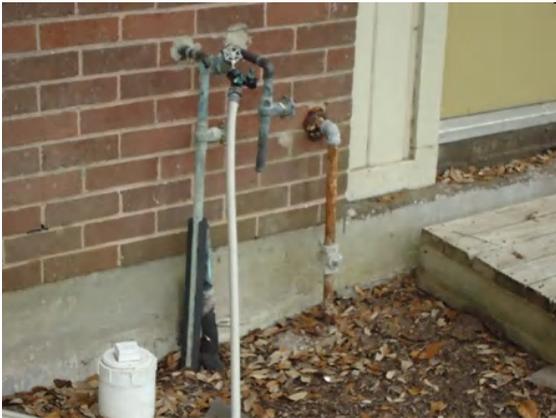
System: D2020 - Domestic Water Distribution

Analysis: The system age is either beyond expected life or does not meet its intended performance under the Guidelines. The system may be in service and functioning but it is recommended to be replaced due to probable increased condition budget needs, the potential failure of its components, or in order to meet the performance Guidelines for this system. The system was installed in 1953. It has a 30-year service life which expired in 1983.

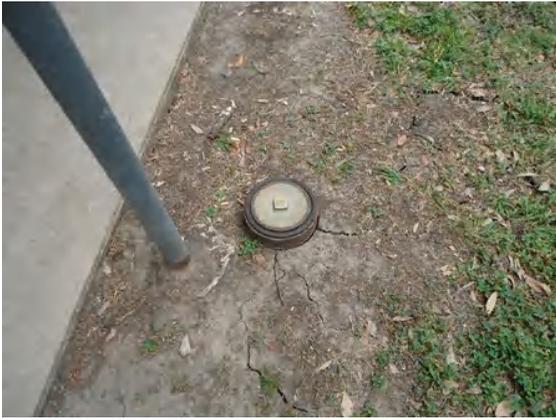
System: D2030 - Sanitary Waste

Analysis: The system age is either beyond expected life or does not meet its intended performance under the Guidelines. The system may be in service and functioning but it is recommended to be replaced due to probable increased condition budget needs, the potential failure of its components, or in order to meet the performance Guidelines for this system. The system was installed in 1953. It has a 30-year service life which expired in 1983.

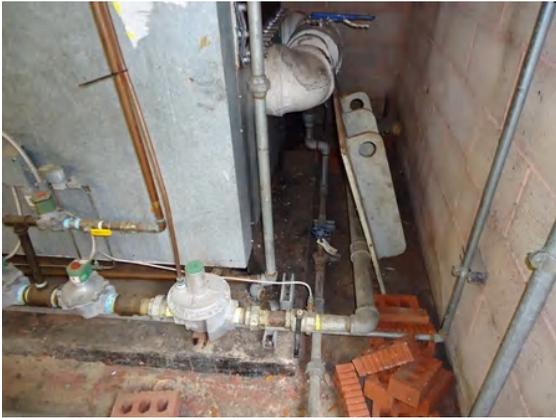
System: D2020 - Domestic Water Distribution

Analysis: The system age is either beyond expected life or does not meet its intended performance under the Guidelines. The system may be in service and functioning but it is recommended to be replaced due to probable increased condition budget needs, the potential failure of its components, or in order to meet the performance Guidelines for this system. The system was installed in 1953. It has a 30-year service life which expired in 1983.

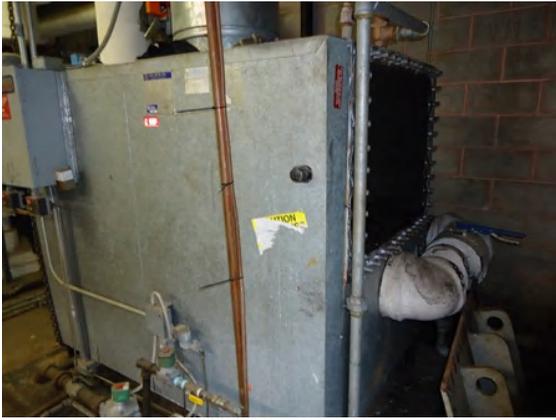
System: D3020 - Heat Generating Systems

Analysis: The system age is either beyond expected life or does not meet its intended performance under the Guidelines. The system may be in service and functioning but it is recommended to be replaced due to probable increased condition budget needs, the potential failure of its components, or in order to meet the performance Guidelines for this system. The system was installed in 1968. It has a 30-year service life which expired in 1998.
