# School Assessment Report

Type: High Schools  
School: Sharpstown High School  
Date: Jul 16, 2012

### School Name: Sharpstown High School

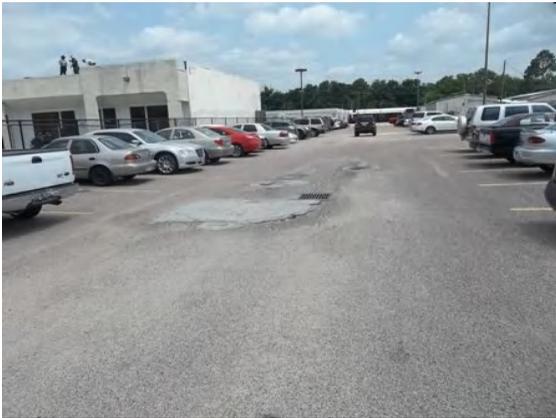
**System:** G2020 - Parking Lots

**Analysis:** The system age is either beyond expected life or does not meet its intended performance under the Guidelines. The system may be in service and functioning but it is recommended to be replaced due to probable increased condition budget needs, the potential failure of its components, or in order to meet the performance Guidelines for this system. The system was installed in 1969. It has a 25-year service life which expired in 1994.

**Deficiency**

**Priority:** 3 - Short Term Conditions (2-3 Years)

**Condition Budget:** \$1,125,071

**Recommendation:** The system should be replaced.

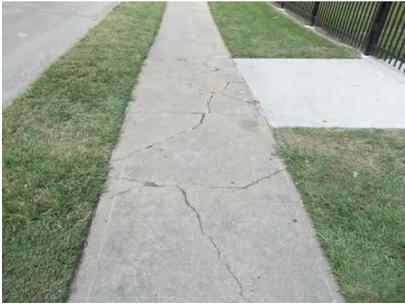
**Analysis:** The system age is either beyond expected life or does not meet its intended performance under the Guidelines. The system may be in service and functioning but it is recommended to be replaced due to probable increased condition budget needs, the potential failure of its components, or in order to meet the performance Guidelines for this system. The system was installed in 1969. It has a 30-year service life which expired in 1999.

**Deficiency**

Location: Site  
Distress: Beyond Expected Life  
Category: Deferred Maintenance  
Priority: 3 - Short Term Conditions (2-3 Years)  
Notes: Walkways beyond useful life. remove and replace damaged areas  
Correction: Renew System  
Qty: 1-Ea.  
Condition Budget: \$234,554

**Recommendation:** The system should be replaced.

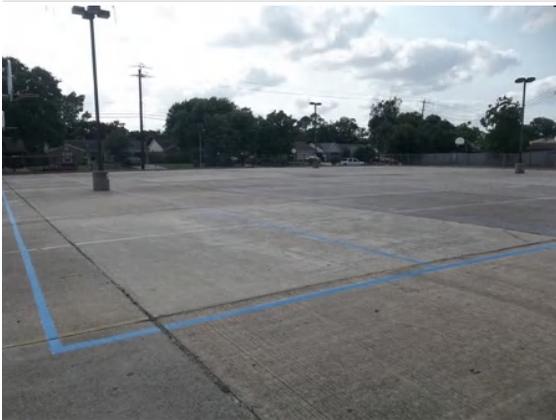
**System:** G2040 - Basketball / hard court play area

**Analysis:** The system age is either beyond expected life or does not meet its intended performance under the Guidelines. The system may be in service and functioning but it is recommended to be replaced due to probable increased condition budget needs, the potential failure of its components, or in order to meet the performance Guidelines for this system. The system was installed in 1969. It has a 10-year service life which expired in 1979.

**Deficiency**

Location: Site  
Distress: Beyond Expected Life  
Category: Deferred Maintenance  
Priority: 3 - Short Term Conditions (2-3 Years)  
Notes: surface cracked, beyond expected life.  
Correction: Renew System  
Qty: 1-Ea.  
Condition Budget: \$42,085

**Recommendation:** The system should be replaced.

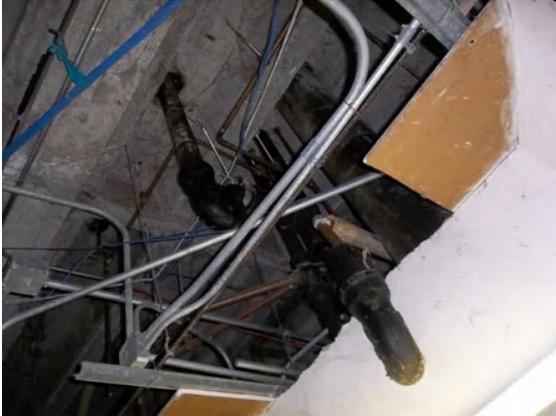
System: D2030 - Sanitary Waste

Analysis: The system age is either beyond expected life or does not meet its intended performance under the Guidelines. The system may be in service and functioning but it is recommended to be replaced due to probable increased condition budget needs, the potential failure of its components, or in order to meet the performance Guidelines for this system. The system was installed in 1969. It has a 30-year service life which expired in 1999.

**Deficiency**

Location: Main  
Distress: Beyond Expected Life  
Category: Deferred Maintenance  
Priority: 3 - Short Term Conditions (2-3 Years)  
Notes: sanitary wastes system beyond useful life. Replace  
Correction: Renew System  
Qty: 1-Ea.  
Condition Budget: \$669,170

Recommendation: The system should be replaced.
