School Assessment Report

Type: K-8th
School: Pilgrim Academy K-8th
Date: Jul 16, 2012

School Name: Pilgrim Academy K-8th

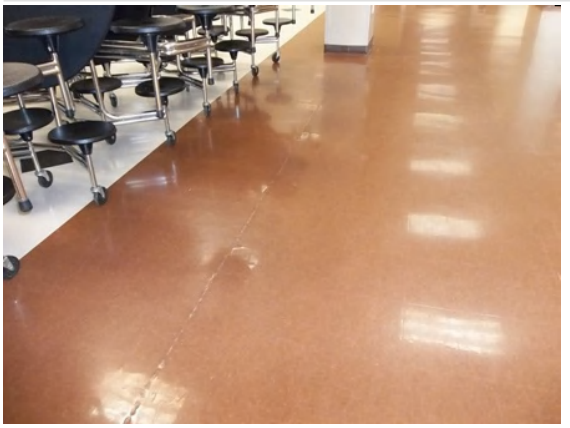
System: C3020410 - VCT
Analysis: The system is in use and functioning with an estimated remaining service life as indicated in the report section "Condition/Replacement Budget Detail". The system was installed in 2007. It has a 10-year service life. However, in the assessment, it was found to be currently deficient.
Recommendation: The system should be replaced.

Deficiency
Location: Main Building
Material: Floor Finishes
Distress: Damaged
Category: Deferred Maintenance
Priority: 3 - Short Term Conditions (2-3 Years)
Notes: The vinyl floor tiles in the dining area are cracked at the line of the columns. Originally this portion of the floor was to be a corridor and have terrazzo flooring. The vinyl floor should be replaced and the expansion joint at the slab taken into consideration to avoid the same damage from repeating.
Correction: Replace VCT Flooring
Qty: 700-S.F.
Condition Budget: $2,809
