# School Assessment Report

Type: High Schools  
School: Austin High School  
Date: Jul 16, 2012

### School Name: Austin High School

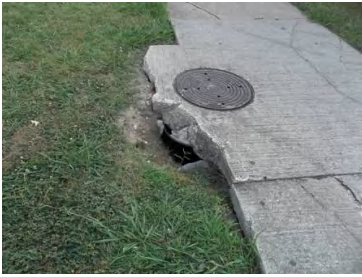
Location: Site  
Distress: Beyond Expected Life  
Category: Deferred Maintenance  
Priority: 3 - Short Term Conditions (2-3 Years)  
Notes: Storm Sewer System beyond useful life. Replace  
Correction: Renew System  
Qty: 1-Ea.  
Condition Budget: \$369,548

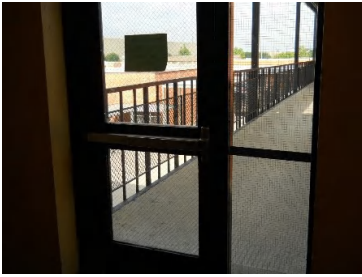
Location: Main  
Distress: Beyond Expected Life  
Category: Deferred Maintenance  
Priority: 3 - Short Term Conditions (2-3 Years)  
Notes: Exterior Doors System beyond useful life. Replace  
Correction: Renew System  
Qty: 1-Ea.  
Condition Budget: \$311,315

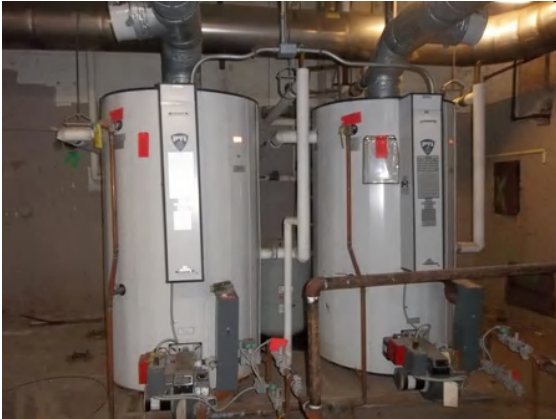
System: D2090 - Other Plumbing Systems-Nat Gas

Analysis: The system age is either beyond expected life or does not meet its intended performance under the Guidelines. The system may be in service and functioning but it is recommended to be replaced due to probable increased condition budget needs, the potential failure of its components, or in order to meet the performance Guidelines for this system. The system was installed in 1980. It has a 20-year service life which expired in 2000.

Recommendation: The system should be replaced.

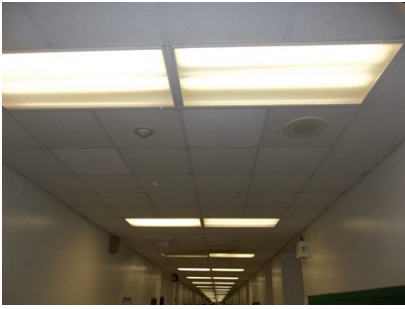
Location: Main  
Distress: Beyond Expected Life  
Category: Deferred Maintenance  
Priority: 3 - Short Term Conditions (2-3 Years)  
Notes: Lighting and Branch Wiring System beyond useful life. Replace  
Correction: Renew System  
Qty: 1-Ea.  
Condition Budget: \$6,825,293

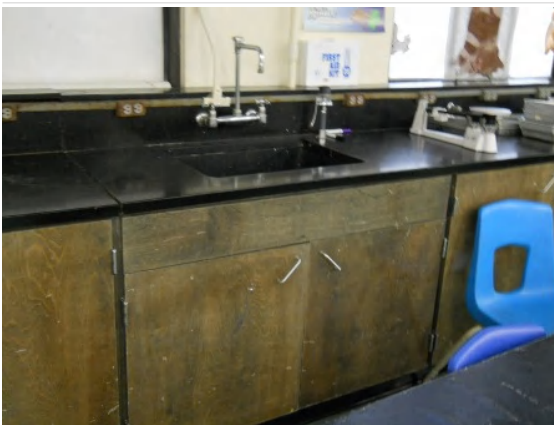
System: E1020 - Institutional Equipment

Analysis: The system age is either beyond expected life or does not meet its intended performance under the Guidelines. The system may be in service and functioning but it is recommended to be replaced due to probable increased condition budget needs, the potential failure of its components, or in order to meet the performance Guidelines for this system. The system was installed in 1990. It has a 20-year service life which expired in 2010.

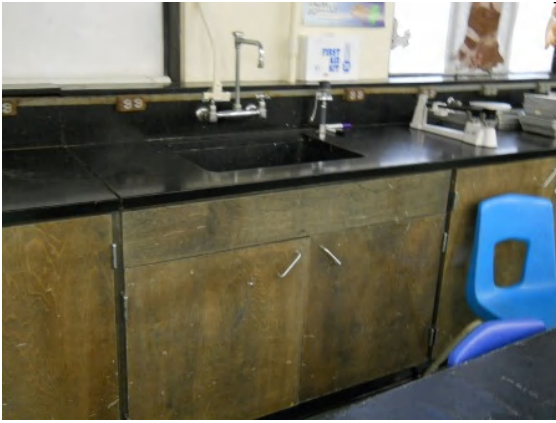
System: E2010 - Fixed Furnishings

Analysis: The system age is either beyond expected life or does not meet its intended performance under the Guidelines. The system may be in service and functioning but it is recommended to be replaced due to probable increased condition budget needs, the potential failure of its components, or in order to meet the performance Guidelines for this system. The system was installed in 1936. It has a 20-year service life which expired in 1956.

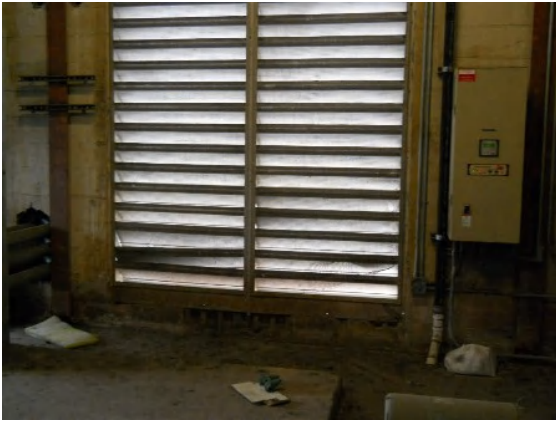
**System:** B2020 - Exterior Windows

**Analysis:** The system age is either beyond expected life or does not meet its intended performance under the Guidelines. The system may be in service and functioning but it is recommended to be replaced due to probable increased condition budget needs, the potential failure of its components, or in order to meet the performance Guidelines for this system. The system was installed in 1975. It has a 30-year service life which expired in 2005.

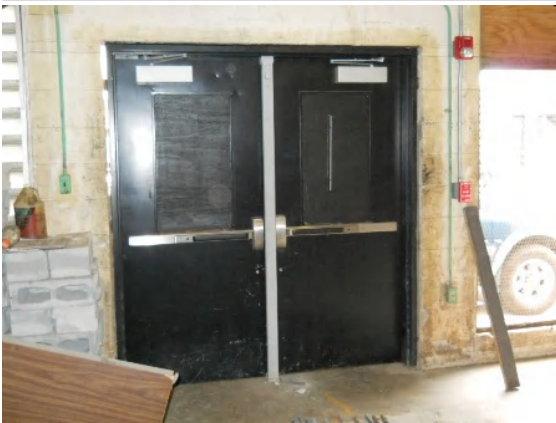
**System:** B2030 - Exterior Doors

**Analysis:** The system age is either beyond expected life or does not meet its intended performance under the Guidelines. The system may be in service and functioning but it is recommended to be replaced due to probable increased condition budget needs, the potential failure of its components, or in order to meet the performance Guidelines for this system. The system was installed in 1975. It has a 30-year service life which expired in 2005.

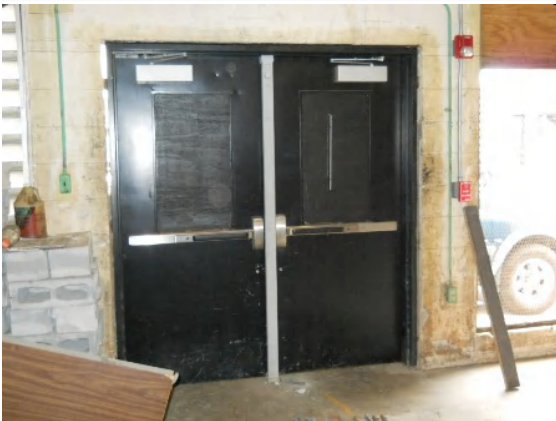
System: C1030 - Fittings

Analysis: The system age is either beyond expected life or does not meet its intended performance under the Guidelines. The system may be in service and functioning but it is recommended to be replaced due to probable increased condition budget needs, the potential failure of its components, or in order to meet the performance Guidelines for this system. The system was installed in 1975. It has a 20-year service life which expired in 1995.

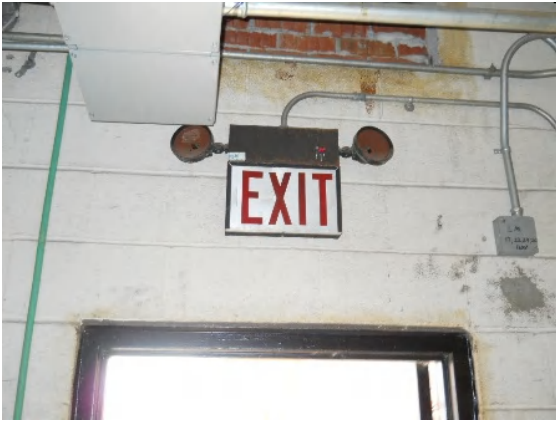
**System:** C3010 - Wall Finishes

**Analysis:** The system age is either beyond expected life or does not meet its intended performance under the Guidelines. The system may be in service and functioning but it is recommended to be replaced due to probable increased condition budget needs, the potential failure of its components, or in order to meet the performance Guidelines for this system. The system was installed in 1975. It has a 10-year service life which expired in 1985.

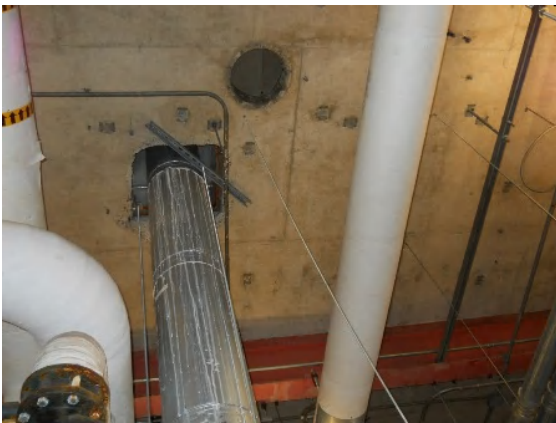
**System:** C3030 - Ceiling Finishes

**Analysis:** The system age is either beyond expected life or does not meet its intended performance under the Guidelines. The system may be in service and functioning but it is recommended to be replaced due to probable increased condition budget needs, the potential failure of its components, or in order to meet the performance Guidelines for this system. The system was installed in 1975. It has a 20-year service life which expired in 1995.

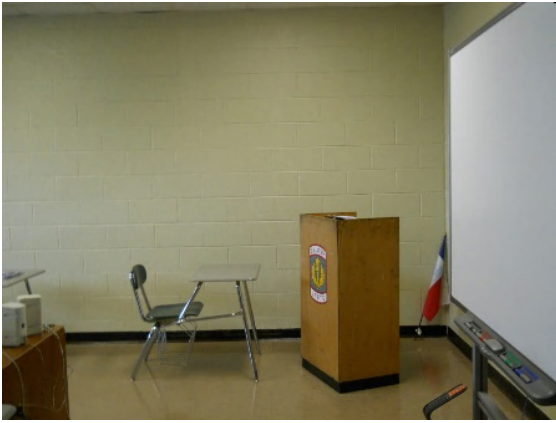
System: C3010 - Wall Finishes

Analysis: The system age is either beyond expected life or does not meet its intended performance under the Guidelines. The system may be in service and functioning but it is recommended to be replaced due to probable increased condition budget needs, the potential failure of its components, or in order to meet the performance Guidelines for this system. The system was installed in 2000. It has a 10-year service life which expired in 2010.

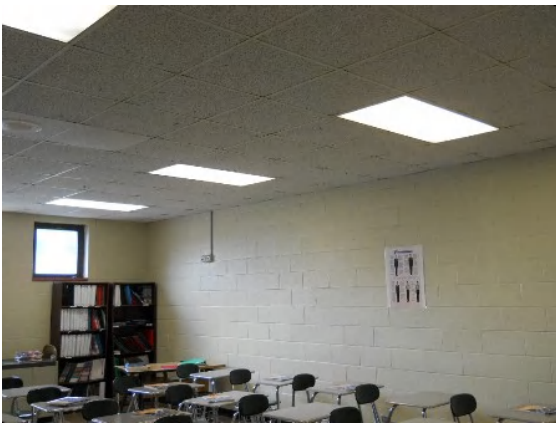
System: C3030 - Ceiling Finishes

Analysis: The system age is either beyond expected life or does not meet its intended performance under the Guidelines. The system may be in service and functioning but it is recommended to be replaced due to probable increased condition budget needs, the potential failure of its components, or in order to meet the performance Guidelines for this system. The system was installed in 1990. It has a 20-year service life which expired in 2010.

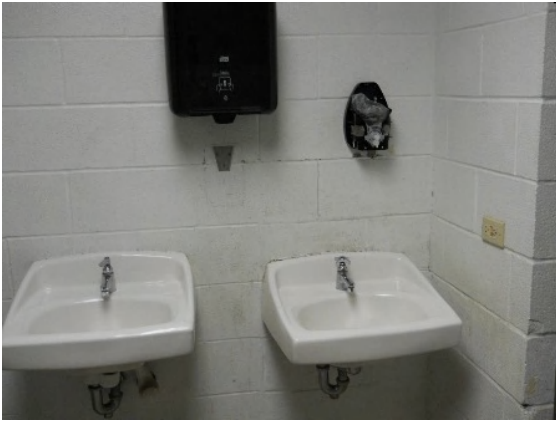
**System:** D2010 - Plumbing Fixtures

**Analysis:** The system age is either beyond expected life or does not meet its intended performance under the Guidelines. The system may be in service and functioning but it is recommended to be replaced due to probable increased condition budget needs, the potential failure of its components, or in order to meet the performance Guidelines for this system. The system was installed in 1975. It has a 30-year service life which expired in 2005.

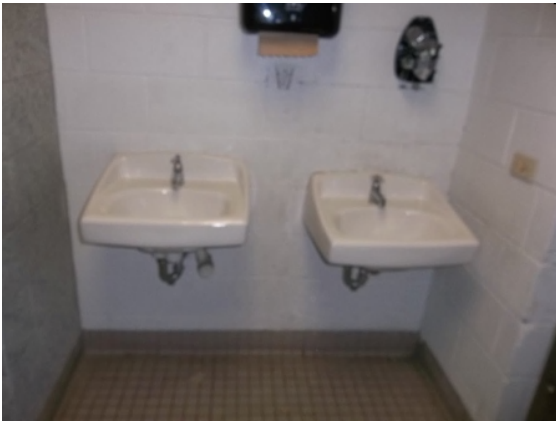
**System:** D2020 - Domestic Water Distribution

**Analysis:** The system age is either beyond expected life or does not meet its intended performance under the Guidelines. The system may be in service and functioning but it is recommended to be replaced due to probable increased condition budget needs, the potential failure of its components, or in order to meet the performance Guidelines for this system. The system was installed in 1975. It has a 30-year service life which expired in 2005.

**Recommendation:** The system should be replaced.

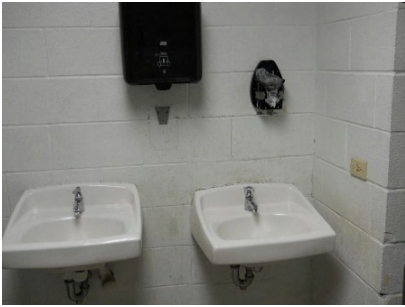
Location: ROTC  
Distress: Beyond Expected Life  
Category: Deferred Maintenance  
Priority: 3 - Short Term Conditions (2-3 Years)  
Notes: Sanitary Sewer System beyond useful life.  
Replace  
Correction: Renew System  
Qty: 1-Ea.  
Condition Budget: \$23,245

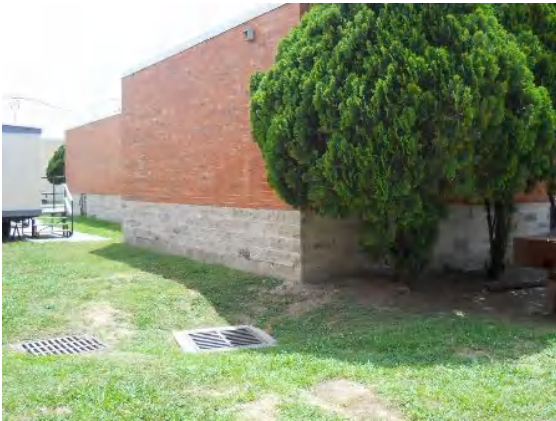
**System:** D2040 - Rain Water Drainage

Analysis: The system age is either beyond expected life or does not meet its intended performance under the Guidelines. The system may be in service and functioning but it is recommended to be replaced due to probable increased condition budget needs, the potential failure of its components, or in order to meet the performance Guidelines for this system. The system was installed in 1975. It has a 30-year service life which expired in 2005.

Location: ROTC  
Distress: Beyond Expected Life  
Category: Deferred Maintenance  
Priority: 3 - Short Term Conditions (2-3 Years)  
Notes: Rain Water Drainage System beyond useful life.  
Replace  
Correction: Renew System  
Qty: 1-Ea.  
Condition Budget: \$3,946

Recommendation: The system should be replaced.

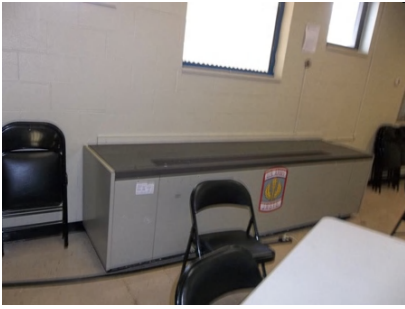
Notes: Distribution Systems (ductwork) beyond useful life.  
Replace

Analysis: The system age is either beyond expected life or does not meet its intended performance under the Guidelines. The system may be in service and functioning but it is recommended to be replaced due to probable increased condition budget needs, the potential failure of its components, or in order to meet the performance Guidelines for this system. The system was installed in 1975. It has a 15-year service life which expired in 1990.

Recommendation: The system should be replaced.

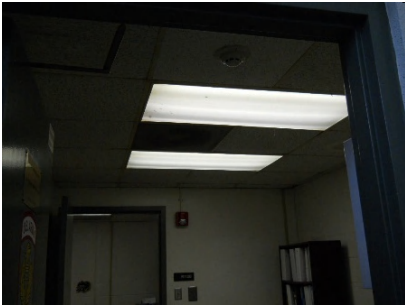
Location: ROTC  
Distress: Beyond Expected Life  
Category: Deferred Maintenance  
Priority: 3 - Short Term Conditions (2-3 Years)  
Notes: Controls & Instrumentation beyond useful life.  
Replace  
Correction: Renew System  
Qty: 1-Ea.  
Condition Budget: \$22,816

**Analysis:** The system age is either beyond expected life or does not meet its intended performance under the Guidelines. The system may be in service and functioning but it is recommended to be replaced due to probable increased condition budget needs, the potential failure of its components, or in order to meet the performance Guidelines for this system. The system was installed in 1975. It has a 30-year service life which expired in 2005.

**Recommendation:** The system should be replaced.

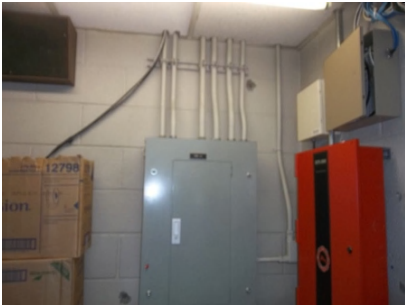
Location: ROTC  
Distress: Beyond Expected Life  
Category: Deferred Maintenance  
Priority: 3 - Short Term Conditions (2-3 Years)  
Notes: Electrical Service/Distribution System beyond useful life. Replace  
Correction: Renew System  
Qty: 1-Ea.  
Condition Budget: \$34,653

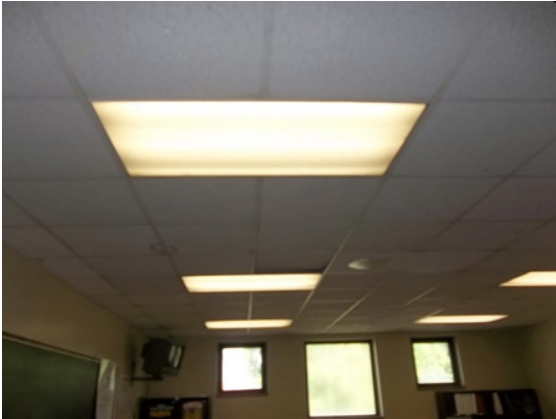
**System:** D5020 - Lighting and Branch Wiring

Analysis: The system age is either beyond expected life or does not meet its intended performance under the Guidelines. The system may be in service and functioning but it is recommended to be replaced due to probable increased condition budget needs, the potential failure of its components, or in order to meet the performance Guidelines for this system. The system was installed in 1975. It has a 30-year service life which expired in 2005.

Location: ROTC  
Distress: Beyond Expected Life  
Category: Deferred Maintenance  
Priority: 3 - Short Term Conditions (2-3 Years)  
Notes: Lighting and Branch Wiring System beyond useful life. Replace  
Correction: Renew System  
Qty: 1-Ea.  
Condition Budget: \$166,315

Recommendation: The system should be replaced.

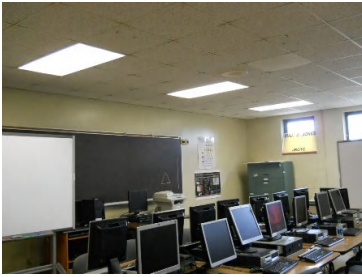
Location: ROTC  
Distress: Beyond Expected Life  
Category: Deferred Maintenance  
Priority: 3 - Short Term Conditions (2-3 Years)  
Notes: Telephone System beyond useful life. Replace  
Correction: Renew System  
Qty: 1-Ea.  
Condition Budget: \$8,761

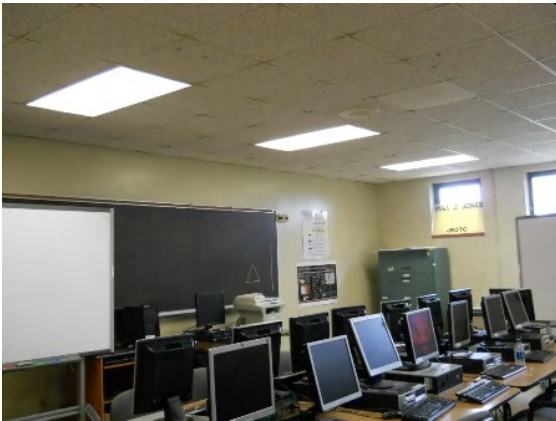
System: D5030920 - LAN System

Analysis: The system age is either beyond expected life or does not meet its intended performance under the Guidelines. The system may be in service and functioning but it is recommended to be replaced due to probable increased condition budget needs, the potential failure of its components, or in order to meet the performance Guidelines for this system. The system was installed in 1975. It has a 15-year service life which expired in 1990.

Location: ROTC  
Distress: Beyond Expected Life  
Category: Deferred Maintenance  
Priority: 3 - Short Term Conditions (2-3 Years)  
Notes: LAN System beyond useful life. Replace  
Correction: Renew System  
Qty: 1-Ea.  
Condition Budget: \$5,813

Recommendation: The system should be replaced.

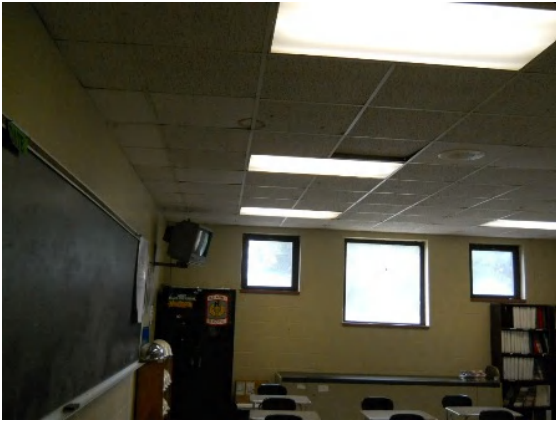
System: D5030920 - Public Address / Clock System

Analysis: The system age is either beyond expected life or does not meet its intended performance under the Guidelines. The system may be in service and functioning but it is recommended to be replaced due to probable increased condition budget needs, the potential failure of its components, or in order to meet the performance Guidelines for this system. The system was installed in 1975. It has a 15-year service life which expired in 1990.

Notes: Public Address / Clock System beyond useful life.  
Replace

Recommendation: The system should be replaced.

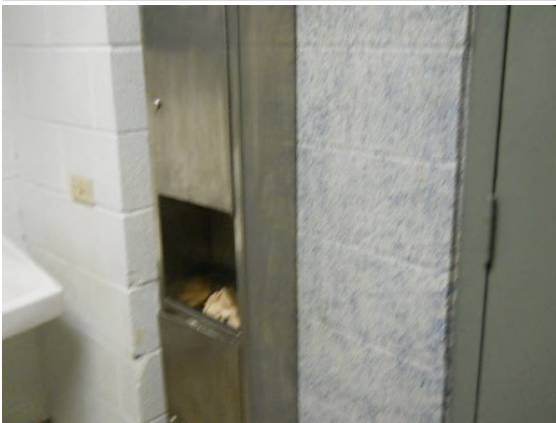
System: E1020 - Institutional Equipment

Analysis: The system age is either beyond expected life or does not meet its intended performance under the Guidelines. The system may be in service and functioning but it is recommended to be replaced due to probable increased condition budget needs, the potential failure of its components, or in order to meet the performance Guidelines for this system. The system was installed in 1975. It has a 20-year service life which expired in 1995.

Notes: Institutional Equipment System beyond useful life.  
Replace

Recommendation: The system should be replaced.

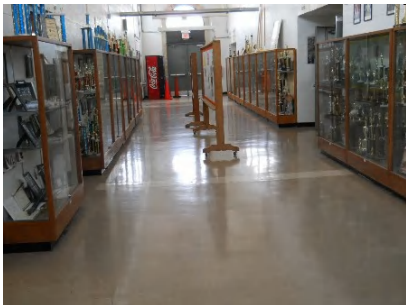
Notes: Fixed Furnishings System beyond useful life.  
Replace

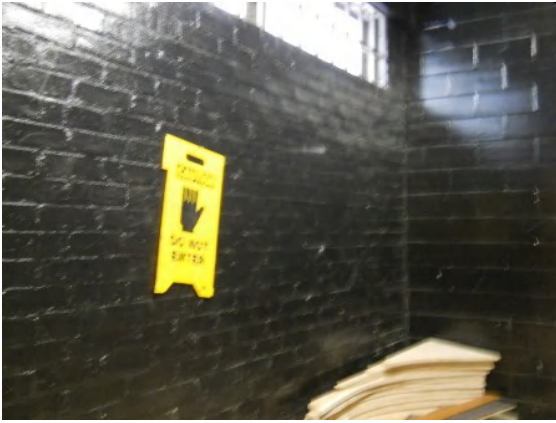
System: C3010 - Wall Finishes

Analysis: The system age is either beyond expected life or does not meet its intended performance under the Guidelines. The system may be in service and functioning but it is recommended to be replaced due to probable increased condition budget needs, the potential failure of its components, or in order to meet the performance Guidelines for this system. The system was installed in 2000. It has a 10-year service life which expired in 2010.

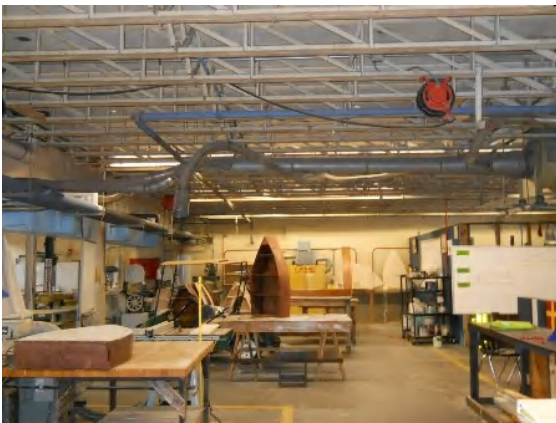
System: C3030 - Ceiling Finishes

Analysis: The system age is either beyond expected life or does not meet its intended performance under the Guidelines. The system may be in service and functioning but it is recommended to be replaced due to probable increased condition budget needs, the potential failure of its components, or in order to meet the performance Guidelines for this system. The system was installed in 1975. It has a 20-year service life which expired in 1995.

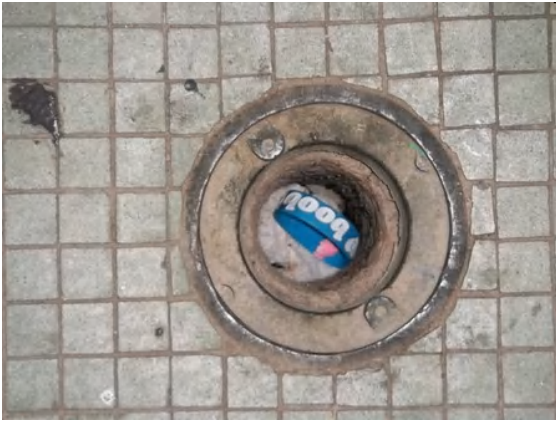
**System:** D2010 - Plumbing Fixtures

**Analysis:** The system age is either beyond expected life or does not meet its intended performance under the Guidelines. The system may be in service and functioning but it is recommended to be replaced due to probable increased condition budget needs, the potential failure of its components, or in order to meet the performance Guidelines for this system. The system was installed in 1975. It has a 30-year service life which expired in 2005.

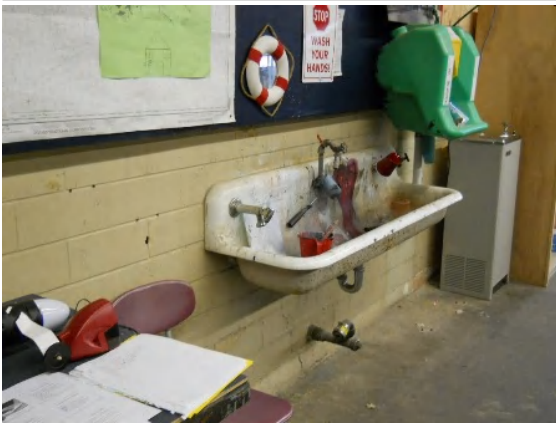
**System:** D2020 - Domestic Water Distribution

**Analysis:** The system age is either beyond expected life or does not meet its intended performance under the Guidelines. The system may be in service and functioning but it is recommended to be replaced due to probable increased condition budget needs, the potential failure of its components, or in order to meet the performance Guidelines for this system. The system was installed in 1975. It has a 30-year service life which expired in 2005.

**Recommendation:** The system should be replaced.

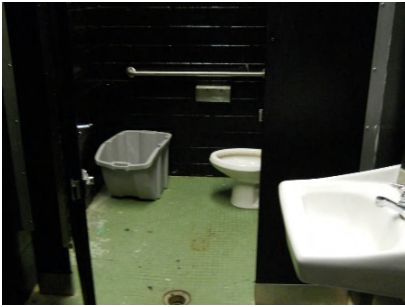
Location: Vocational Shop 01  
Distress: Beyond Expected Life  
Category: Deferred Maintenance  
Priority: 3 - Short Term Conditions (2-3 Years)  
Notes: Sanitary Sewer System beyond useful life.  
Replace

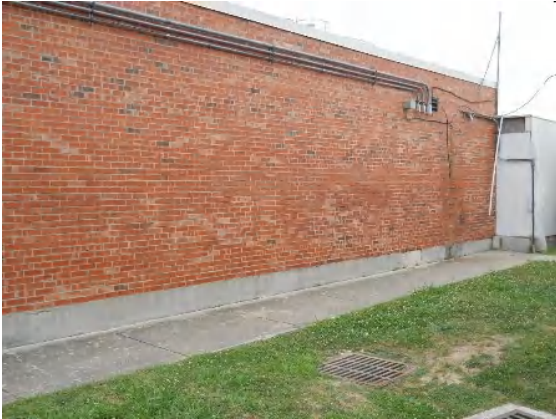
**System:** D2040 - Rain Water Drainage

Analysis: The system age is either beyond expected life or does not meet its intended performance under the Guidelines. The system may be in service and functioning but it is recommended to be replaced due to probable increased condition budget needs, the potential failure of its components, or in order to meet the performance Guidelines for this system. The system was installed in 1975. It has a 30-year service life which expired in 2005.

Recommendation: The system should be replaced.

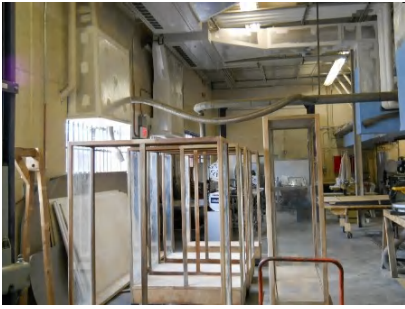
Location: Vocational Shop 01  
Distress: Beyond Expected Life  
Category: Deferred Maintenance  
Priority: 3 - Short Term Conditions (2-3 Years)  
Notes: Other Electrical System beyond useful life.  
Replace

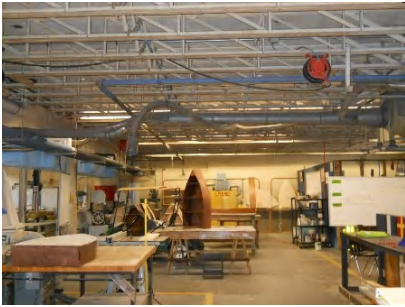
Location: Vocational Shop 01  
Distress: Beyond Expected Life  
Category: Deferred Maintenance  
Priority: 3 - Short Term Conditions (2-3 Years)  
Notes: Controls & Instrumentation beyond useful life.  
Replace  
Correction: Renew System  
Qty: 1-Ea.  
Condition Budget: \$24,506

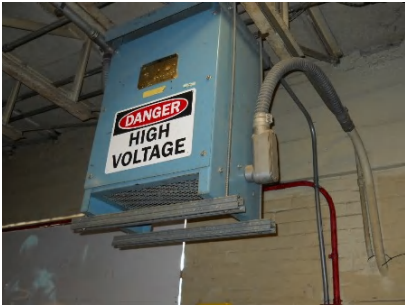
Location: Vocational Shop 01  
Distress: Beyond Expected Life  
Category: Deferred Maintenance  
Priority: 3 - Short Term Conditions (2-3 Years)  
Notes: Electrical Service/Distribution System beyond useful life. Replace  
Correction: Renew System  
Qty: 1-Ea.  
Condition Budget: \$37,092

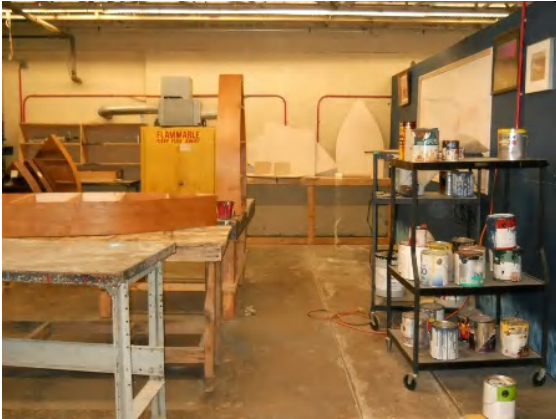
System: D5020 - Lighting and Branch Wiring

Analysis: The system age is either beyond expected life or does not meet its intended performance under the Guidelines. The system may be in service and functioning but it is recommended to be replaced due to probable increased condition budget needs, the potential failure of its components, or in order to meet the performance Guidelines for this system. The system was installed in 1975. It has a 30-year service life which expired in 2005.

Recommendation: The system should be replaced.

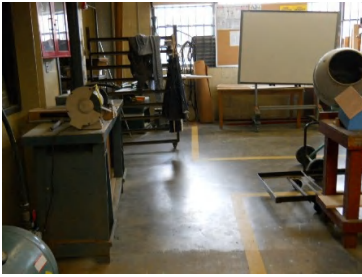
Location: Vocational Shop 01  
Distress: Beyond Expected Life  
Category: Deferred Maintenance  
Priority: 3 - Short Term Conditions (2-3 Years)  
Notes: Telephone System beyond useful life. Replace  
Correction: Renew System  
Qty: 1-Ea.  
Condition Budget: \$9,389

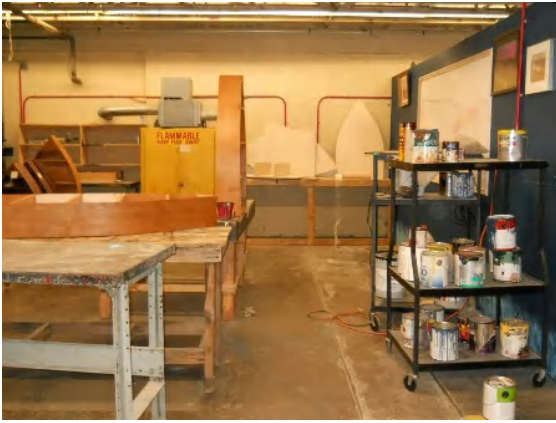
System: D5030920 - Public Address / Clock System

Analysis: The system age is either beyond expected life or does not meet its intended performance under the Guidelines. The system may be in service and functioning but it is recommended to be replaced due to probable increased condition budget needs, the potential failure of its components, or in order to meet the performance Guidelines for this system. The system was installed in 1975. It has a 15-year service life which expired in 1990.

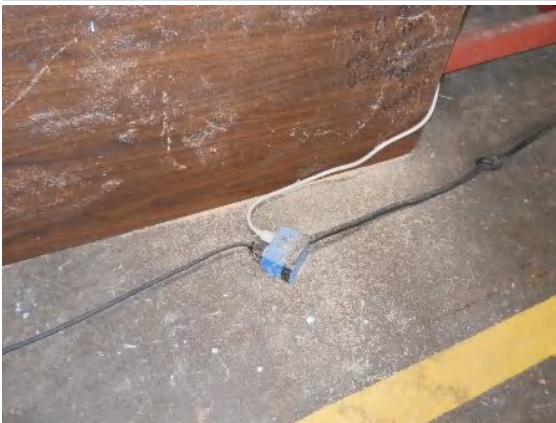
System: D5090 - Other Electrical Systems

Analysis: The system age is either beyond expected life or does not meet its intended performance under the Guidelines. The system may be in service and functioning but it is recommended to be replaced due to probable increased condition budget needs, the potential failure of its components, or in order to meet the performance Guidelines for this system. The system was installed in 1975. It has a 20-year service life which expired in 1995.

Recommendation: The system should be replaced.
