School Assessment Report

Type: High Schools
School: Madison High School
Date: Jul 16, 2012

School Name: Madison High School

Madison High School campus is located at 13719 Whiteheather, Houston TX, and consists of 5 main school building(s). The original campus was constructed in 1966 and an addition to the main school building was constructed in 1988 to house mechanical equipment. Ancillary buildings on campus include, Gym Building E, Library Building D, Classroom Buildings B and C, Storage Building F, Greenhouse, T-Buildings and miscellaneous metal sheds. In addition to the buildings, the campus contains covered walkways, baseball field, football practice field and track. This report contains condition and adequacy data collected during the 2012 Facility Condition Assessment (FCA). The detailed condition and deficiency statements are contained in this report for each building and other facilities on the campus.

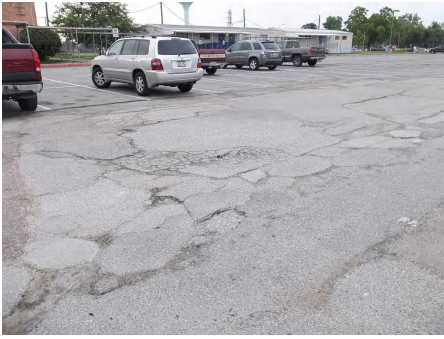
Location: Site
Distress: Beyond Expected Life
Category: Deferred Maintenance
Priority: 3 - Short Term Conditions (2-3 Years)
Notes: Areas of pavement on the site are in good condition, but the majority of the pavement is in poor condition and should be replaced.
Correction: Renew System
Qty: 1-Ea.
Condition Budget: \$1,165,050

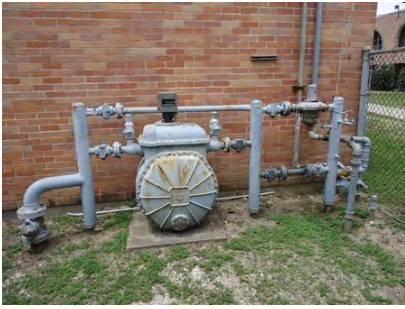
Location: Site
Distress: Beyond Expected Life
Category: Deferred Maintenance
Priority: 3 - Short Term Conditions (2-3 Years)
Notes: Fuel Distribution System is beyond its expected life and it's recommended to be replaced.

Correction: Renew System
Qty: 1-Ea.
Condition Budget: \$79,316

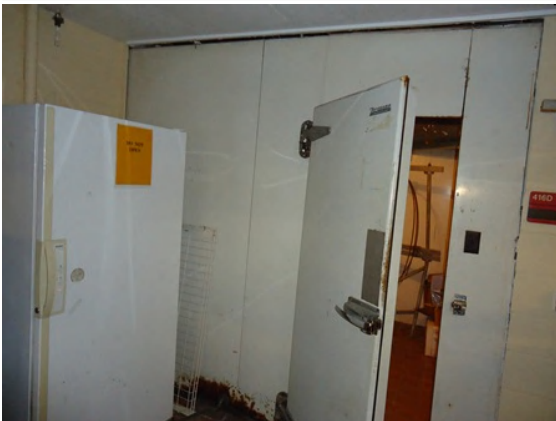
System: E1090 - Other Equipment

Analysis: The system age is either beyond expected life or does not meet its intended performance under the Guidelines. The system may be in service and functioning but it is recommended to be replaced due to probable increased condition budget needs, the potential failure of its components, or in order to meet the performance Guidelines for this system. The system was installed in 1966. It has a 20-year service life which expired in 1986.

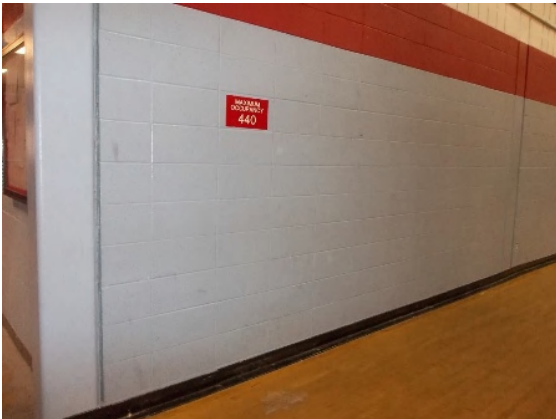
System: C3010 - Wall Finishes

Analysis: The system age is either beyond expected life or does not meet its intended performance under the Guidelines. The system may be in service and functioning but it is recommended to be replaced due to probable increased condition budget needs, the potential failure of its components, or in order to meet the performance Guidelines for this system. The system was installed in 1988. It has a 20-year service life which expired in 2008.

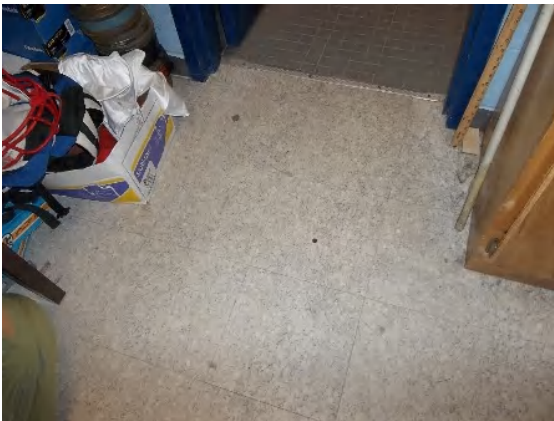
System: C3020210 - VCT

Analysis: The system age is either beyond expected life or does not meet its intended performance under the Guidelines. The system may be in service and functioning but it is recommended to be replaced due to probable increased condition budget needs, the potential failure of its components, or in order to meet the performance Guidelines for this system. The system was installed in 1988. It has a 12-year service life which expired in 2000.

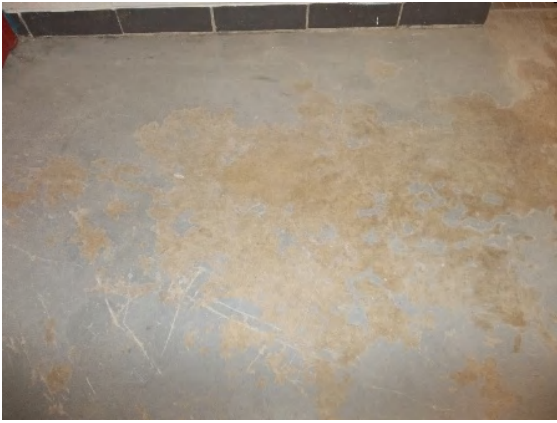
System: C3020410 - Painted Concrete Floor

Analysis: The system age is either beyond expected life or does not meet its intended performance under the Guidelines. The system may be in service and functioning but it is recommended to be replaced due to probable increased condition budget needs, the potential failure of its components, or in order to meet the performance Guidelines for this system. The system was installed in 1988. It has a 10-year service life which expired in 1998.

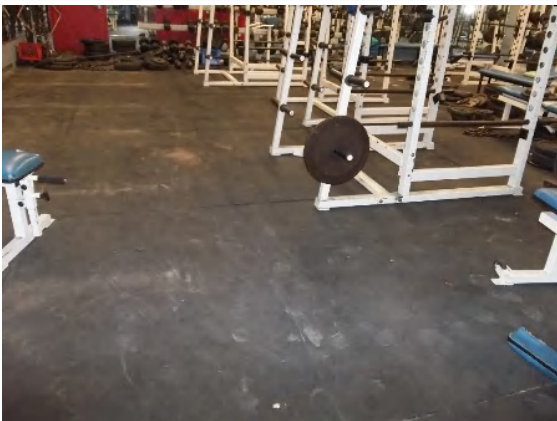
System: C3020410 - Rubber Pads

Analysis: The system age is either beyond expected life or does not meet its intended performance under the Guidelines. The system may be in service and functioning but it is recommended to be replaced due to probable increased condition budget needs, the potential failure of its components, or in order to meet the performance Guidelines for this system. The system was installed in 1988. It has a 15-year service life which expired in 2003.

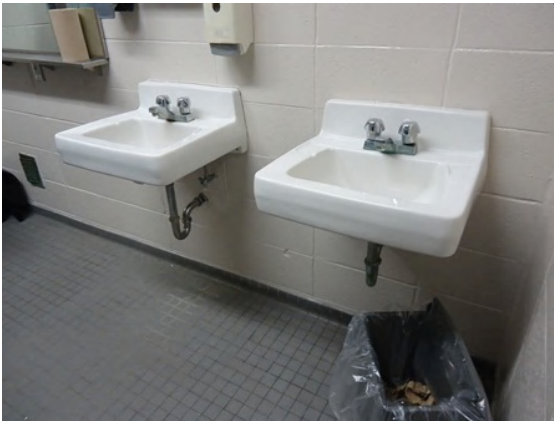
System: D2010 - Plumbing Fixtures

Analysis: The system age is either beyond expected life or does not meet its intended performance under the Guidelines. The system may be in service and functioning but it is recommended to be replaced due to probable increased condition budget needs, the potential failure of its components, or in order to meet the performance Guidelines for this system. The system was installed in 1988. It has a 30-year service life. However, in the assessment, it was found to be currently deficient.

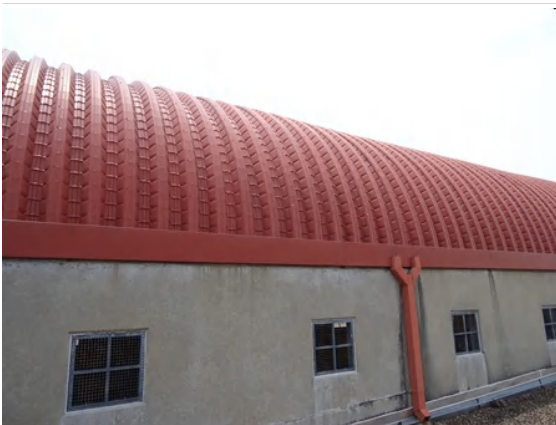
System: **B3010130 - Preformed Metal Roofing**

Analysis: The system age is either beyond expected life or does not meet its intended performance under the Guidelines. The system may be in service and functioning but it is recommended to be replaced due to probable increased condition budget needs, the potential failure of its components, or in order to meet the performance Guidelines for this system. The system was installed in 1988. It has a 0-year service life which expired in 1988.

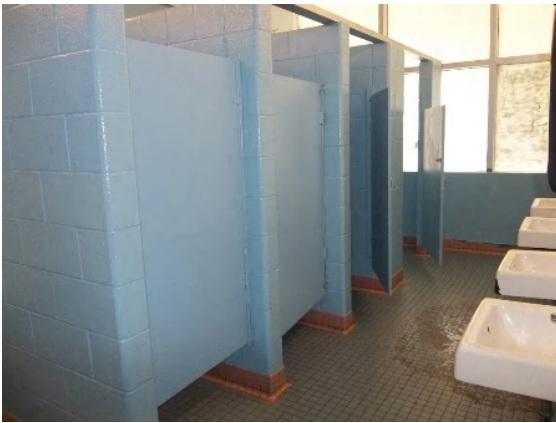
System: C1030 - Fittings

Analysis: The system age is either beyond expected life or does not meet its intended performance under the Guidelines. The system may be in service and functioning but it is recommended to be replaced due to probable increased condition budget needs, the potential failure of its components, or in order to meet the performance Guidelines for this system. The system was installed in 1988. It has a 20-year service life which expired in 2008.

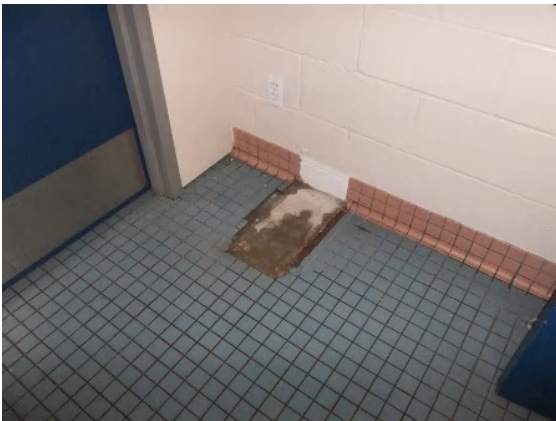
System: C3020210 - Ceramic Tile

Analysis: The system age is either beyond expected life or does not meet its intended performance under the Guidelines. The system may be in service and functioning but it is recommended to be replaced due to probable increased condition budget needs, the potential failure of its components, or in order to meet the performance Guidelines for this system. The system was installed in 1988. It has a 30-year service life. However, in the assessment, it was found to be currently deficient.

Notes: The ceramic floors, due to sewage back up, stains and other damage, should be replaced.

Recommendation: The system should be replaced.

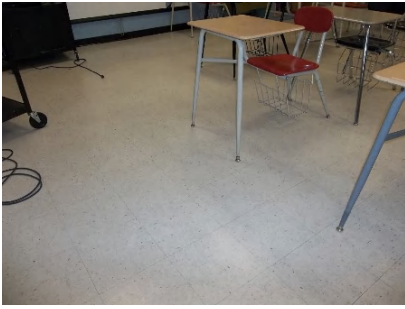
Location: Library -Building 4 (D)
Distress: Beyond Expected Life
Category: Deferred Maintenance
Priority: 3 - Short Term Conditions (2-3 Years)
Notes: The VCT flooring seems to be original to the building and beyond its expected useful life.
Correction: Renew System
Qty: 1-Ea.
Condition Budget: \$47,360

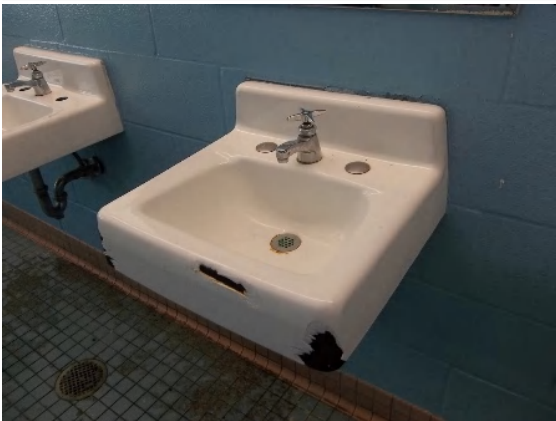
System: D2010 - Plumbing Fixtures

Analysis: The system age is either beyond expected life or does not meet its intended performance under the Guidelines. The system may be in service and functioning but it is recommended to be replaced due to probable increased condition budget needs, the potential failure of its components, or in order to meet the performance Guidelines for this system. The system was installed in 1988. It has a 30-year service life. However, in the assessment, it was found to be currently deficient.

Location: Library -Building 4 (D)
Distress: Beyond Expected Life
Category: Deferred Maintenance
Priority: 3 - Short Term Conditions (2-3 Years)
Notes: Minor updates have been done to retrofit ADA stalls. However, Plumbing Fixtures are beyond their expected life and it's recommended to be replaced.
Correction: Renew System
Qty: 1-Ea.
Condition Budget: \$212,849

Recommendation: The system should be replaced.

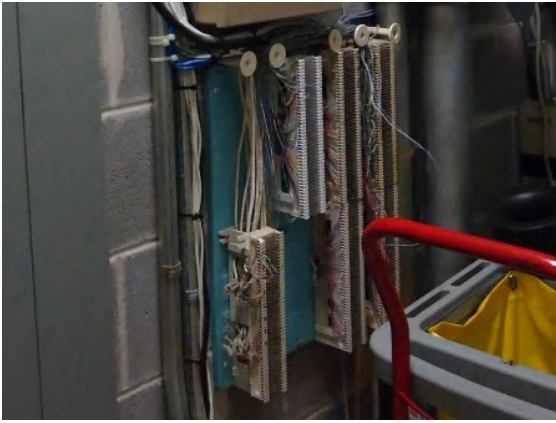
System: D5030310 - Telephone Systems

Analysis: The system age is either beyond expected life or does not meet its intended performance under the Guidelines. The system may be in service and functioning but it is recommended to be replaced due to probable increased condition budget needs, the potential failure of its components, or in order to meet the performance Guidelines for this system. The system was installed in 1988. It has a 15-year service life which expired in 2003.

Notes: Telephone Systems are beyond their expected life and it's recommended to be replaced.

Recommendation: The system should be replaced.

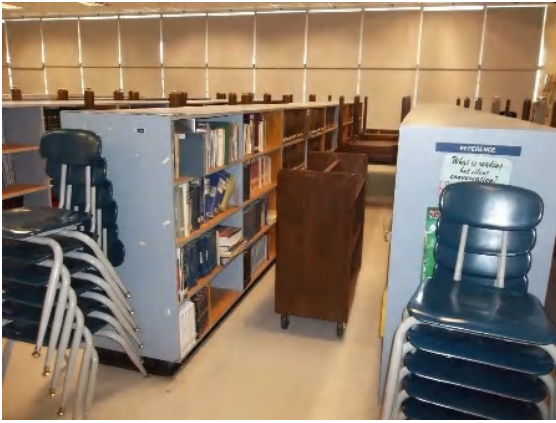
System: E1020 - Institutional Equipment

Analysis: The system age is either beyond expected life or does not meet its intended performance under the Guidelines. The system may be in service and functioning but it is recommended to be replaced due to probable increased condition budget needs, the potential failure of its components, or in order to meet the performance Guidelines for this system. The system was installed in 1988. It has a 20-year service life which expired in 2008.

Recommendation: The system should be replaced.

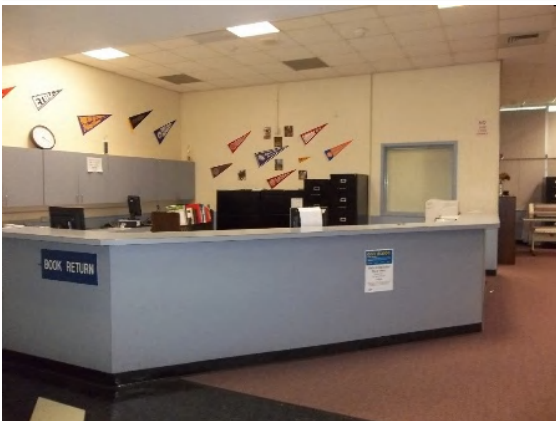
System: E2010 - Fixed Furnishings

Analysis: The system age is either beyond expected life or does not meet its intended performance under the Guidelines. The system may be in service and functioning but it is recommended to be replaced due to probable increased condition budget needs, the potential failure of its components, or in order to meet the performance Guidelines for this system. The system was installed in 1988. It has a 20-year service life which expired in 2008.

Recommendation: The system should be replaced.

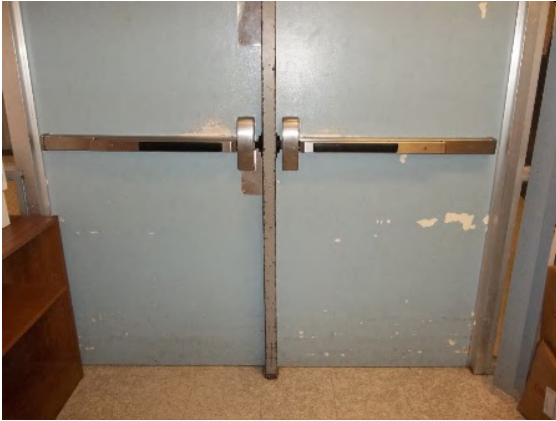
System: B2030 - Exterior Doors

Analysis: The system age is either beyond expected life or does not meet its intended performance under the Guidelines. The system may be in service and functioning but it is recommended to be replaced due to probable increased condition budget needs, the potential failure of its components, or in order to meet the performance Guidelines for this system. The system was installed in 1966. It has a 30-year service life which expired in 1996.

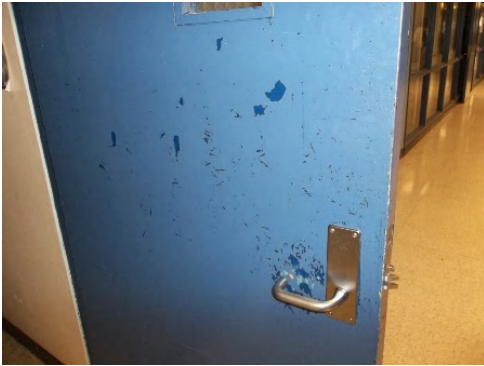
Location: Main -Building 1 (A)
Distress: Beyond Expected Life
Category: Deferred Maintenance
Priority: 3 - Short Term Conditions (2-3 Years)
Notes: The interior doors have hardware installed at a later date (likely 1992), but the doors themselves seem to be original to the building and beyond their expected useful life.

Correction: Renew System
Qty: 1-Ea.
Condition Budget: \$572,144

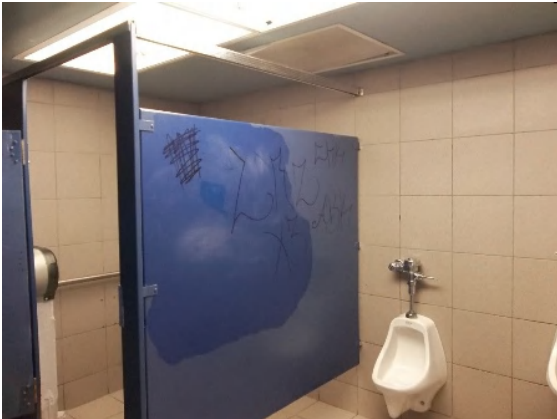
System: C1030 - Fittings

Analysis: The system age is either beyond expected life or does not meet its intended performance under the Guidelines. The system may be in service and functioning but it is recommended to be replaced due to probable increased condition budget needs, the potential failure of its components, or in order to meet the performance Guidelines for this system. The system was installed in 2004. It has a 20-year service life. However, in the assessment, it was found to be currently deficient.

Recommendation: The system should be replaced.

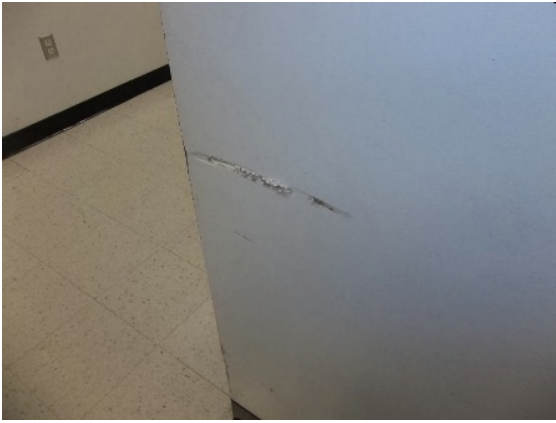
System: C3010 - Wall Finishes

Analysis: The system age is either beyond expected life or does not meet its intended performance under the Guidelines. The system may be in service and functioning but it is recommended to be replaced due to probable increased condition budget needs, the potential failure of its components, or in order to meet the performance Guidelines for this system. The system was installed in 1966. It has a 10-year service life which expired in 1976.

Recommendation: The system should be replaced.

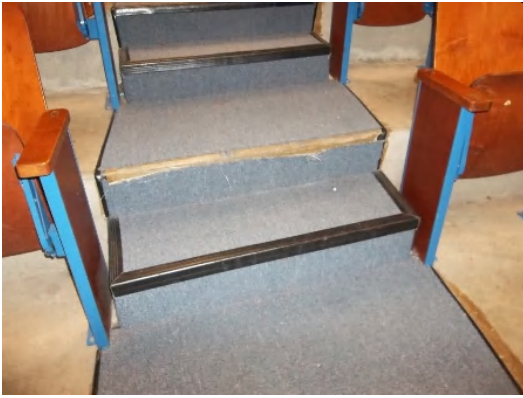
Location: Main -Building 1 (A)
Distress: Beyond Expected Life
Category: Deferred Maintenance
Priority: 3 - Short Term Conditions (2-3 Years)
Notes: Carpets in the building are in fair condition except for excessive staining and damaged seams. The system should be replaced for aesthetics and practical reasons, such as potential tripping hazard at the seams.

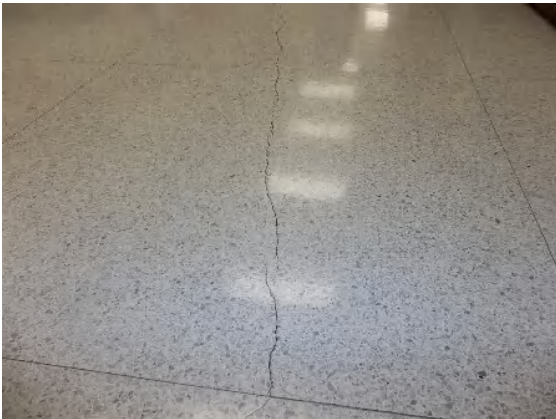
System: C3020410 - Terrazzo

Analysis: The system is in use and functioning with an estimated remaining service life as indicated in the report section "Condition/Replacement Budget Detail". The system was installed in 1966. It has a 50-year service life. However, in the assessment, it was found to be currently deficient.

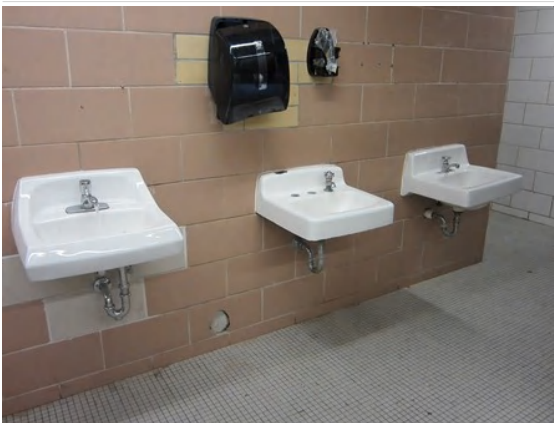
System: D2010 - Plumbing Fixtures

Analysis: The system age is either beyond expected life or does not meet its intended performance under the Guidelines. The system may be in service and functioning but it is recommended to be replaced due to probable increased condition budget needs, the potential failure of its components, or in order to meet the performance Guidelines for this system. The system was installed in 2004. It has a 30-year service life. However, in the assessment, it was found to be currently deficient.

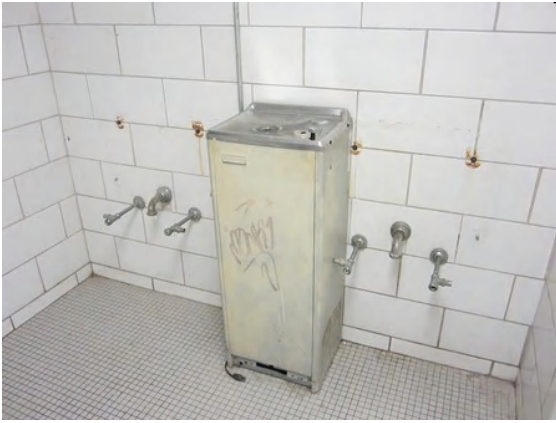
System: D2020 - Domestic Water Distribution

Analysis: The system age is either beyond expected life or does not meet its intended performance under the Guidelines. The system may be in service and functioning but it is recommended to be replaced due to probable increased condition budget needs, the potential failure of its components, or in order to meet the performance Guidelines for this system. The system was installed in 1966. It has a 30-year service life which expired in 1996.

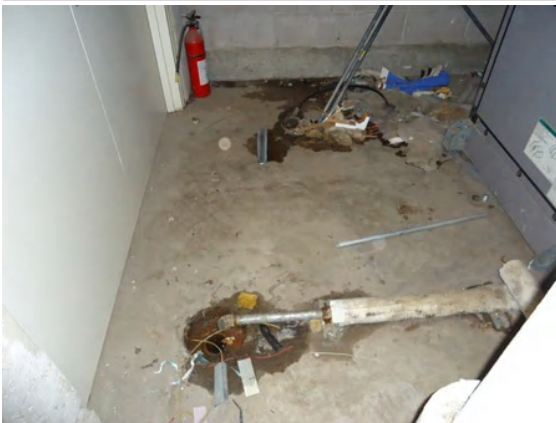
System: D2030 - Sanitary Waste

Analysis: The system age is either beyond expected life or does not meet its intended performance under the Guidelines. The system may be in service and functioning but it is recommended to be replaced due to probable increased condition budget needs, the potential failure of its components, or in order to meet the performance Guidelines for this system. The system was installed in 1966. It has a 30-year service life which expired in 1996.

Recommendation: The system should be replaced.

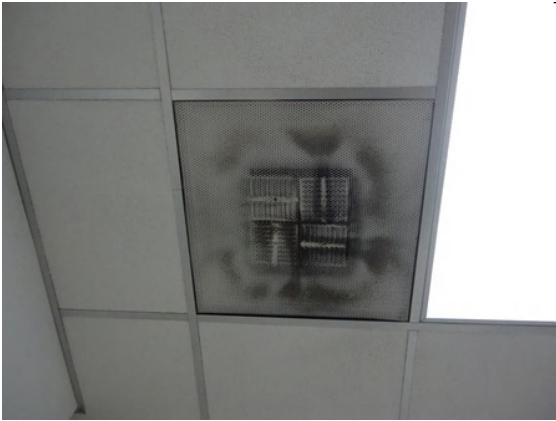
System: D3070 - Systems Testing & Balance

Analysis: The system age is either beyond expected life or does not meet its intended performance under the Guidelines. The system may be in service and functioning but it is recommended to be replaced due to probable increased condition budget needs, the potential failure of its components, or in order to meet the performance Guidelines for this system. The system was installed in 2003. It has a 30-year service life. However, in the assessment, it was found to be currently deficient.

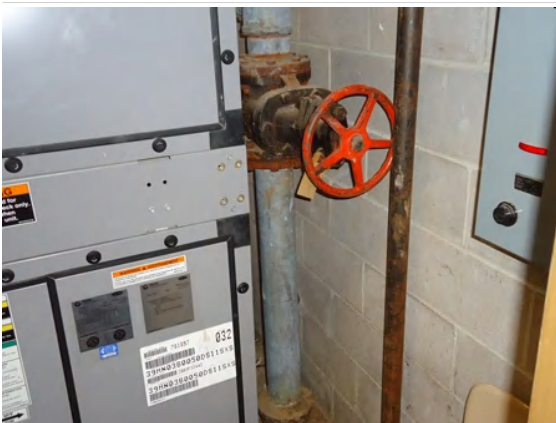
System: D4020 - Standpipes

Analysis: The system age is either beyond expected life or does not meet its intended performance under the Guidelines. The system may be in service and functioning but it is recommended to be replaced due to probable increased condition budget needs, the potential failure of its components, or in order to meet the performance Guidelines for this system. The system was installed in 1966. It has a 40-year service life which expired in 2006.

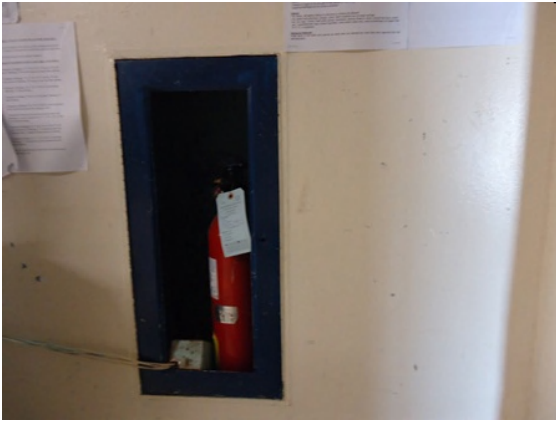
System: D4030 - Fire Protection Specialties

Analysis: The system age is either beyond expected life or does not meet its intended performance under the Guidelines. The system may be in service and functioning but it is recommended to be replaced due to probable increased condition budget needs, the potential failure of its components, or in order to meet the performance Guidelines for this system. The system was installed in 2003. It has a 15-year service life. However, in the assessment, it was found to be currently deficient.

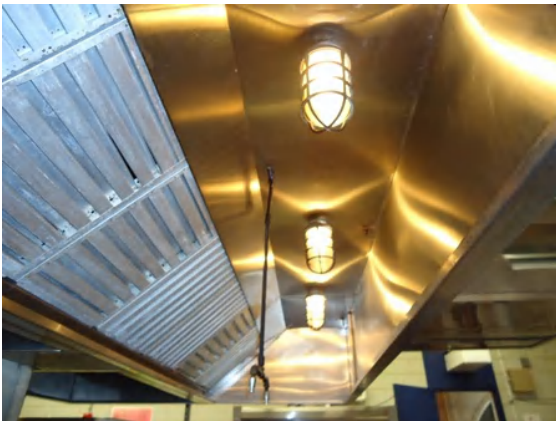
System: D4090 - Other Fire Protection Systems

Analysis: The system age is either beyond expected life or does not meet its intended performance under the Guidelines. The system may be in service and functioning but it is recommended to be replaced due to probable increased condition budget needs, the potential failure of its components, or in order to meet the performance Guidelines for this system. The system was installed in 1997. It has a 15-year service life. However, in the assessment, it was found to be currently deficient.

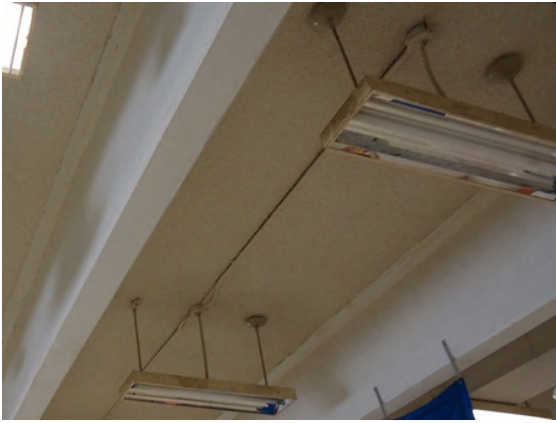
System: D5020 - Lighting and Branch Wiring

Analysis: The system age is either beyond expected life or does not meet its intended performance under the Guidelines. The system may be in service and functioning but it is recommended to be replaced due to probable increased condition budget needs, the potential failure of its components, or in order to meet the performance Guidelines for this system. The system was installed in 1966. It has a 30-year service life which expired in 1996.

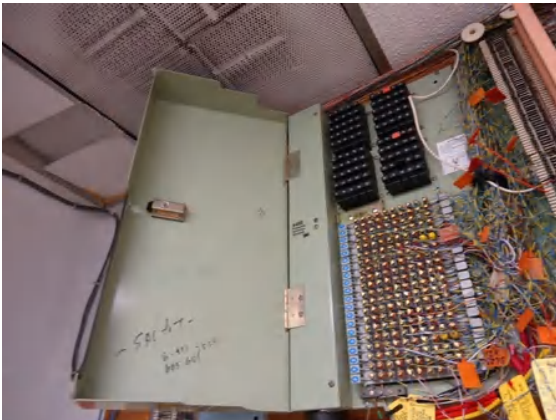
System: D5030310 - Telephone Systems

Analysis: The system age is either beyond expected life or does not meet its intended performance under the Guidelines. The system may be in service and functioning but it is recommended to be replaced due to probable increased condition budget needs, the potential failure of its components, or in order to meet the performance Guidelines for this system. The system was installed in 1966. It has a 15-year service life which expired in 1981.

Recommendation: The system should be replaced.

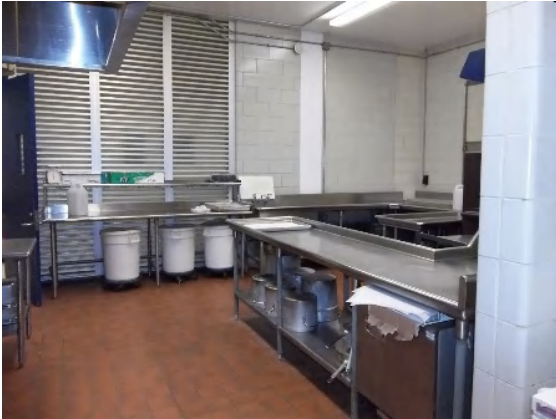
System: E1090 - Other Equipment

Analysis: The system age is either beyond expected life or does not meet its intended performance under the Guidelines. The system may be in service and functioning but it is recommended to be replaced due to probable increased condition budget needs, the potential failure of its components, or in order to meet the performance Guidelines for this system. The system was installed in 1992. It has a 20-year service life. However, in the assessment, it was found to be currently deficient.

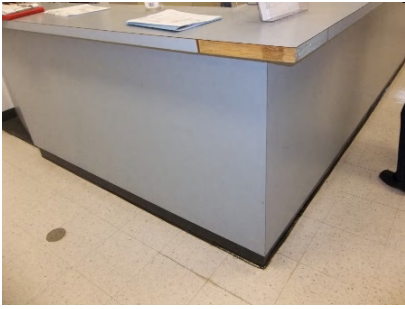
Location: Main -Building 1 (A)

Notes: The fixed furnishings seem to have been installed sometime during the 1990's and are damaged.

Recommendation: The system should be replaced.

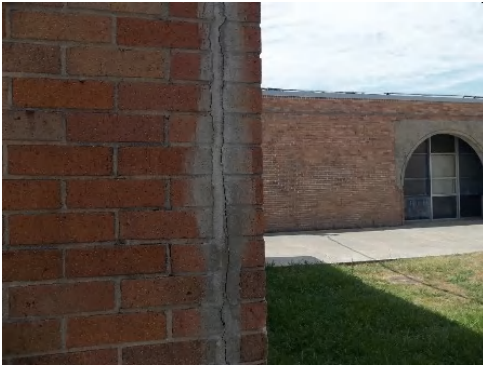
Location: Storage -Building 7 (F)

Analysis: The system age is either beyond expected life or does not meet its intended performance under the Guidelines. The system may be in service and functioning but it is recommended to be replaced due to probable increased condition budget needs, the potential failure of its components, or in order to meet the performance Guidelines for this system. The system was installed in 1966. It has a 75-year service life. However, in the assessment, it was found to be currently deficient.

Notes: The wall by the main entrance has a major portion made out of damaged plywood; on the east and west walls there are considerable cracks in the masonry.

Recommendation: The system should be replaced.

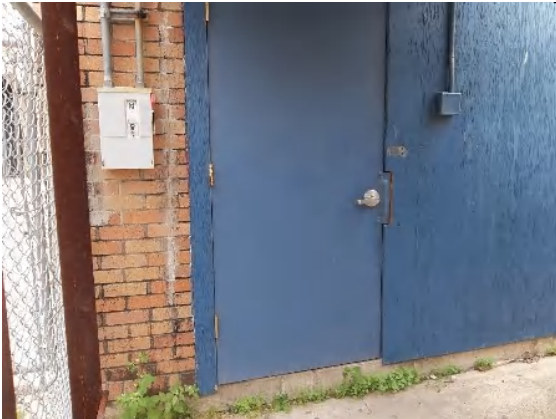
System: B2030 - Exterior Doors

Analysis: The system age is either beyond expected life or does not meet its intended performance under the Guidelines. The system may be in service and functioning but it is recommended to be replaced due to probable increased condition budget needs, the potential failure of its components, or in order to meet the performance Guidelines for this system. The system was installed in 1966. It has a 30-year service life which expired in 1996.

Recommendation: The system should be replaced.
