School Assessment Report

Type: High Schools
School: Milby High School
Date: Jul 16, 2012

School Name: Milby High School

Milby High School campus is located at 1601 Broadway Street, Houston TX, and consists of 8 main school buildings. The original campus was constructed in 1926 and additions to the main school building was/were constructed in 1934, 1940, 1959, 1960, and 1978. Ancillary buildings on campus include classroom buildings, gym, T-Buildings, storage building. In addition to the buildings, the campus contains covered walkways, baseball field, football field with bleachers, and track. This report contains condition and adequacy data collected during the 2012 Facility Condition Assessment (FCA). The detailed condition and deficiency statements are contained in this report for each building and other facilities on the campus.

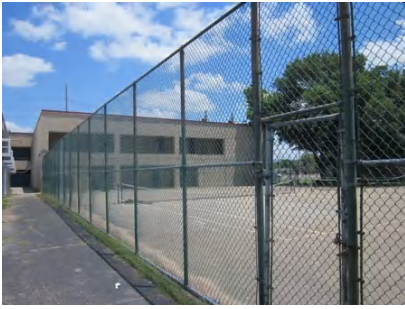
Location: Site

Distress: Inadequate

Notes: The tennis court is inadequate. Replace the equipment and resurface the courts.
