School Assessment Report

School: Sam Houston High School

Date: Jul 16, 2012

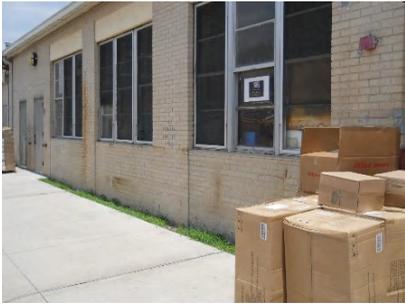
Location: Building 5 - E
Distress: Beyond Expected Life
Category: Deferred Maintenance
Priority: 3 - Short Term Conditions (2-3 Years)
Notes: Exterior Windows System beyond useful life.
Replace

Correction: Renew System
Qty: 1-Ea.
Condition Budget: \$151,005

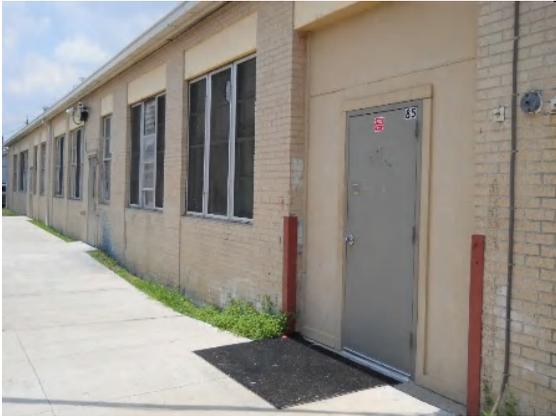
System: B2030 - Exterior Doors

Analysis: The system age is either beyond expected life or does not meet its intended performance under the Guidelines. The system may be in service and functioning but it is recommended to be replaced due to probable increased condition budget needs, the potential failure of its components, or in order to meet the performance Guidelines for this system. The system was installed in 1978. It has a 30-year service life which expired in 2008.

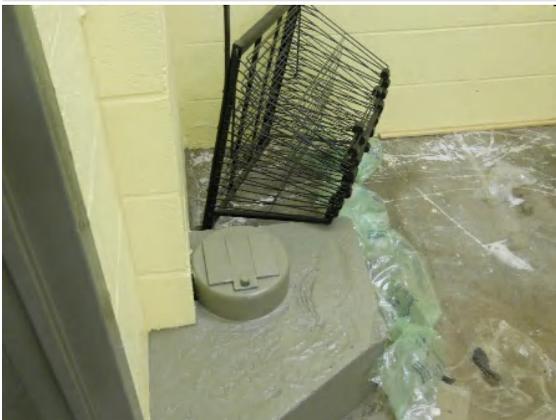
System: C1030 - Fittings

Analysis: The system age is either beyond expected life or does not meet its intended performance under the Guidelines. The system may be in service and functioning but it is recommended to be replaced due to probable increased condition budget needs, the potential failure of its components, or in order to meet the performance Guidelines for this system. The system was installed in 1978. It has a 20-year service life which expired in 1998.

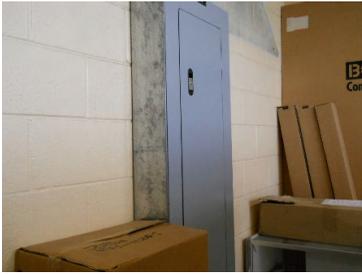
Location: Building 5 - E
Distress: Beyond Expected Life
Category: Deferred Maintenance
Priority: 3 - Short Term Conditions (2-3 Years)
Notes: Wall Finishes System beyond useful life. Replace
Correction: Renew System
Qty: 1-Ea.
Condition Budget: \$88,611

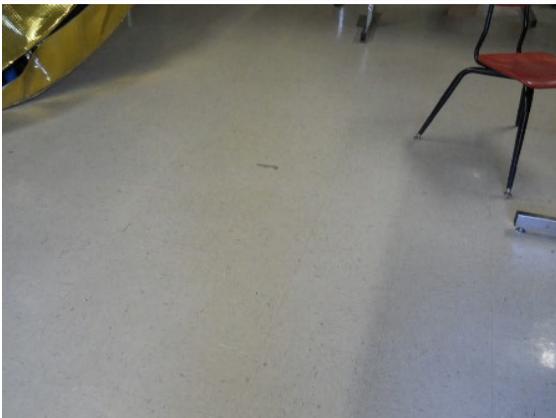
System: C3020410 - VCT

Analysis: The system age is either beyond expected life or does not meet its intended performance under the Guidelines. The system may be in service and functioning but it is recommended to be replaced due to probable increased condition budget needs, the potential failure of its components, or in order to meet the performance Guidelines for this system. The system was installed in 1978. It has a 12-year service life which expired in 1990.

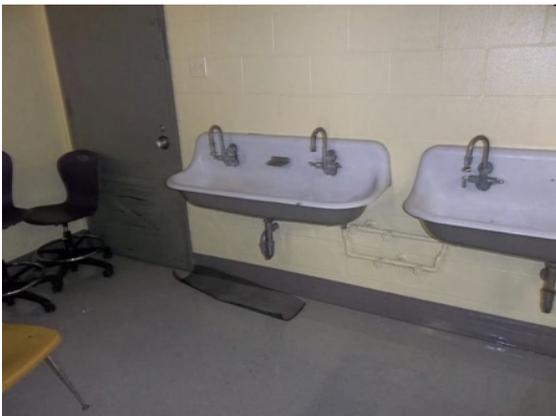
System: D2020 - Domestic Water Distribution

Analysis: The system age is either beyond expected life or does not meet its intended performance under the Guidelines. The system may be in service and functioning but it is recommended to be replaced due to probable increased condition budget needs, the potential failure of its components, or in order to meet the performance Guidelines for this system. The system was installed in 1978. It has a 30-year service life which expired in 2008.

Location: Building 5 - E
Distress: Beyond Expected Life
Category: Deferred Maintenance
Priority: 3 - Short Term Conditions (2-3 Years)
Notes: Domestic Water Distribution System beyond useful life. Replace
Correction: Renew System
Qty: 1-Ea.
Condition Budget: \$11,404

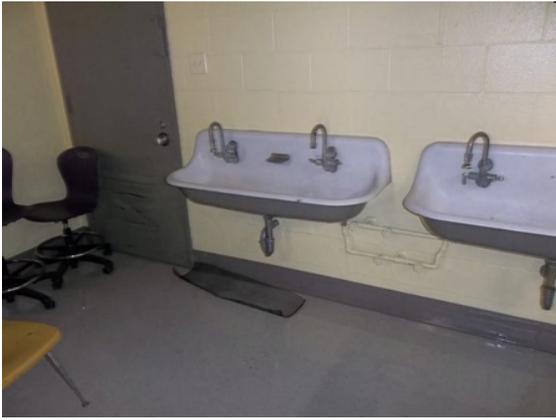
System: D2030 - Sanitary Waste

Analysis: The system age is either beyond expected life or does not meet its intended performance under the Guidelines. The system may be in service and functioning but it is recommended to be replaced due to probable increased condition budget needs, the potential failure of its components, or in order to meet the performance Guidelines for this system. The system was installed in 1978. It has a 30-year service life which expired in 2008.

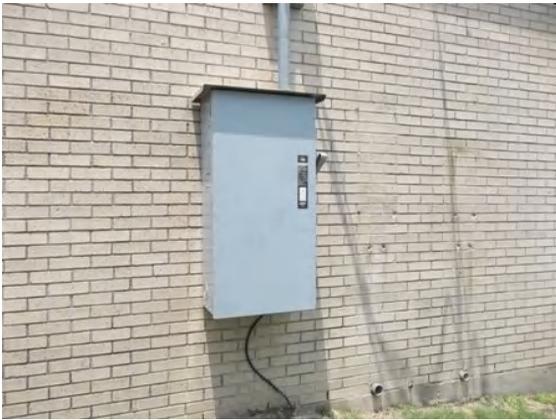
System: D5010 - Electrical Service/Distribution

Analysis: The system age is either beyond expected life or does not meet its intended performance under the Guidelines. The system may be in service and functioning but it is recommended to be replaced due to probable increased condition budget needs, the potential failure of its components, or in order to meet the performance Guidelines for this system. The system was installed in 1978. It has a 30-year service life which expired in 2008.

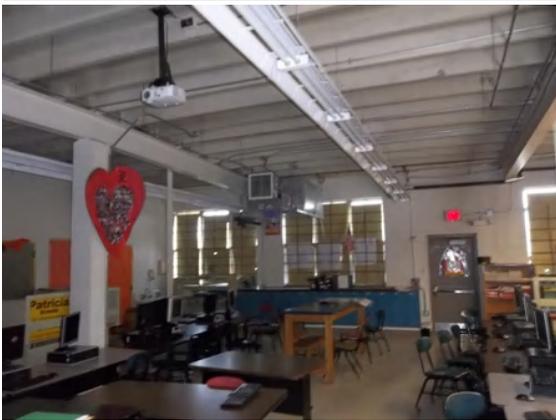
System: D5020 - Lighting and Branch Wiring

Analysis: The system age is either beyond expected life or does not meet its intended performance under the Guidelines. The system may be in service and functioning but it is recommended to be replaced due to probable increased condition budget needs, the potential failure of its components, or in order to meet the performance Guidelines for this system. The system was installed in 1978. It has a 30-year service life which expired in 2008.

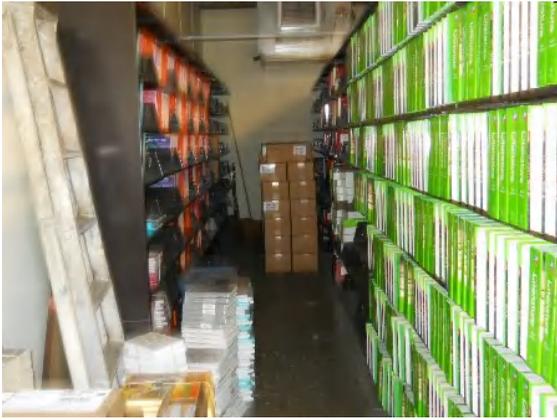
System: E2010 - Fixed Furnishings

Analysis: The system age is either beyond expected life or does not meet its intended performance under the Guidelines. The system may be in service and functioning but it is recommended to be replaced due to probable increased condition budget needs, the potential failure of its components, or in order to meet the performance Guidelines for this system. The system was installed in 1978. It has a 20-year service life which expired in 1998.

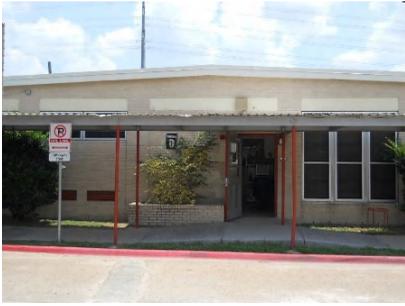
Location: Cosmetology Building 4 - D
Distress: Beyond Expected Life
Category: Deferred Maintenance
Priority: 3 - Short Term Conditions (2-3 Years)
Notes: Exterior Windows System beyond useful life.
Replace

Correction: Renew System
Qty: 1-Ea.

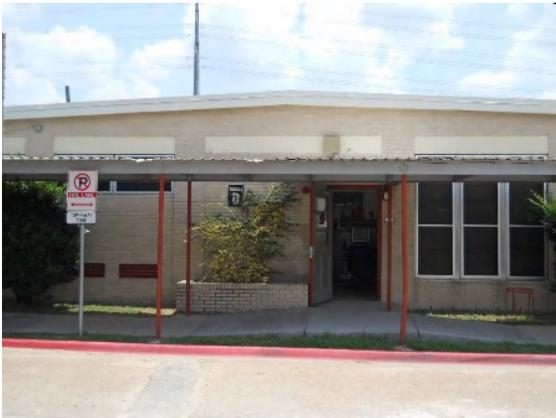
System: B2030 - Exterior Doors

Analysis: The system age is either beyond expected life or does not meet its intended performance under the Guidelines. The system may be in service and functioning but it is recommended to be replaced due to probable increased condition budget needs, the potential failure of its components, or in order to meet the performance Guidelines for this system. The system was installed in 1978. It has a 30-year service life which expired in 2008.

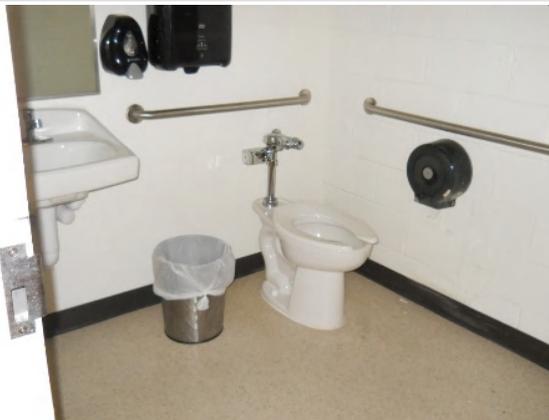
System: C1030 - Fittings

Analysis: The system age is either beyond expected life or does not meet its intended performance under the Guidelines. The system may be in service and functioning but it is recommended to be replaced due to probable increased condition budget needs, the potential failure of its components, or in order to meet the performance Guidelines for this system. The system was installed in 1978. It has a 20-year service life which expired in 1998.

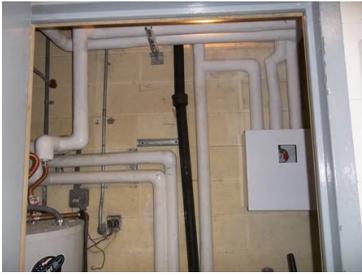
Location: Cosmetology Building 4 - D
Distress: Beyond Expected Life
Category: Deferred Maintenance
Priority: 3 - Short Term Conditions (2-3 Years)
Notes: Sanitary Sewer System beyond useful life. Replace
Correction: Renew System
Qty: 1-Ea.
Condition Budget: \$7,600

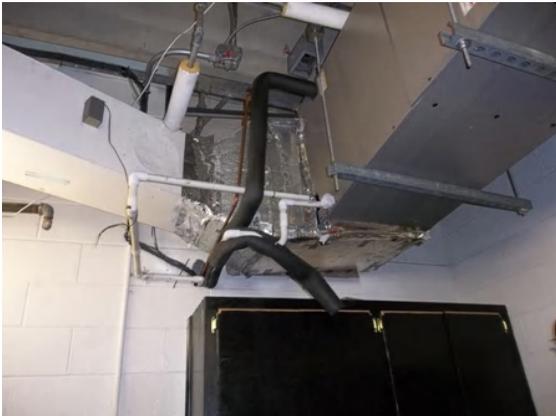
System: D3040 - Distribution Systems

Analysis: The system age is either beyond expected life or does not meet its intended performance under the Guidelines. The system may be in service and functioning but it is recommended to be replaced due to probable increased condition budget needs, the potential failure of its components, or in order to meet the performance Guidelines for this system. The system was installed in 1978. It has a 30-year service life which expired in 2008.

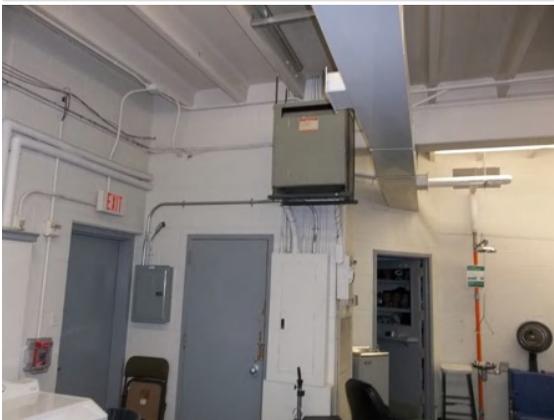
System: D5010 - Electrical Service/Distribution

Analysis: The system age is either beyond expected life or does not meet its intended performance under the Guidelines. The system may be in service and functioning but it is recommended to be replaced due to probable increased condition budget needs, the potential failure of its components, or in order to meet the performance Guidelines for this system. The system was installed in 1978. It has a 30-year service life which expired in 2008.

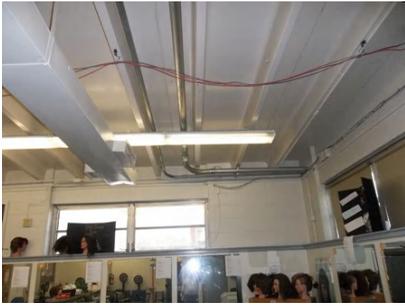
Location: Cosmetology Building 4 - D
Distress: Beyond Expected Life
Category: Deferred Maintenance
Priority: 3 - Short Term Conditions (2-3 Years)
Notes: Lighting and Branch Wiring System beyond useful life. Replace
Correction: Renew System
Qty: 1-Ea.
Condition Budget: \$54,576

Recommendation: The system should be replaced.

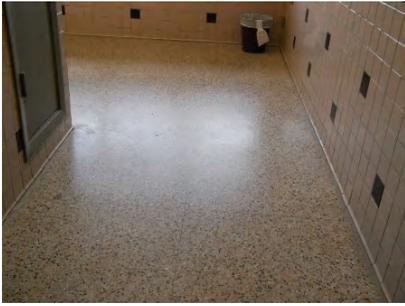
Location: Main Building 1 - A
Distress: Beyond Expected Life
Category: Deferred Maintenance
Priority: 3 - Short Term Conditions (2-3 Years)
Notes: Tile & Coverings System beyond useful life.
Replace
Correction: Renew System
Qty: 1-Ea.
Condition Budget: \$85,797

Recommendation: The system should be replaced.

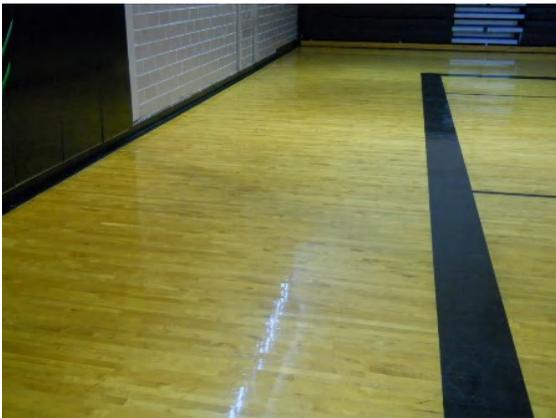
System: C3020410 - Wood

Analysis: The system age is either beyond expected life or does not meet its intended performance under the Guidelines. The system may be in service and functioning but it is recommended to be replaced due to probable increased condition budget needs, the potential failure of its components, or in order to meet the performance Guidelines for this system. The system was installed in 1954. It has a 0-year service life which expired in 1954.

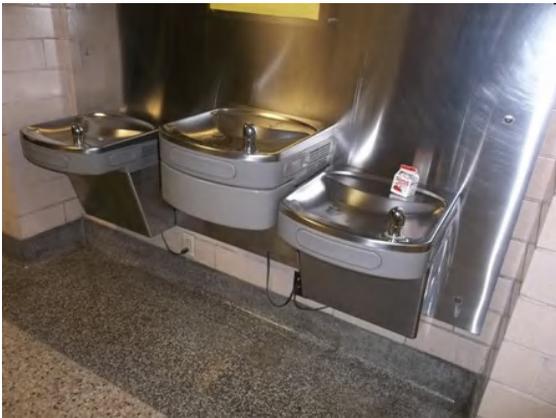
System: D2020 - Domestic Water Distribution

Analysis: The system age is either beyond expected life or does not meet its intended performance under the Guidelines. The system may be in service and functioning but it is recommended to be replaced due to probable increased condition budget needs, the potential failure of its components, or in order to meet the performance Guidelines for this system. The system was installed in 1954. It has a 30-year service life which expired in 1984.

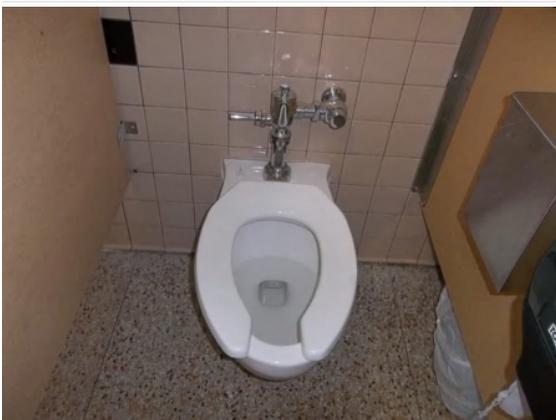
System: D2030 - Sanitary Waste

Analysis: The system age is either beyond expected life or does not meet its intended performance under the Guidelines. The system may be in service and functioning but it is recommended to be replaced due to probable increased condition budget needs, the potential failure of its components, or in order to meet the performance Guidelines for this system. The system was installed in 1954. It has a 30-year service life which expired in 1984.

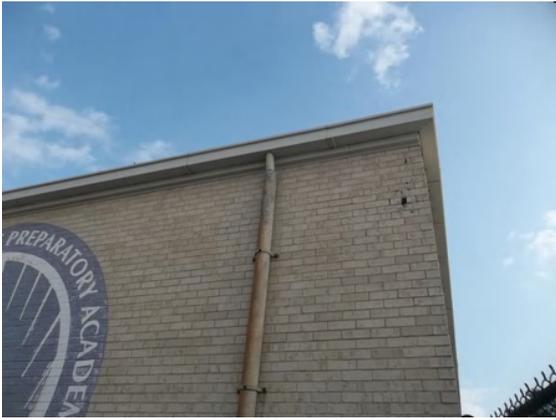
System: D2040 - Rain Water Drainage

Analysis: The system age is either beyond expected life or does not meet its intended performance under the Guidelines. The system may be in service and functioning but it is recommended to be replaced due to probable increased condition budget needs, the potential failure of its components, or in order to meet the performance Guidelines for this system. The system was installed in 1980. It has a 30-year service life which expired in 2010.

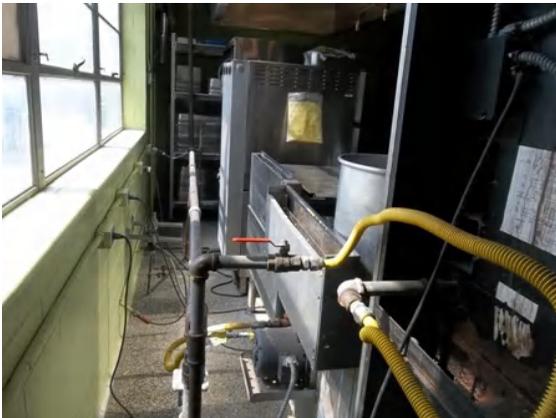
System: D2090 - Other Plumbing Systems-Nat Gas

Analysis: The system age is either beyond expected life or does not meet its intended performance under the Guidelines. The system may be in service and functioning but it is recommended to be replaced due to probable increased condition budget needs, the potential failure of its components, or in order to meet the performance Guidelines for this system. The system was installed in 1980. It has a 20-year service life which expired in 2000.

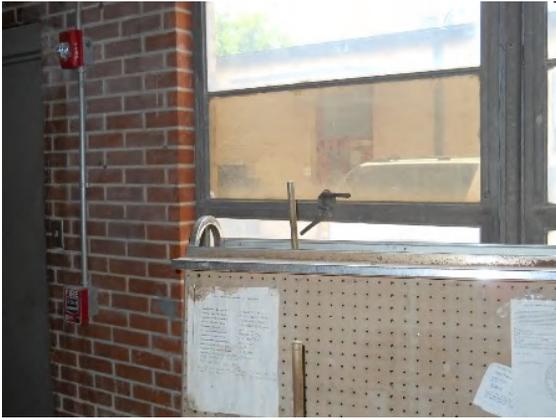
System: B2020 - Exterior Windows

Analysis: The system age is either beyond expected life or does not meet its intended performance under the Guidelines. The system may be in service and functioning but it is recommended to be replaced due to probable increased condition budget needs, the potential failure of its components, or in order to meet the performance Guidelines for this system. The system was installed in 1954. It has a 30-year service life which expired in 1984.

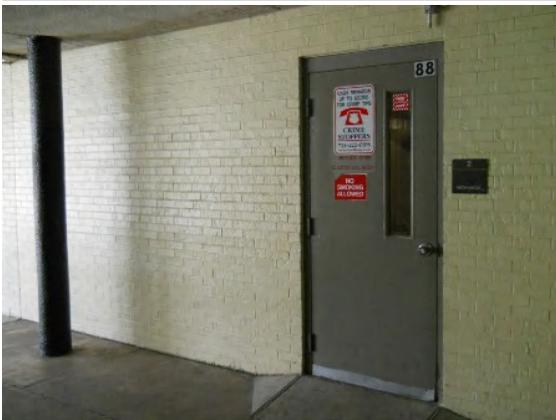
System: B2030 - Exterior Doors

Analysis: The system age is either beyond expected life or does not meet its intended performance under the Guidelines. The system may be in service and functioning but it is recommended to be replaced due to probable increased condition budget needs, the potential failure of its components, or in order to meet the performance Guidelines for this system. The system was installed in 1954. It has a 30-year service life which expired in 1984.

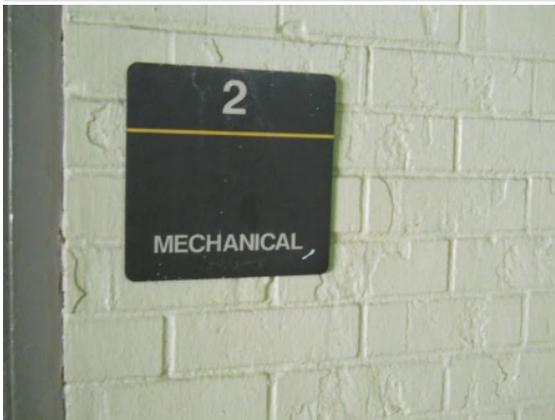
System: C1020 - Interior Doors

Analysis: The system age is either beyond expected life or does not meet its intended performance under the Guidelines. The system may be in service and functioning but it is recommended to be replaced due to probable increased condition budget needs, the potential failure of its components, or in order to meet the performance Guidelines for this system. The system was installed in 1954. It has a 40-year service life which expired in 1994.

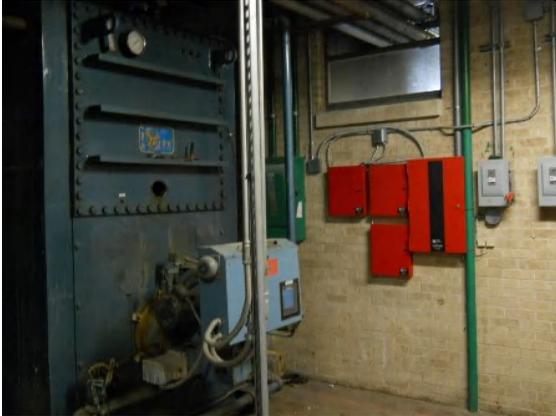
System: C3010 - Wall Finishes

Analysis: The system age is either beyond expected life or does not meet its intended performance under the Guidelines. The system may be in service and functioning but it is recommended to be replaced due to probable increased condition budget needs, the potential failure of its components, or in order to meet the performance Guidelines for this system. The system was installed in 1954. It has a 10-year service life which expired in 1964.

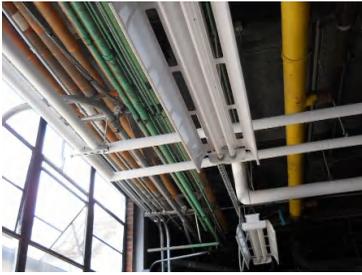
Location: Mechanical Building 6 - F
Distress: Beyond Expected Life
Category: Deferred Maintenance
Priority: 3 - Short Term Conditions (2-3 Years)
Notes: Ceiling Finishes Beyond useful life. replace
Correction: Renew System
Qty: 1-Ea.
Condition Budget: \$3,421

Recommendation: The system should be replaced.
