School Assessment Report

School: Sharpstown International School, Charter High School

Date: Jul 16, 2012

School Name: Sharpstown International School, Charter High School

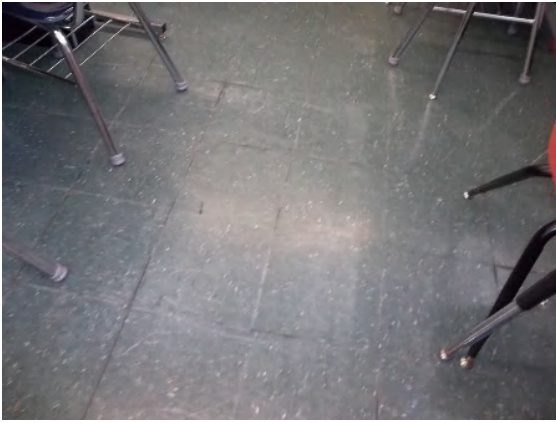
Location: Main Bld 1

Analysis: The system age is either beyond expected life or does not meet its intended performance under the Guidelines. The system may be in service and functioning but it is recommended to be replaced due to probable increased condition budget needs, the potential failure of its components, or in order to meet the performance Guidelines for this system. The system was installed in 1980. It has a 0-year service life which expired in 1980.

Recommendation: The system should be replaced.

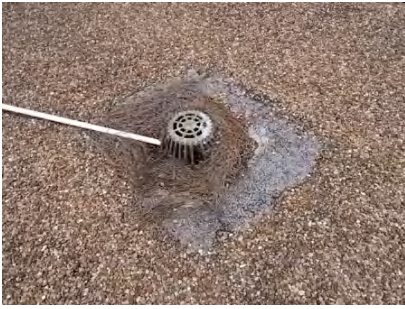
Location: Main Bld 1

Analysis: The system age is either beyond expected life or does not meet its intended performance under the Guidelines. The system may be in service and functioning but it is recommended to be replaced due to probable increased condition budget needs, the potential failure of its components, or in order to meet the performance Guidelines for this system. The system was installed in 1967. It has a 30-year service life which expired in 1997.

Recommendation: The system should be replaced.
